Averill Creek Watershed Habitat Assessment and Restoration Plan.

June 2021

Prepared by
D.R. Clough RP Bio
D.R. Clough Consulting
6966 Leland Road,
Lantzville B.C. V0R 2H0
drclough@shaw.ca

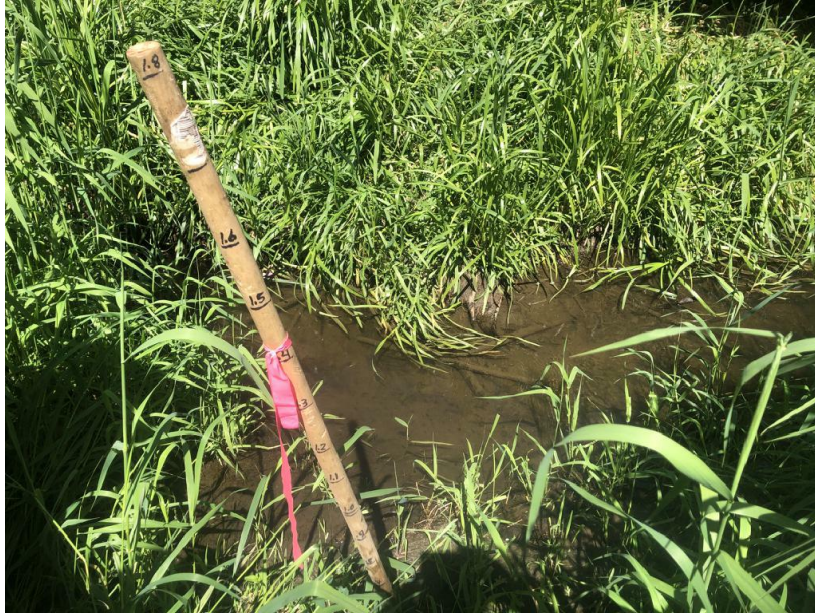
1.) Placemark 29- Reach 1, grass choked low gradient channel collects fines.

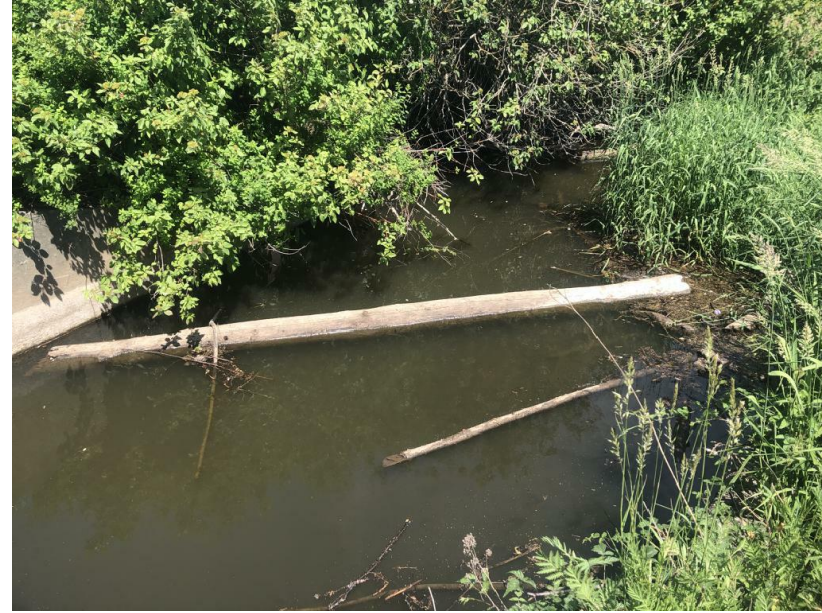
2.) Placemark 28- Reach 1, pool below highway is a sediment sump.

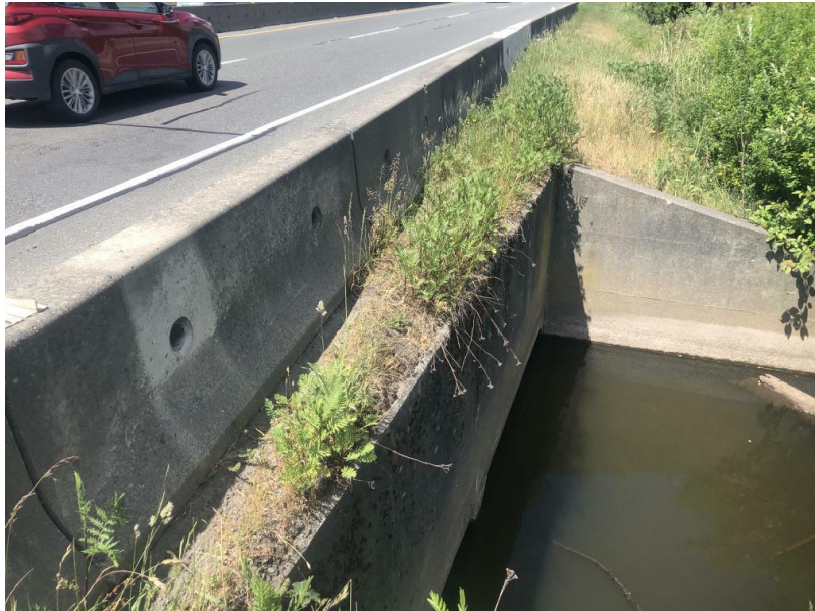
3.) Placemark 28- Reach 1, highway culvert barely above summer water level

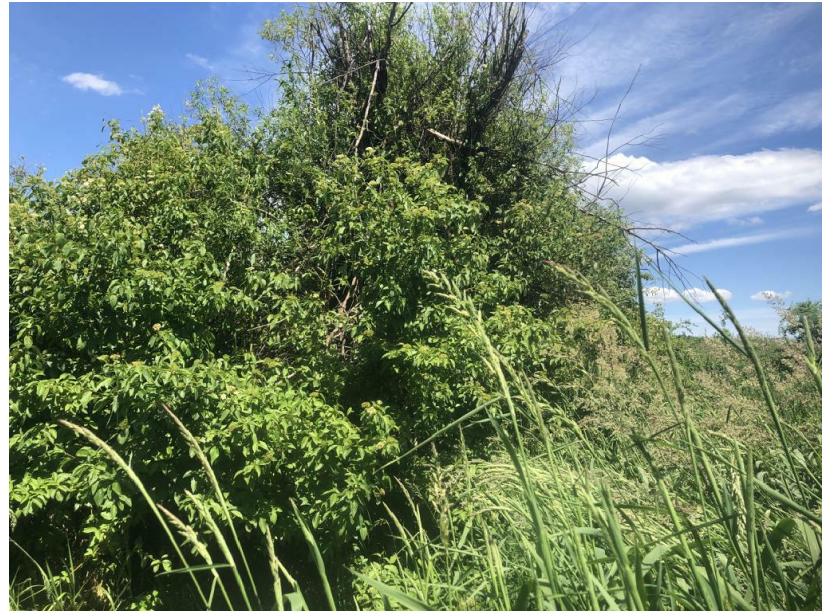
4.) Placemark 29- Reach 1, shrub and canary grass dominated riparian

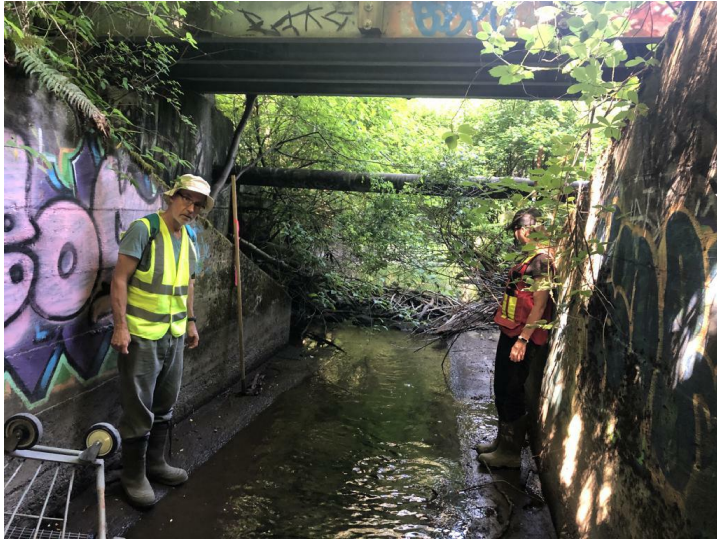
1.) Placemark 3- Reach 2 Culvert under Highway 1.

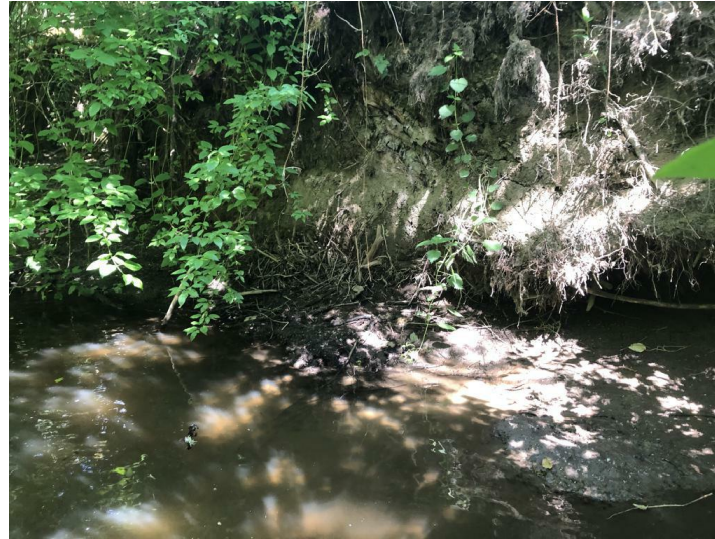
2.) Placemark 6- Reach 2, Pool 2. Heavy erosion along left bank

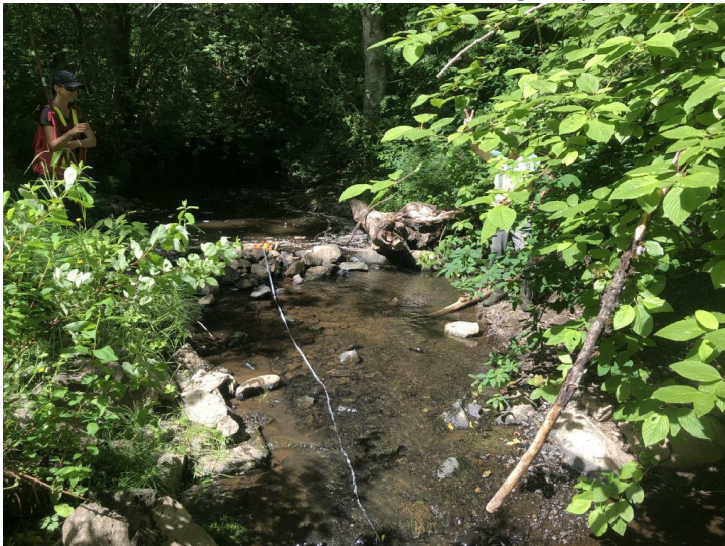
3.) Placemark 8- Reach 2, Riffle 2. Old spawning gravel crest.

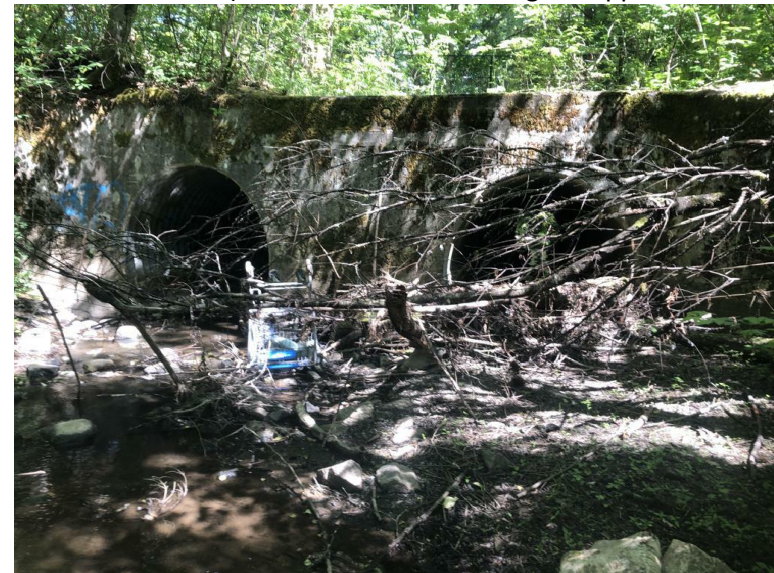
4.) Placemark 32- R3 end; culverts at the confluence with Raphael Creek.

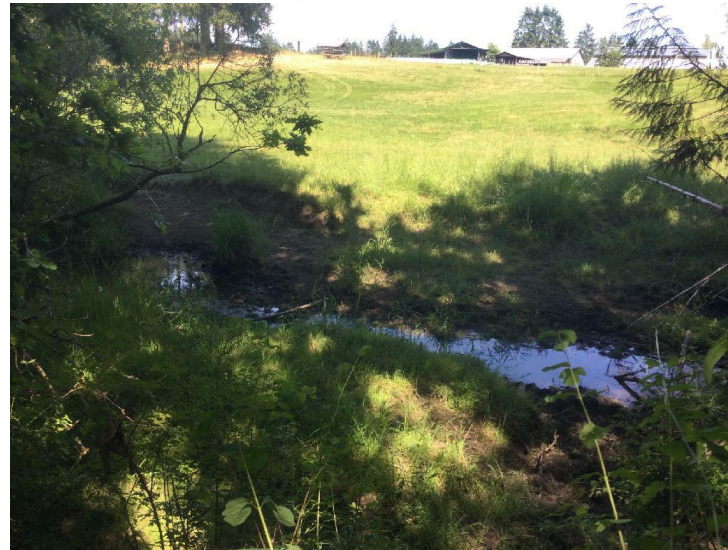
4.) Reach 4, eroded banks from livestock access.

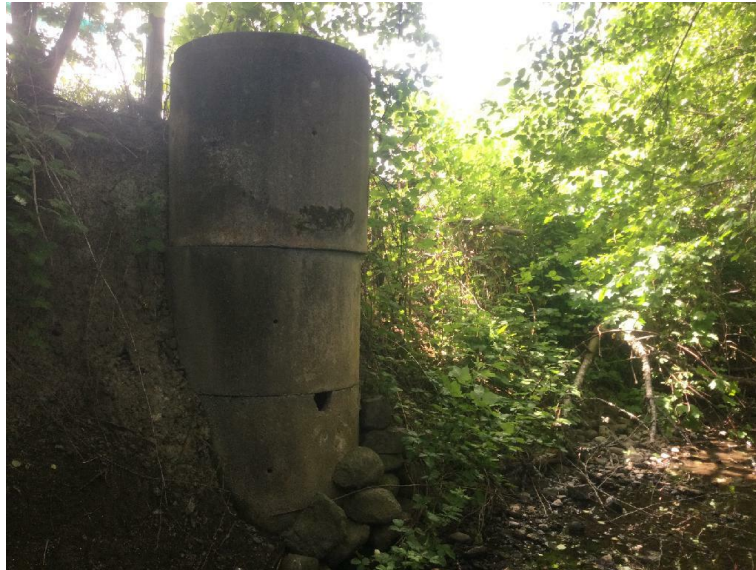
1.) Placemark 28- Reach 5, Riffle 2 well in creek.

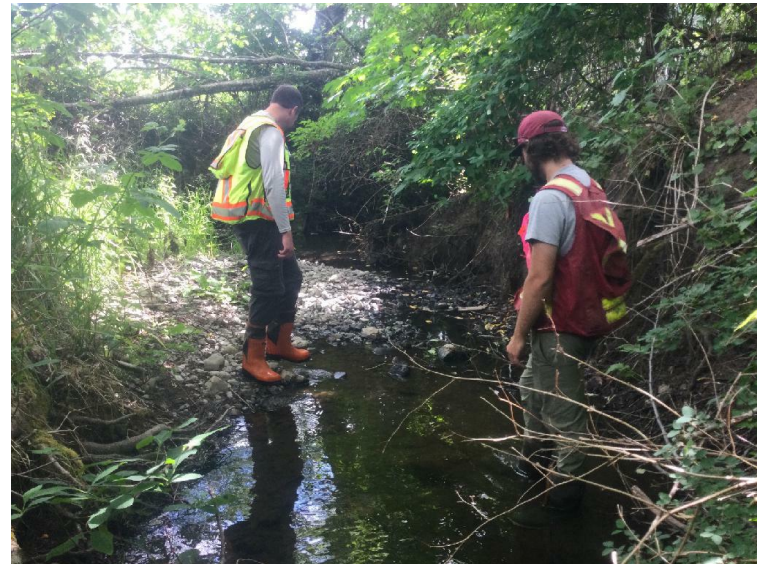
2.) Placemark 29- Reach 5, Pool 3 erosion on river right.

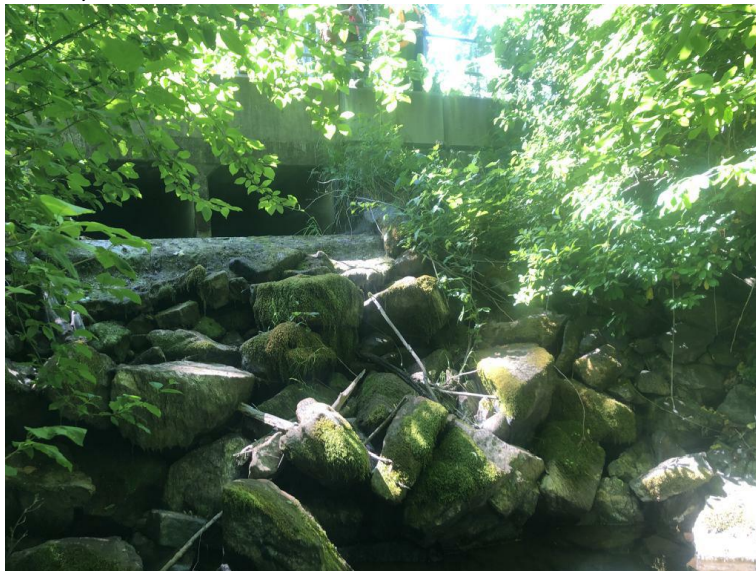
3.) Placemark 32-Reach 5 end at Somenos rd. - Fish passage barrier.

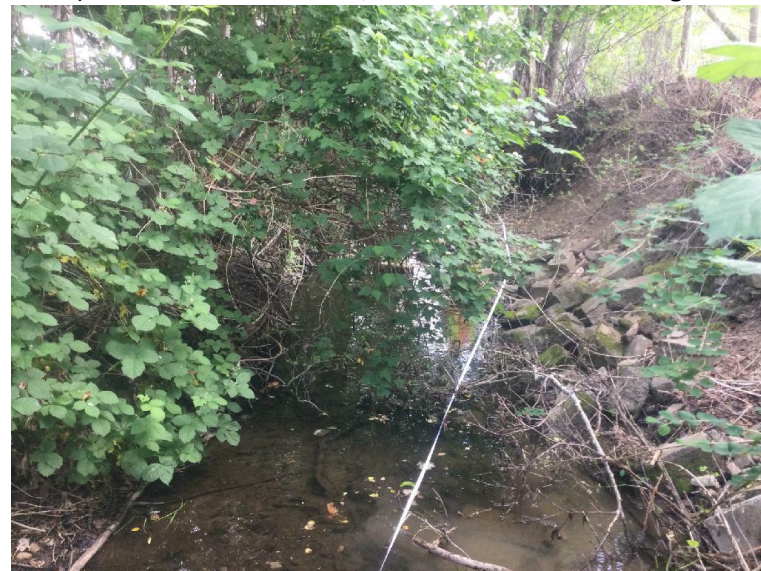
4.) Placemark 33- Reach 5, Pool 5 heavy erosion river right.

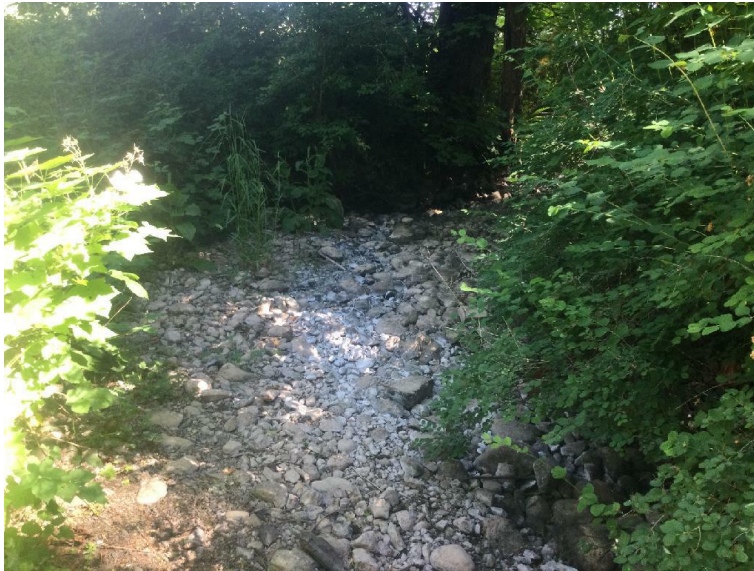
1.) Lower Reach, dry channel

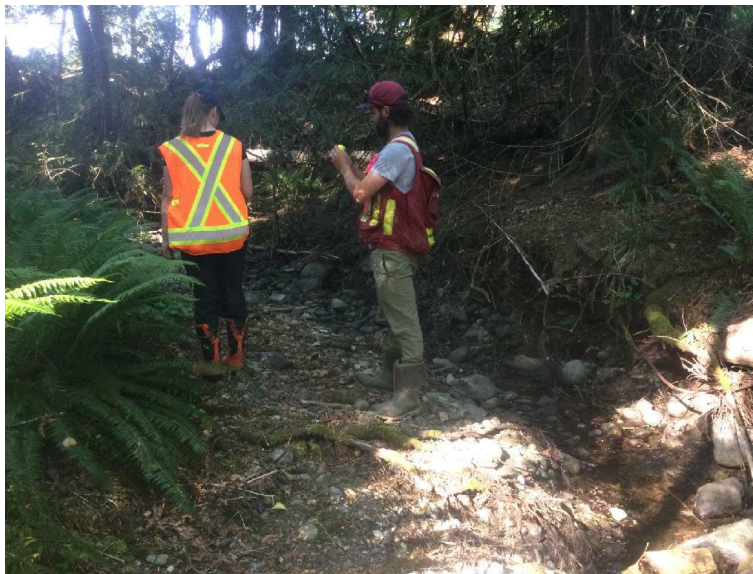
3.) Upper reach, bank erosion through golf course.

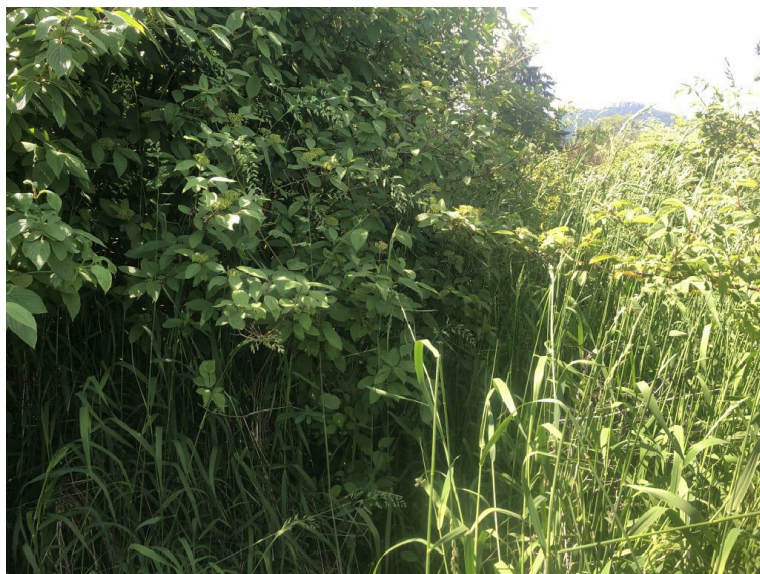
R1- Poor riparian depth and invasive canary grass

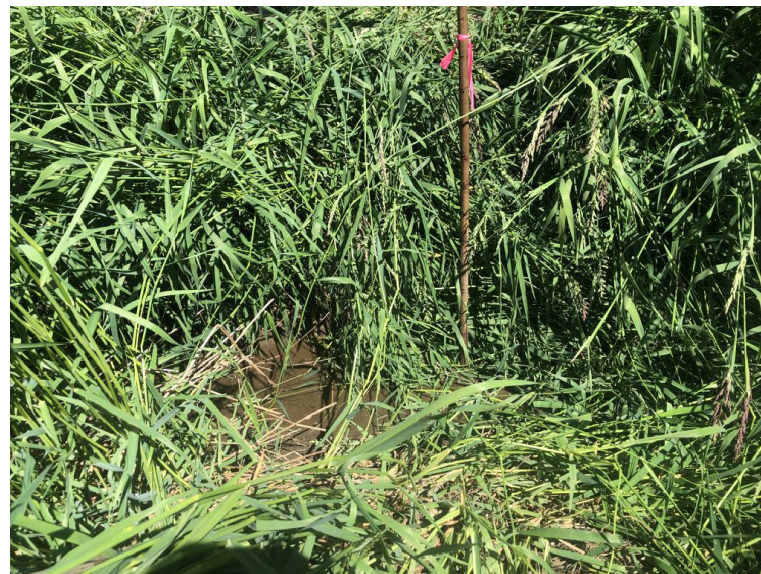
R1-Old farming irrigation ditch

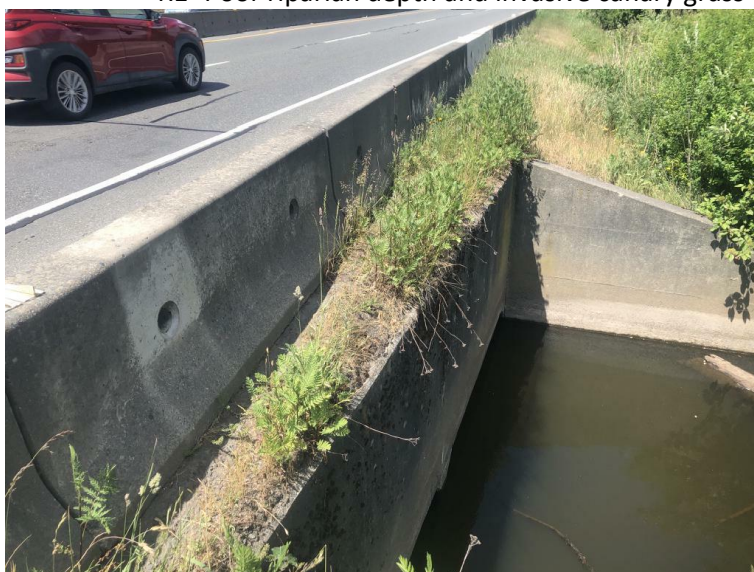
R1- Highway runoff goes straight to creek

R1	Highway runoff management plan.	Placemark 28, bridge and adjacent shoulder.	Build impermeable curb over bridge leading to rain garden.	H
R1	Sump maintenance	Highway culvert outlet.	Remove fines and debris from sump area and downstream. Fines can be used for filling irrigation ditches or creating planting mounds.	M
R2	Railway culvert is undersized (2.5m) for flow and fish passage.	Placemark 3. Railway Culvert.	Long term plan should be replacement with bridge. Routine maintenance is required to remove debris blockages. It also has garbage and a beaver dam at the upstream end.	M
R2	Spawning Gravel. Deficient in stable spawning gravel. Previous sites damaged by log debris.	Placemark 5, 8, 13 and 17. (generally at pool tail-outs)	Placemark 5: 5m wide by 3m long spawning bed upstream of riffle 1. Use imported anchor rock for crest. Placemark 8: Maintenance at existing SG site. Reposition rocks and replenish gravel. Placemark 13: Maintenance at existing SG site. Reposition anchor rocks and replenish gravel. Placemark 17: Add gravel. No crest needed.	H

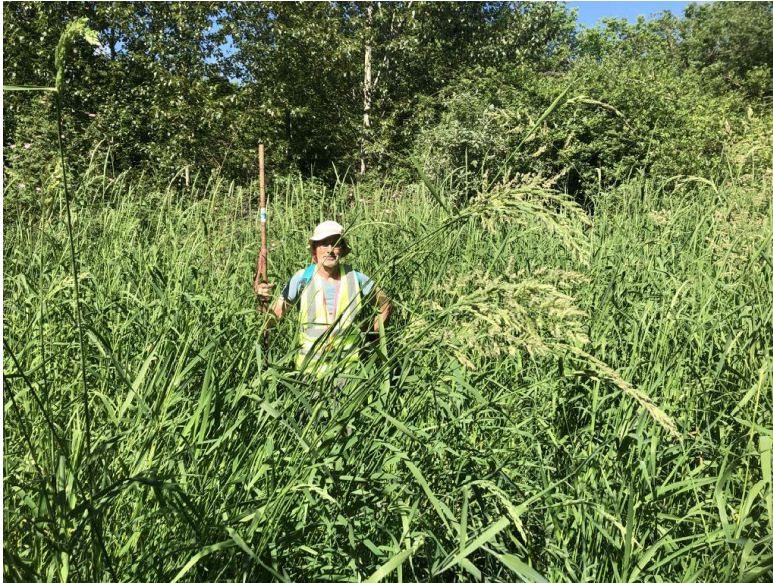
R2- Wetland on river left full of Canary Grass and Himalayan Balsam

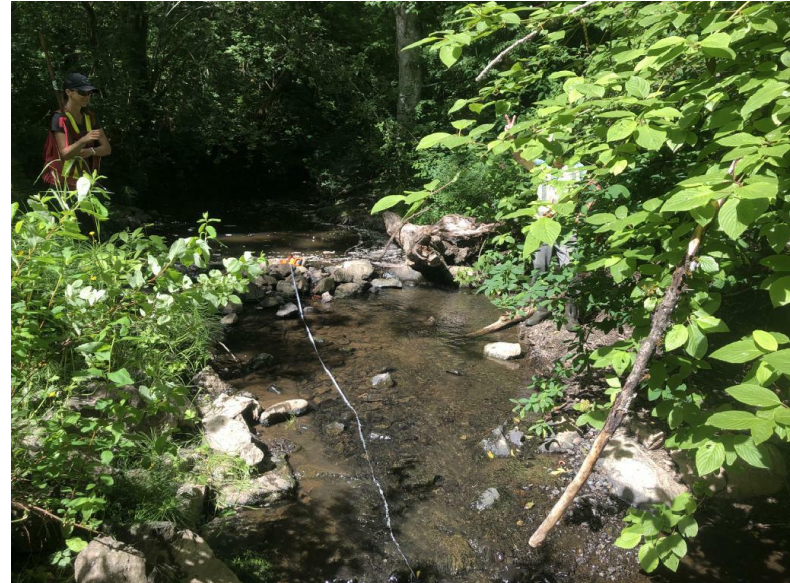
R2 –Failing riffle crest from previous restoration.

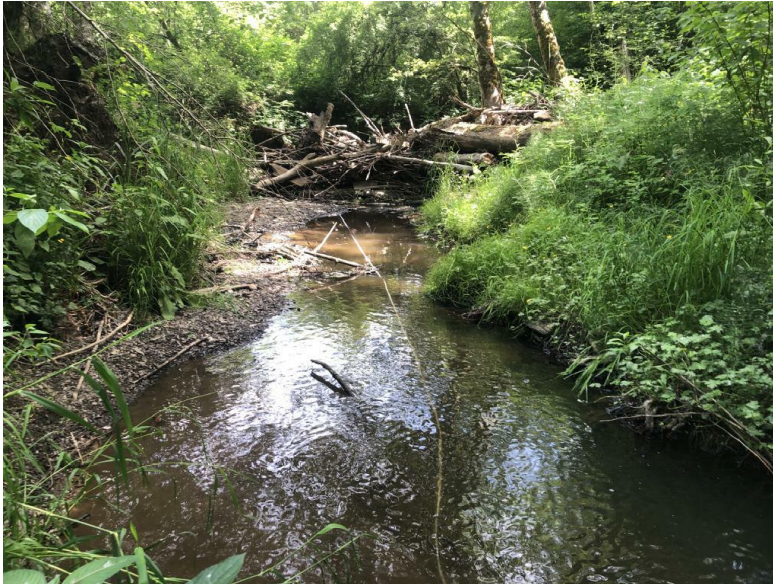
R2 – Debris Jam at pool 5

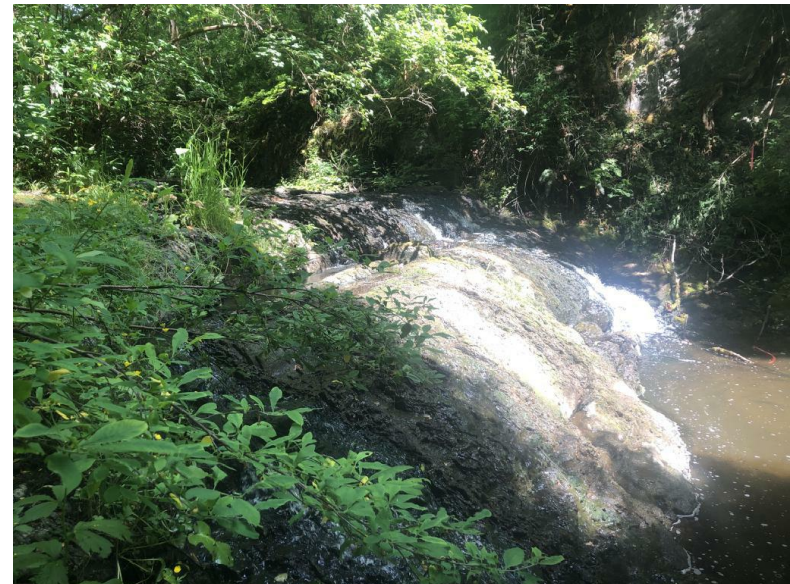
R2 – Bedrock falls, 2.2m slide (anadromous barrier)

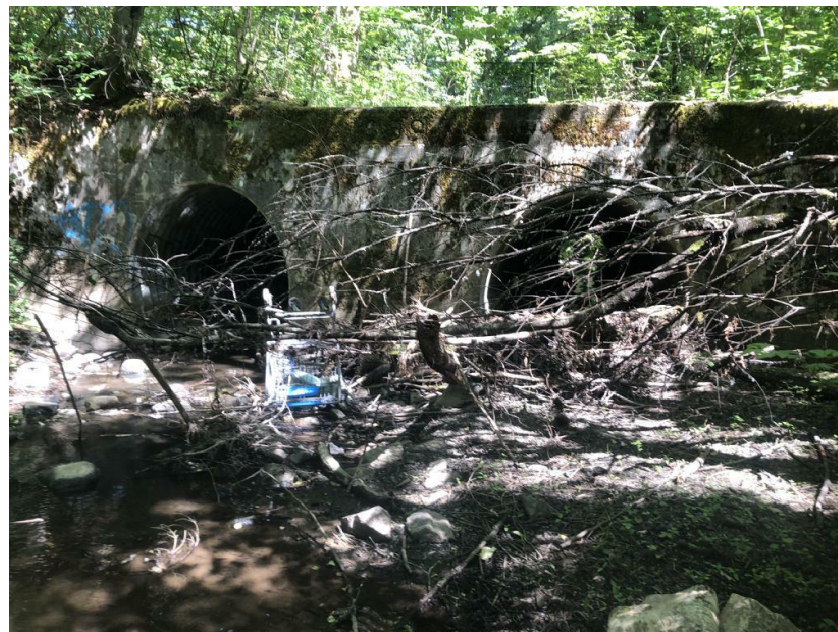
R3 – Double culvert at foot trail with debris and garbage

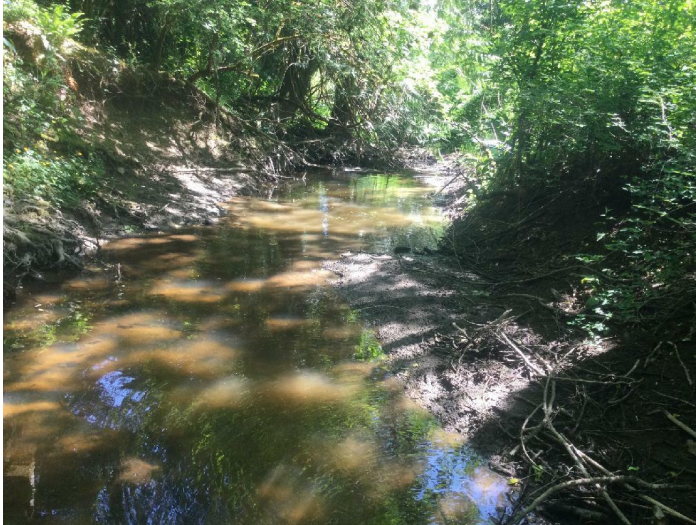
R3 –Pool 6 full of fines and heavily eroded, unstable banks

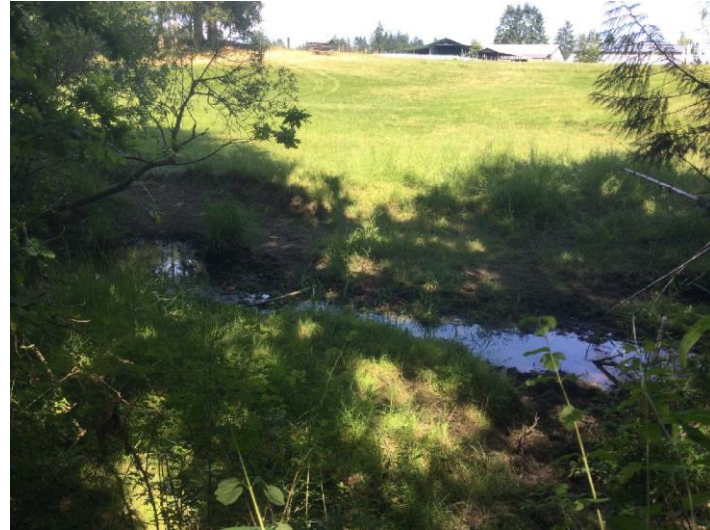
R3 – Cows in creek on east side of the railroad.

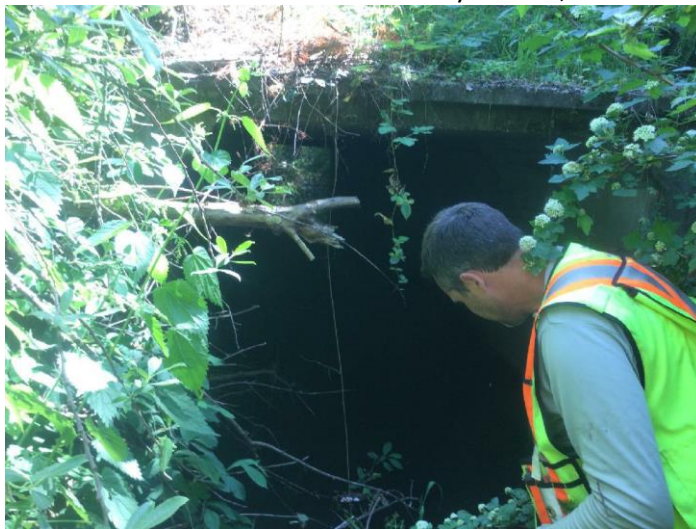
R3 – Drinkwater rd. concrete box culvert

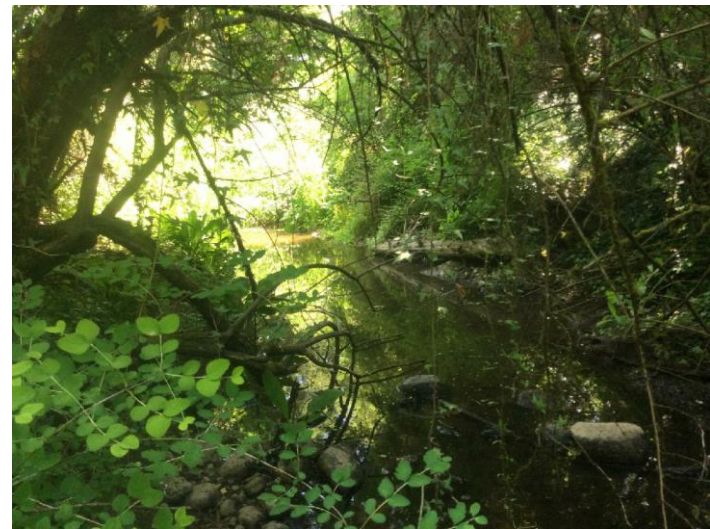
R3 – Breaks in riparian near riffle 2.

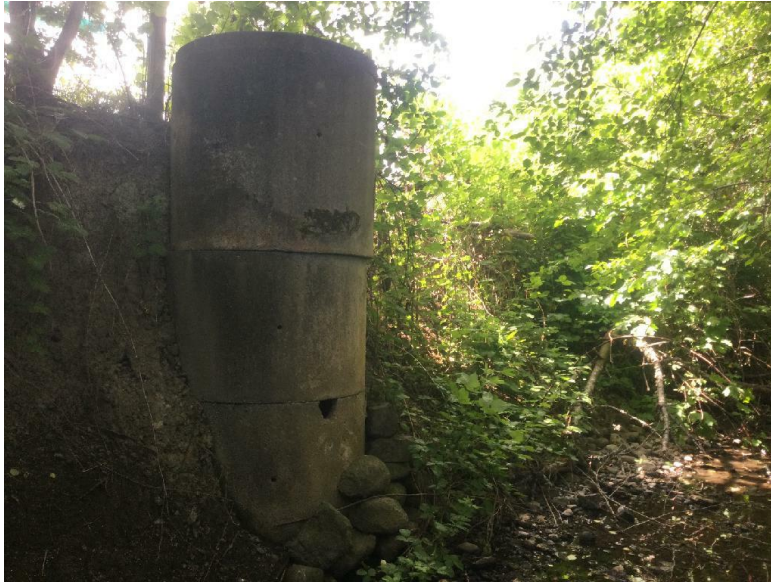
R3 – Old farm well now in creek due to erosion.

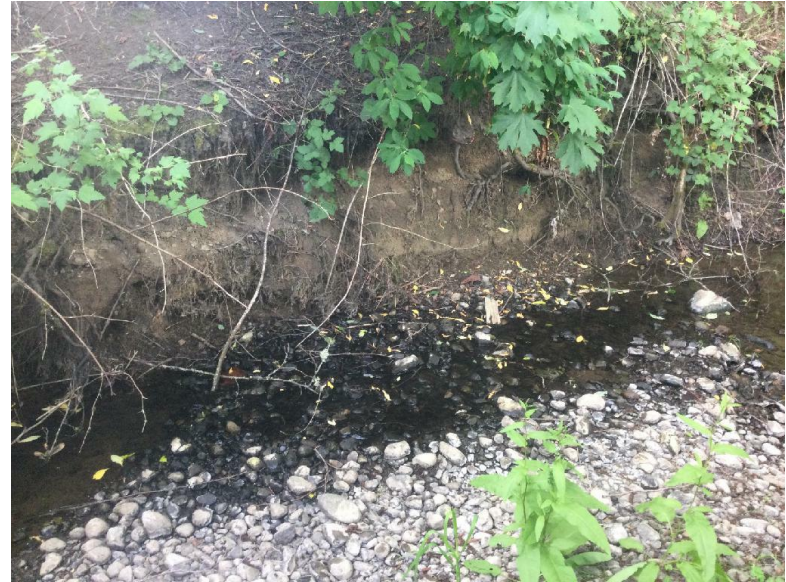
R3 – Heavy bank erosion on river right.

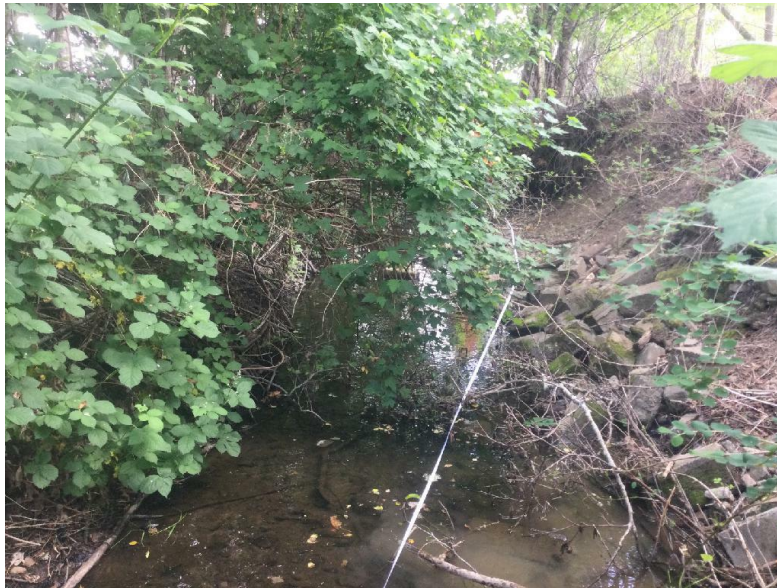
R3 – Old concrete falling into the creek

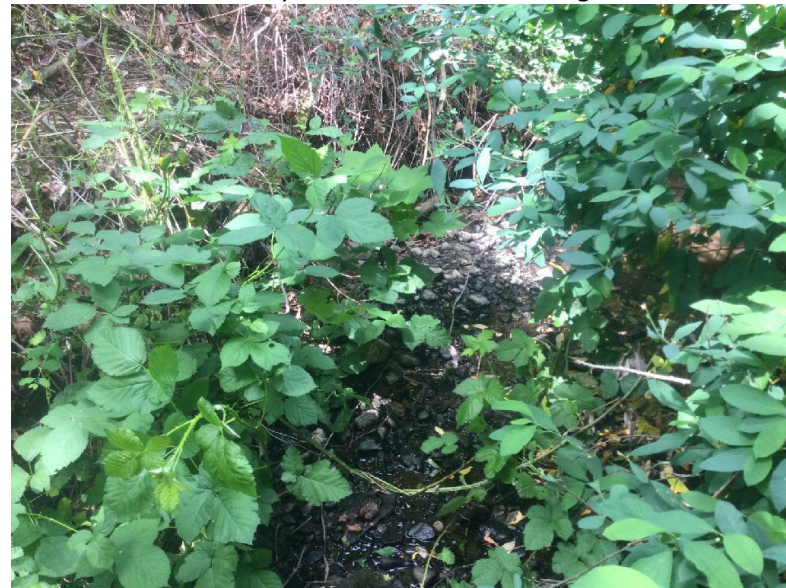
R3 – Evidence of goats grazing on blackberry in riparian.

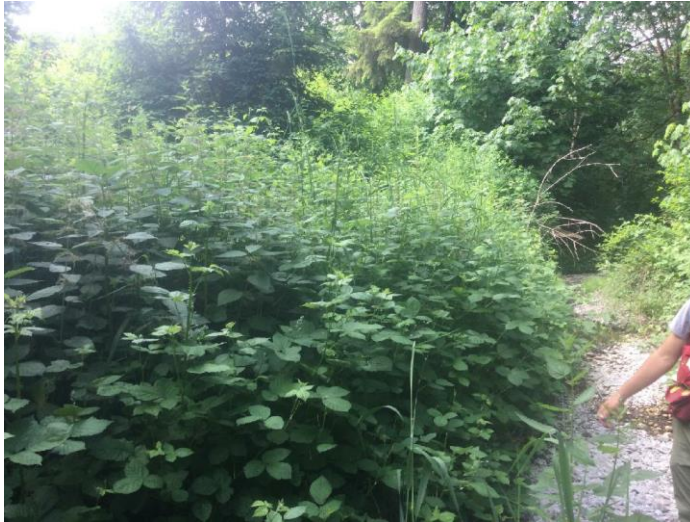
R3 – Blackberry infestation on southern aspect near Somenos rd.

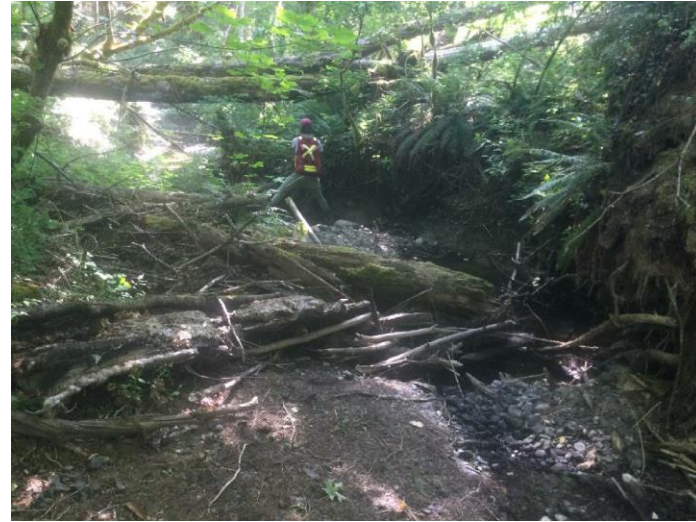
R3 – Heavy bank erosion river right.

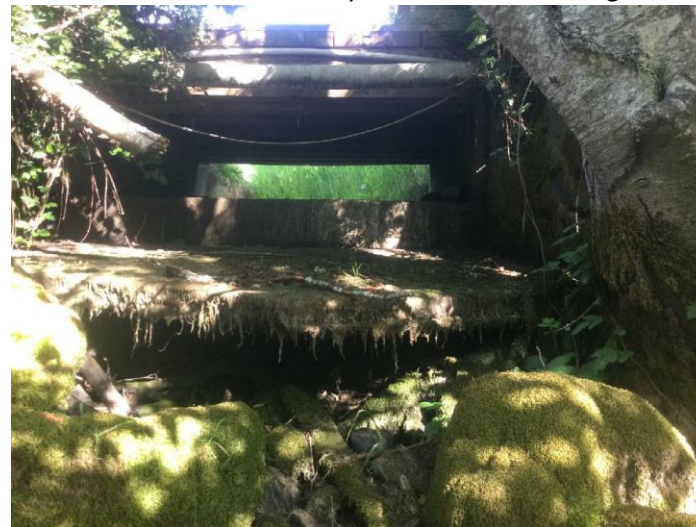
R3 – Golf course spill way is eroding (Duncan Meadows)
