# Bings Creek Watershed Habitat Assessment and Restoration Plan.

December 2020

Prepared by  
D.R. Clough RP Bio  
D.R. Clough Consulting  
6966 Leland Road,  
Lantzville B.C. V0R 2H0  
drclough@shaw.ca

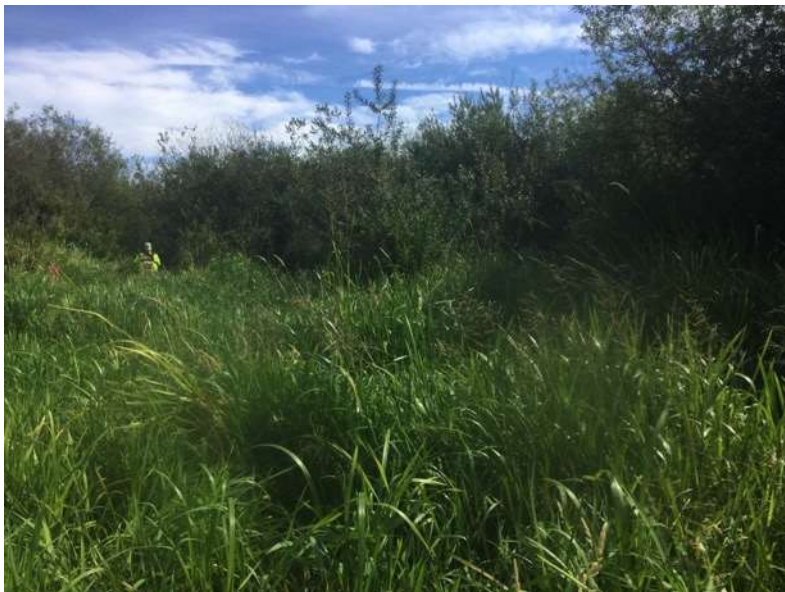
1.) R1- lower reach, old pasture, fenced and ditched.

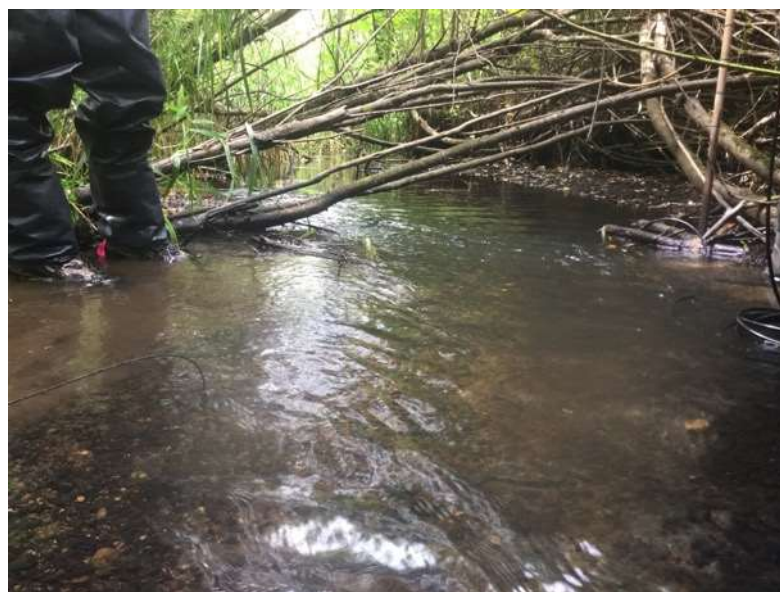
2.) Site 7 –Shrub dominated, low banks, some gravel.

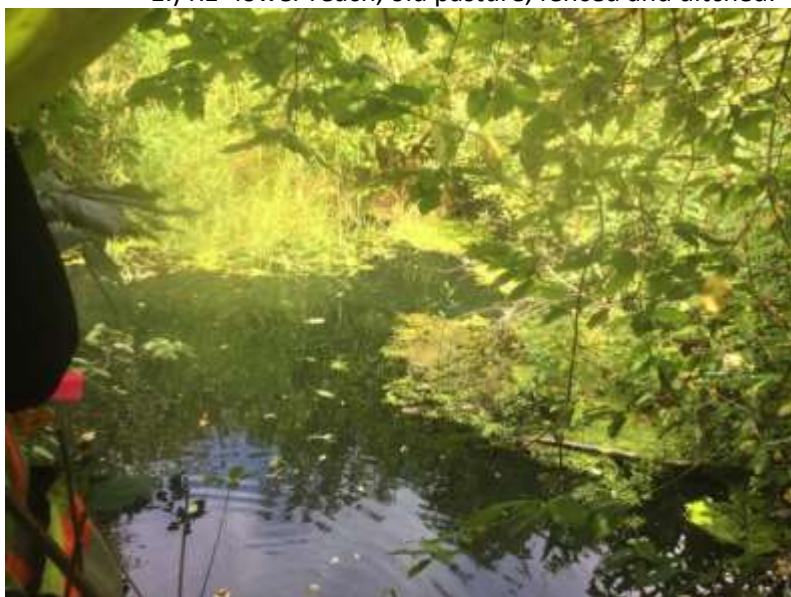
3.) Anoxic manmade offchannel ( O<sub>2</sub> - <3ppm)

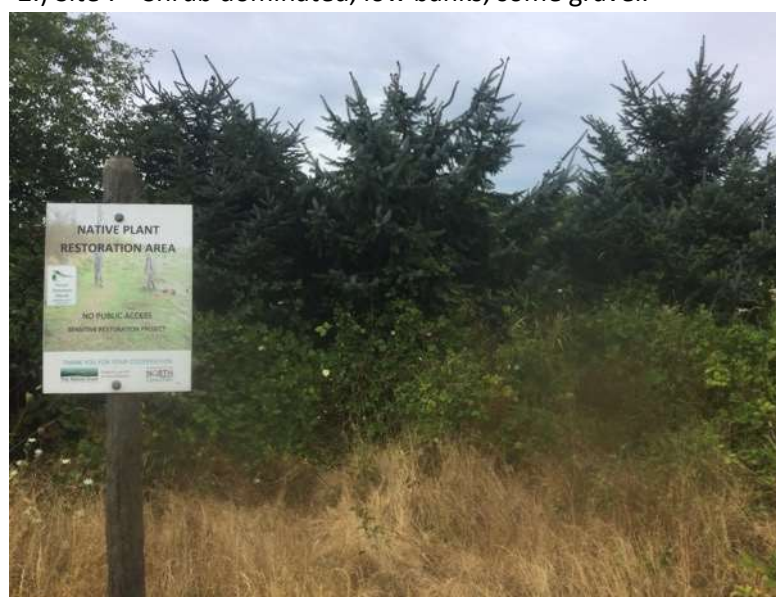
4.) Upper reach Spruce tree plantings successful.

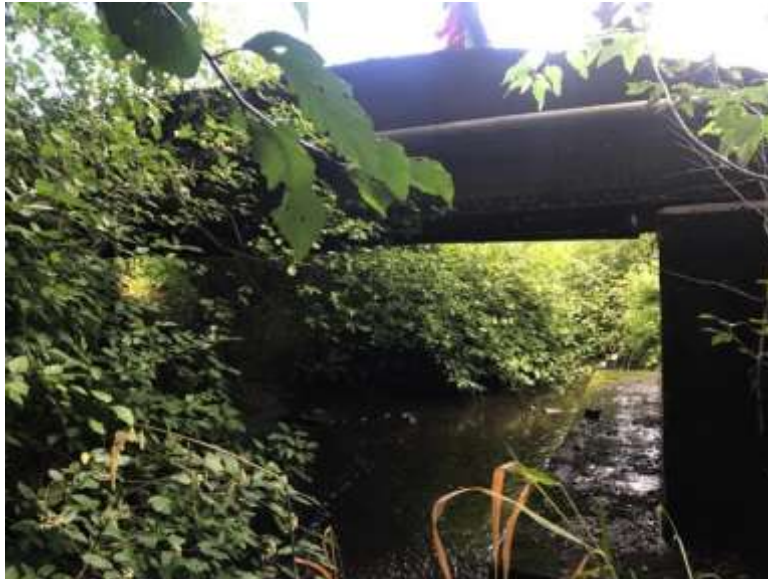
1.) R2 Site 117, E&N Bridge

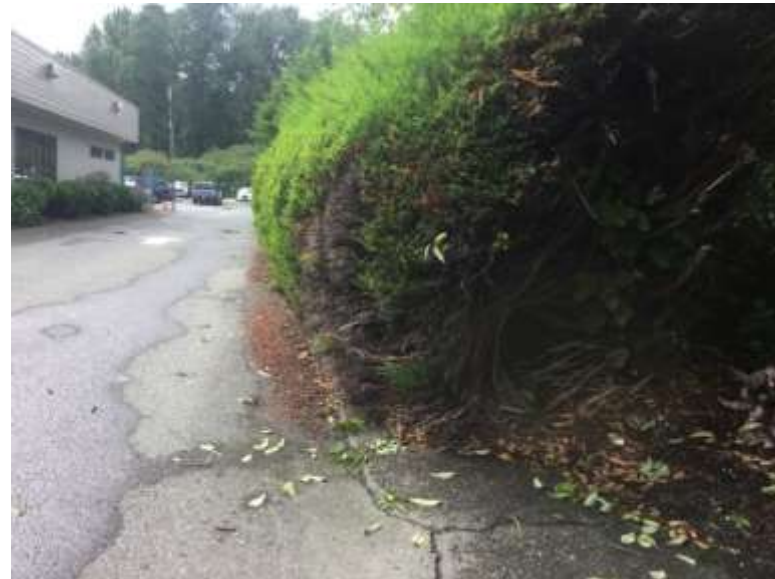
2.) R2 Site 118 –RCMP property is channelized, close to pavement.

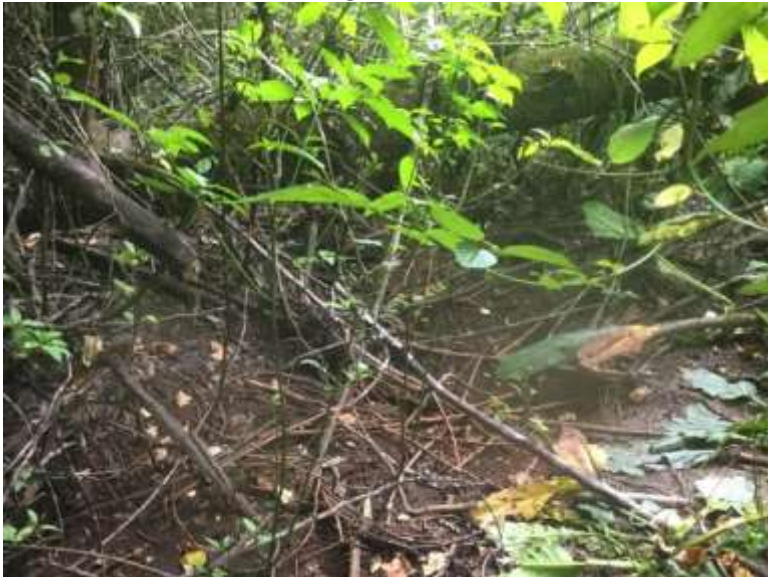
3.) R2 Site 26 Floodplain, feeds south arm

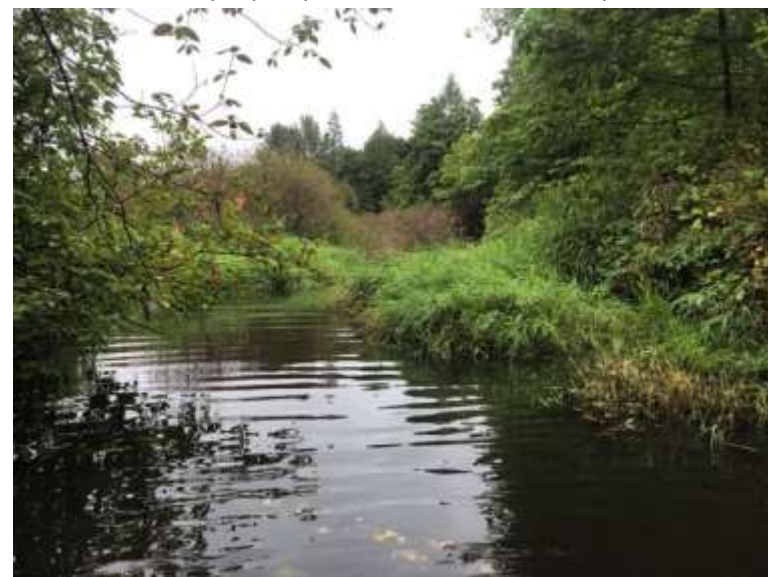
4.) R2 Beaver created pools below Mary St .

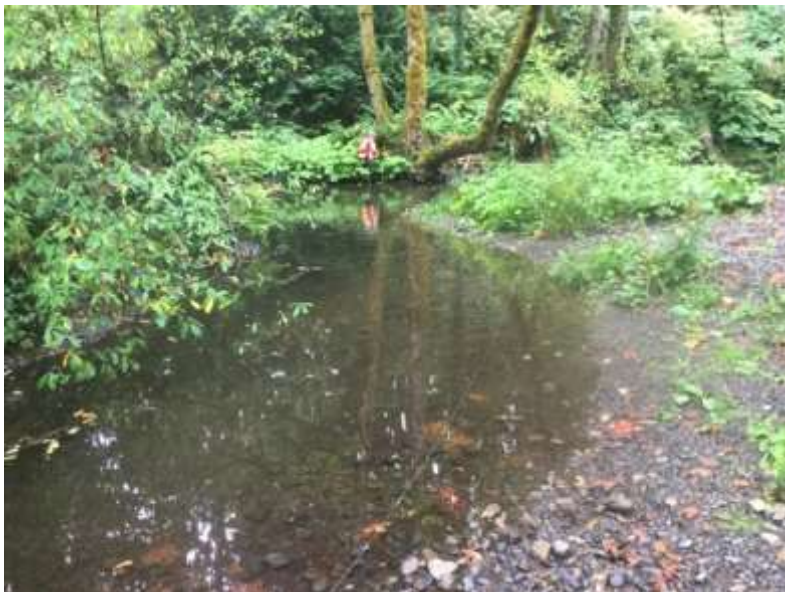
1.) R3 Site 37, this gravel offers the best salmon spawning habitat

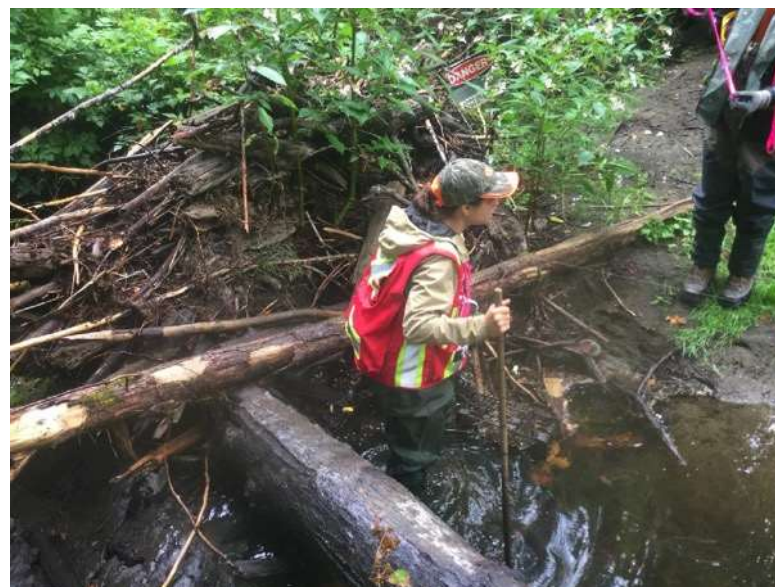
2.) R3 Site 33 log and debris jam

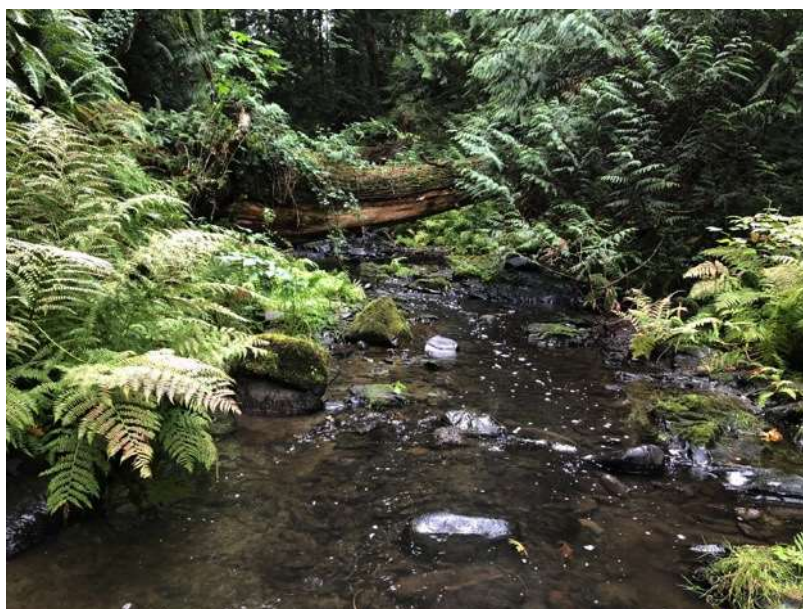
3.) R3 - Site 38 good riparian zone, least altered reach

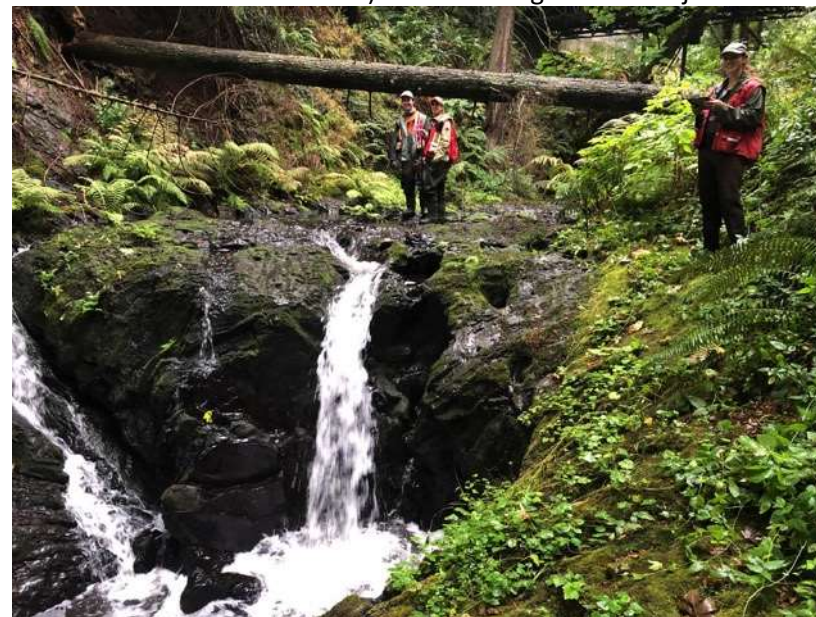
4.) R3 end at Bedrock Falls 2.2m (Site 42).

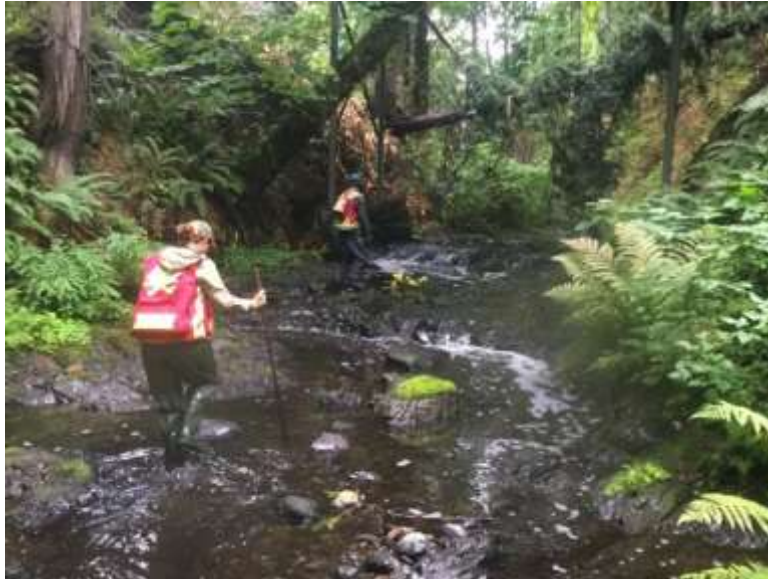
1.) R4 .Boulder riffle in bedrock, bridge crossing upstream.

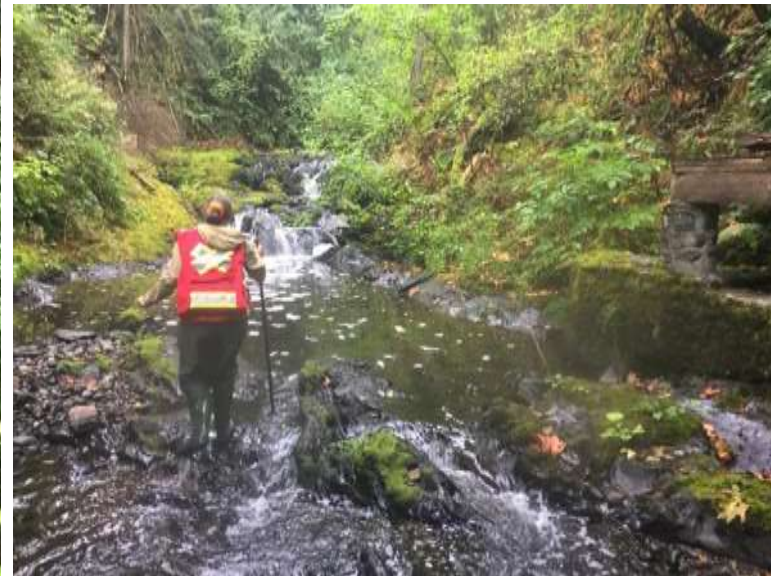
2.) R4 below falls 2 is old water inlet structure

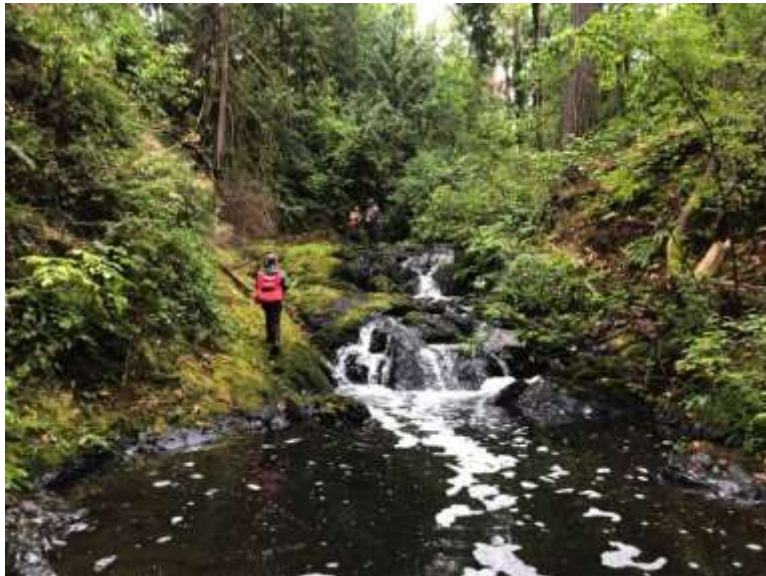
3.) R4 –Falls 2 is 2.2m ht on steps.

There is a barrier falls at the start and another falls (100m upstream) just above the bridge. Both are approximately 2.5m of drop from bedrock substrates. These are the main fish barriers to salmon and they do offer the possibility of fish access improvements. A drill rod was found in the bedrock of the first falls indicating they have been previously manipulated.

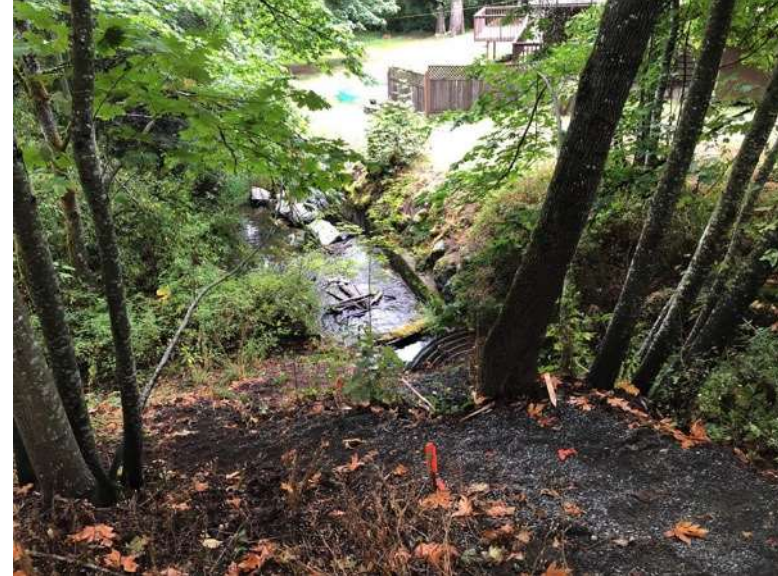
4.) R4 ends at CV Trail barrier culvert, Veg removal on right bank

The third barrier is at the end of the reach at the CNR culvert under Cowichan Valley Trail. The 6 foot diameter metal pipe is a fish barrier. It is on 10% gradient with no residual depth and a bend in at the two pipe sections. There is a pile of garbage and debris at the top end of the pipe and a concrete splash apron at the outlet. The apron, gradient, bend and debris all contribute to fish passage difficulty. The pipe has bottom sections rusted out but it is not failing. If the pipe is replaced, a larger natural bottom crossing is recommended such as an Arch or Bridge. Based on the channel, debris buildup, it needs to be increased in size.

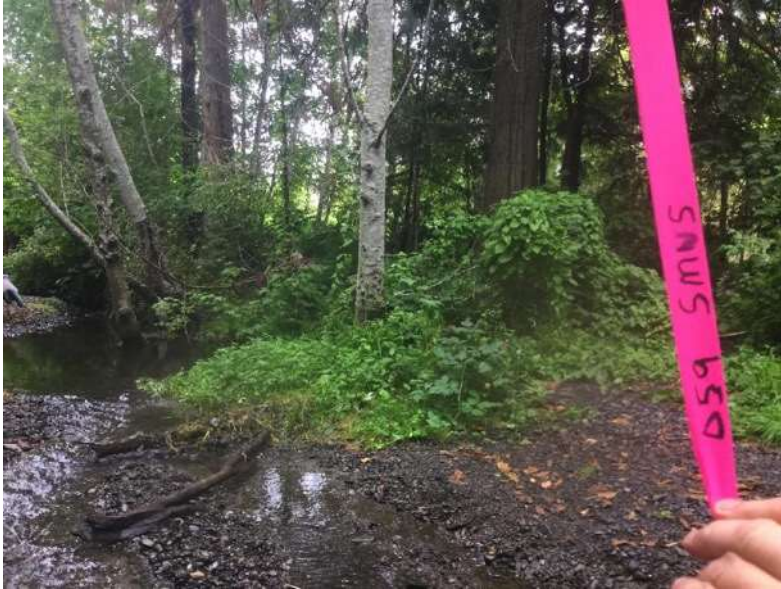
1.) R5 .Stn 59 typical riffle/pool, Alder nearby overstory.

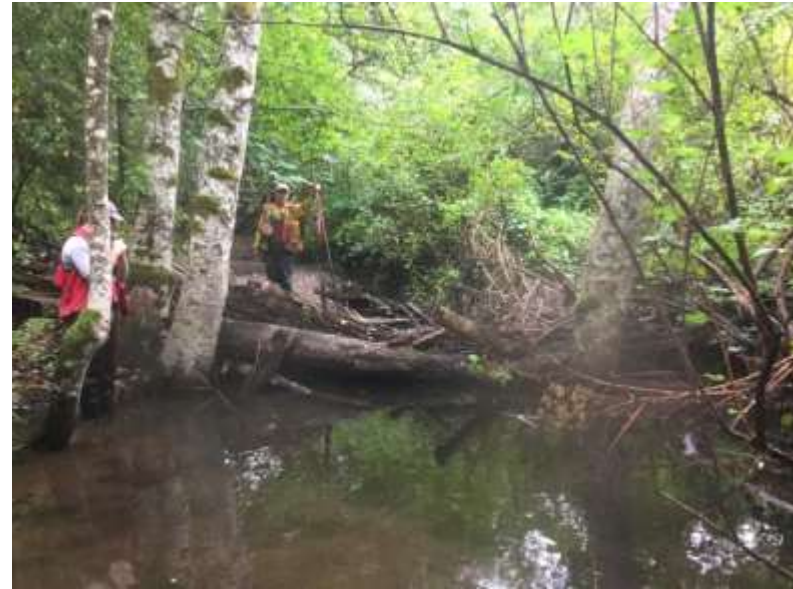
2.) R5 Pools have loose wood cover

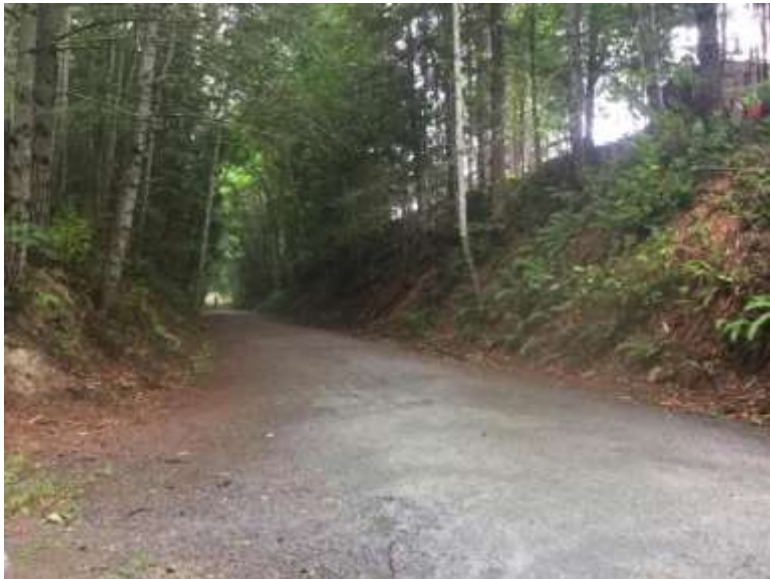
3.) R5 Cowichan Trail, Conifers but no CWD

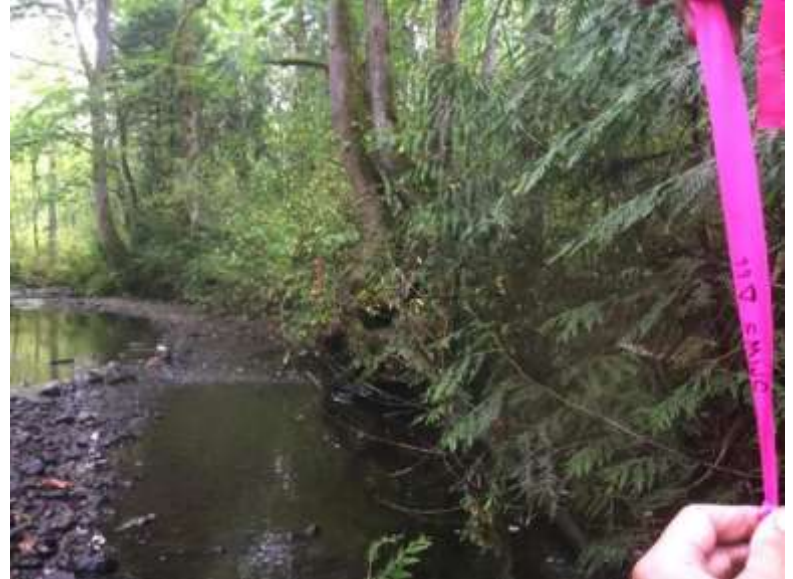
4.) R5- long pools with no cover (site 66)

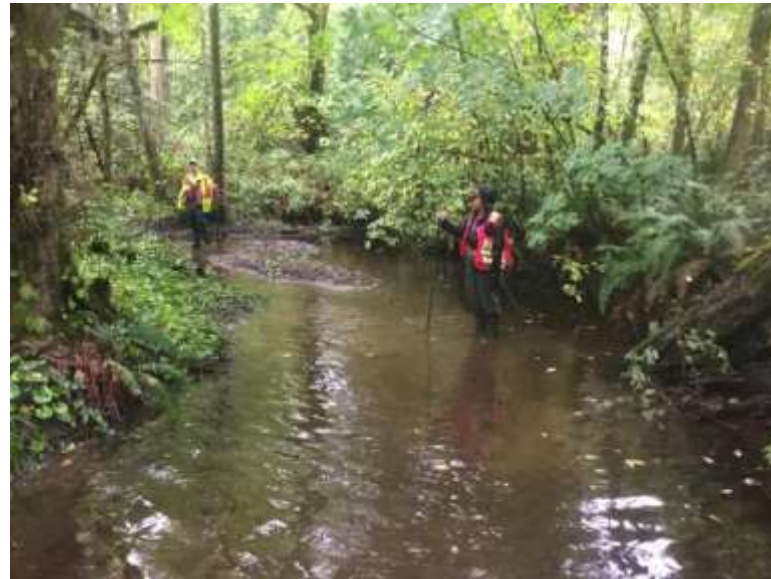
2.) R6 – typical pool 5.5 m wide but only 0.35m deep (Site 84)

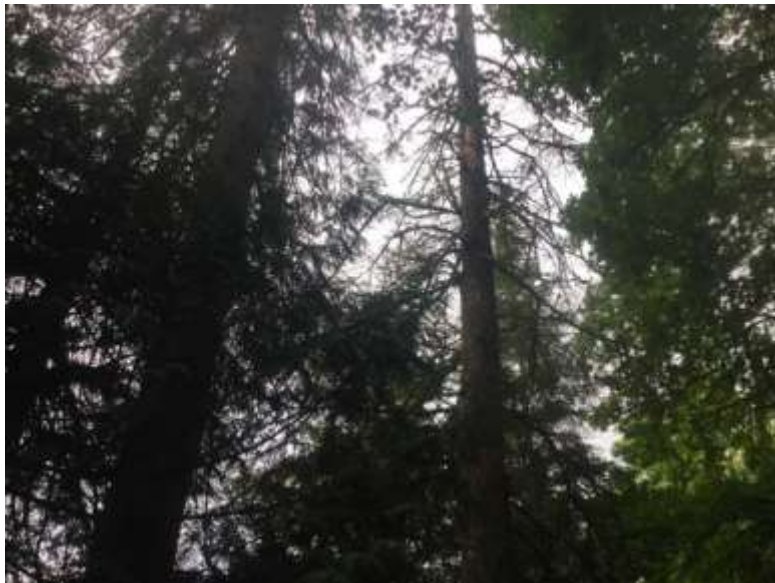
3.) R6 Dead Grand Fir, need underplanting (Site 91)

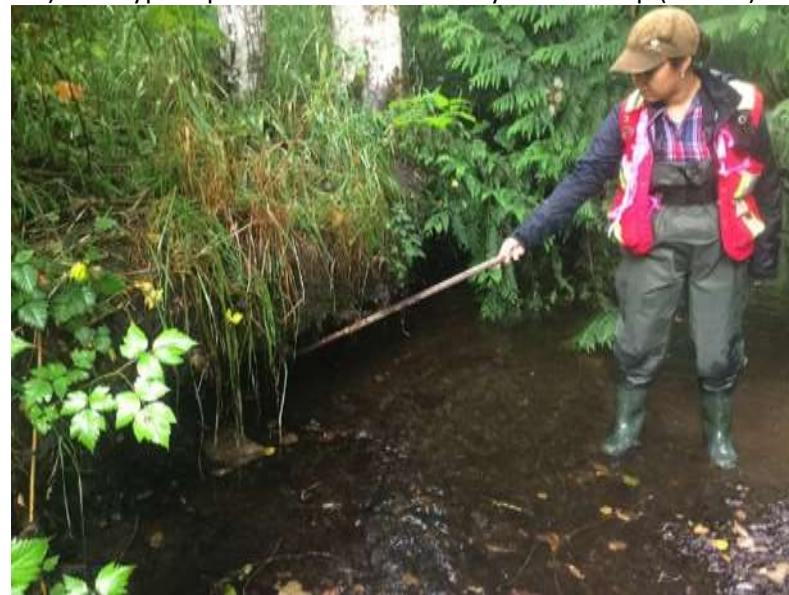
4.) R6- Undercut bank offers cover but lacks root structure. (Site 89)

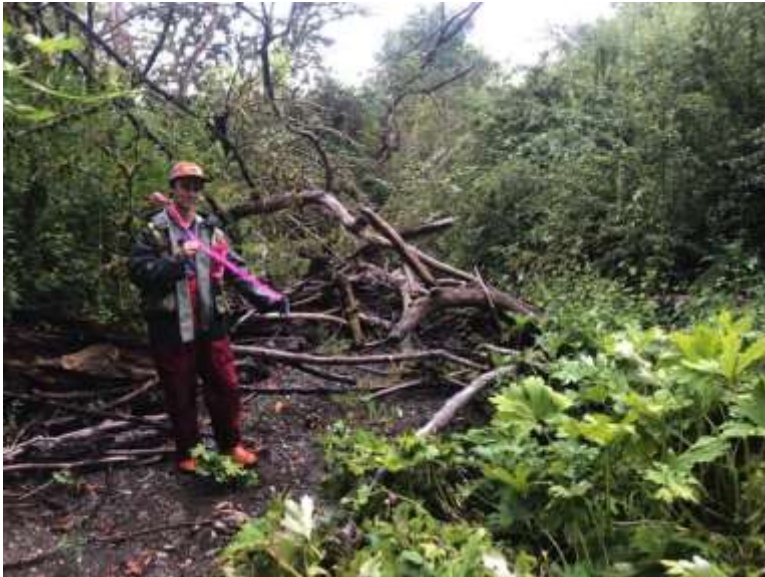
1.) R7 Debris and sediment at confluence of 7a & 7b tributaries

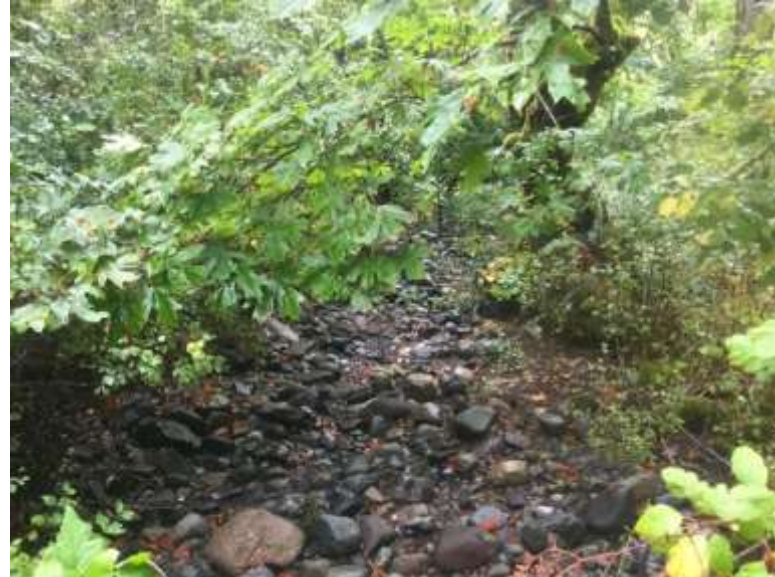
2.) R7a – below Drinkwater rd culvert: long dry gravel run

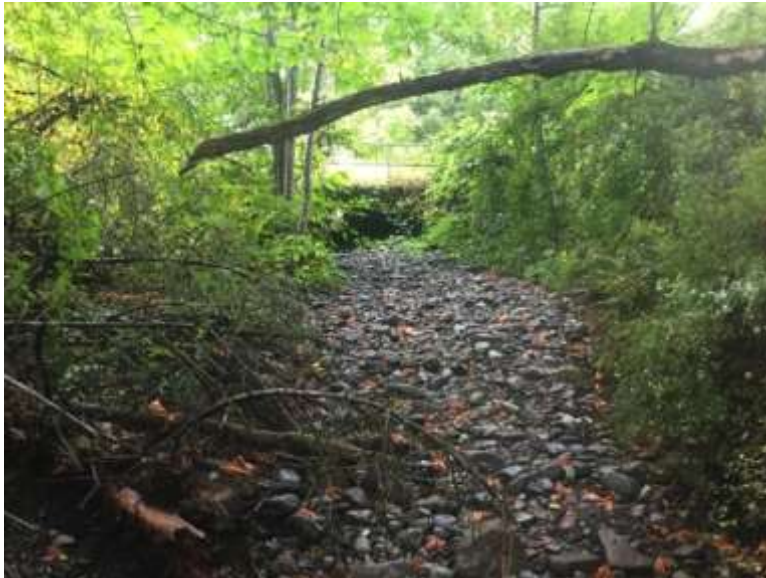
3.) R7b below culvert, dry, low banks.

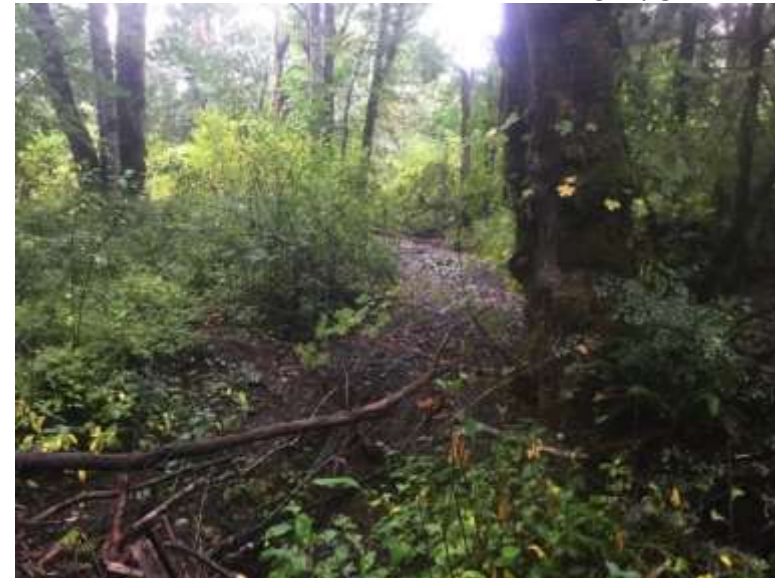
4.) R7b- wide floodplains interconnect 7a & 7B (Site 108)

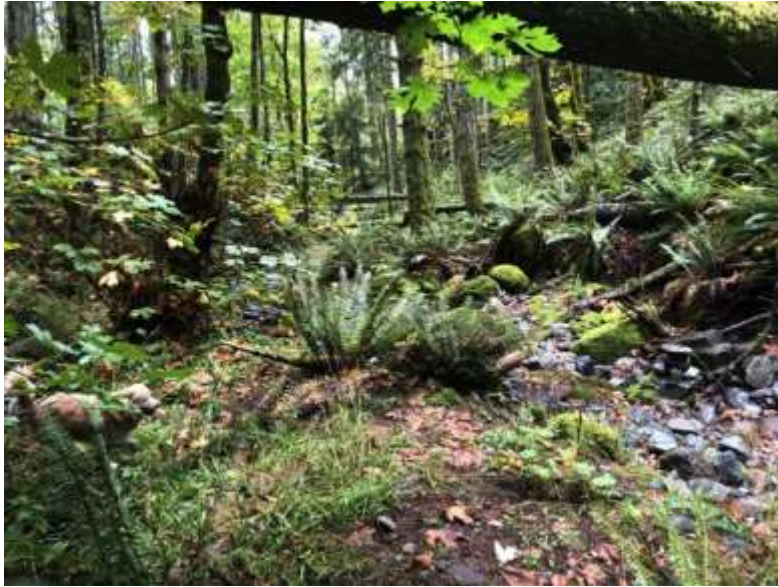
1.) R8 – Headwater forest, dry channel.

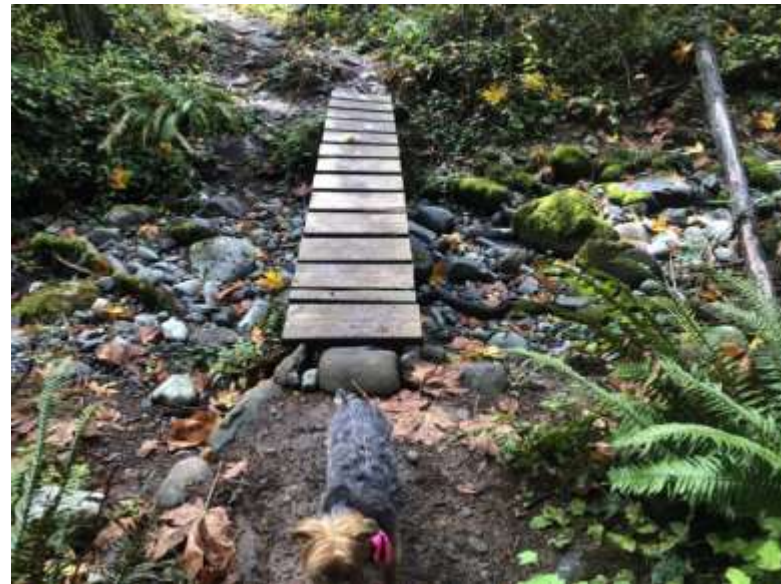
2.) R8- Footbridge is inadequate size, results in stream walking

R8	Obstructions	Entire Reach	None observed	L
R8	Erosion	Lower reach near trail	First crossing washes out, too low and erodes footings every year. Replace with proper bridge (contact district)	M

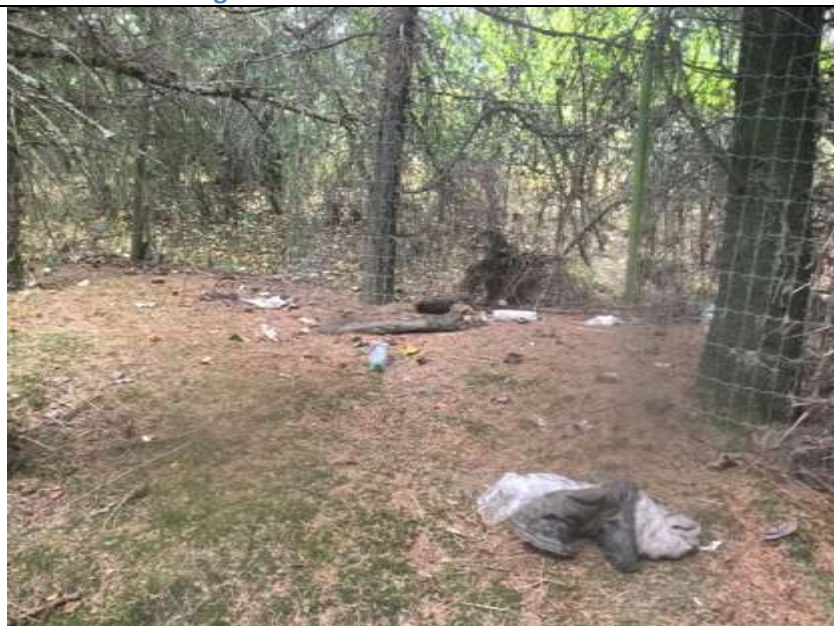
R1-Next to Boardwalk

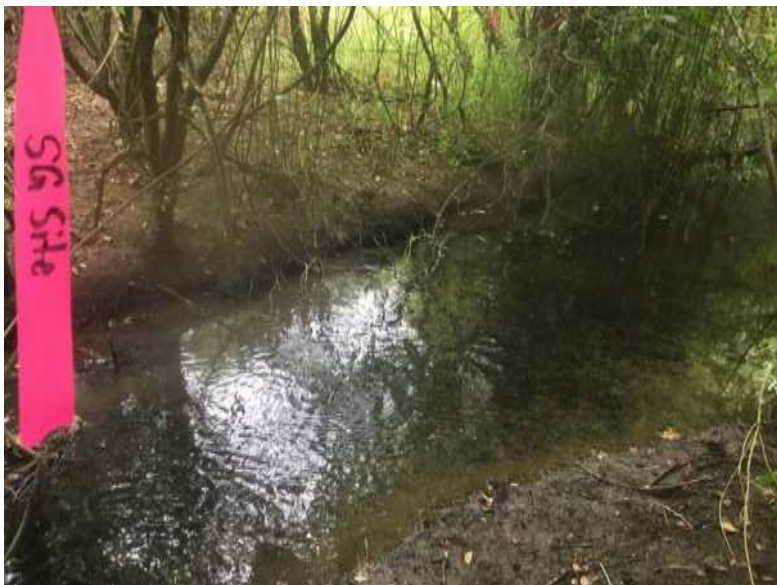
R1 Spawning Gravel addition – sites 7,13,14,15,16,17,20,22.

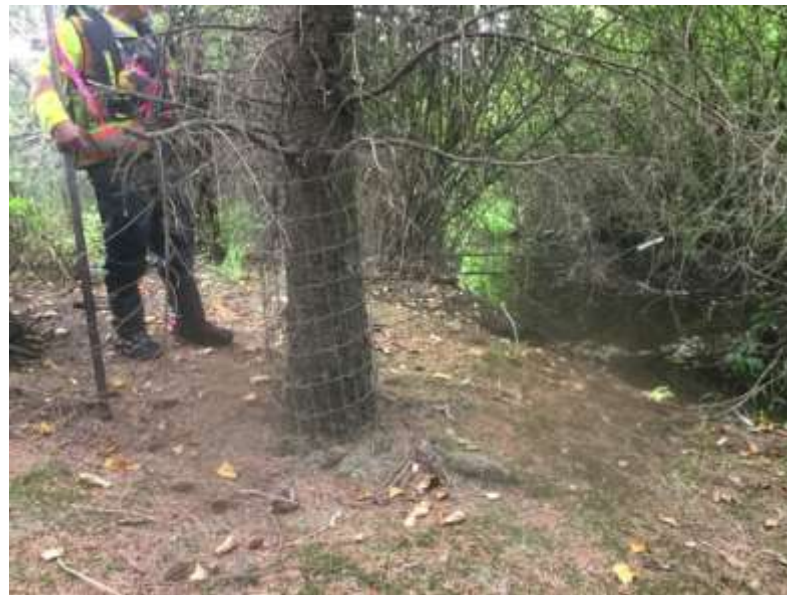
R1- Riparian planting Spruce with beaver protection

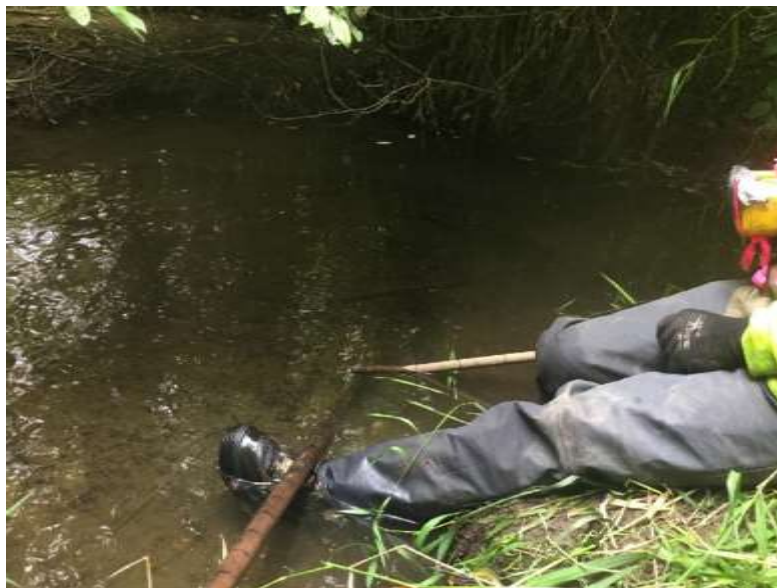
R1- LWD Sites 13, 16, 19,

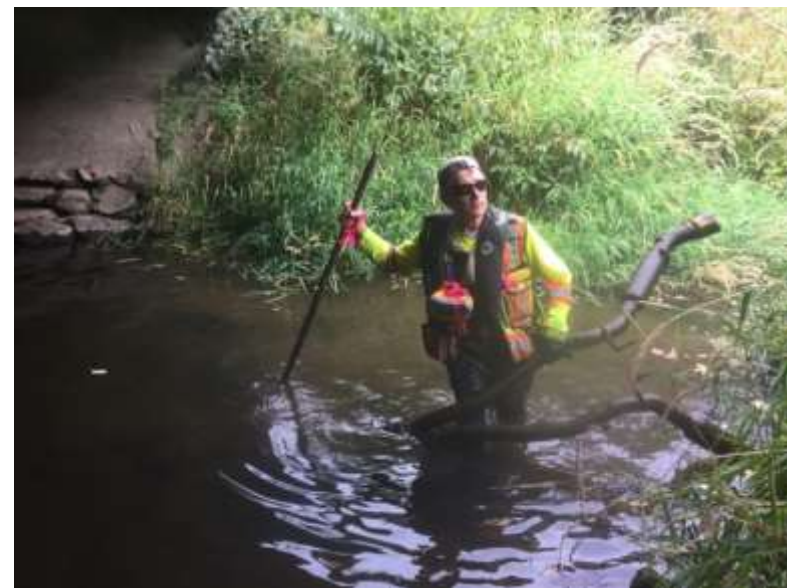
R1 -Garbage Cleanup – instream & banks

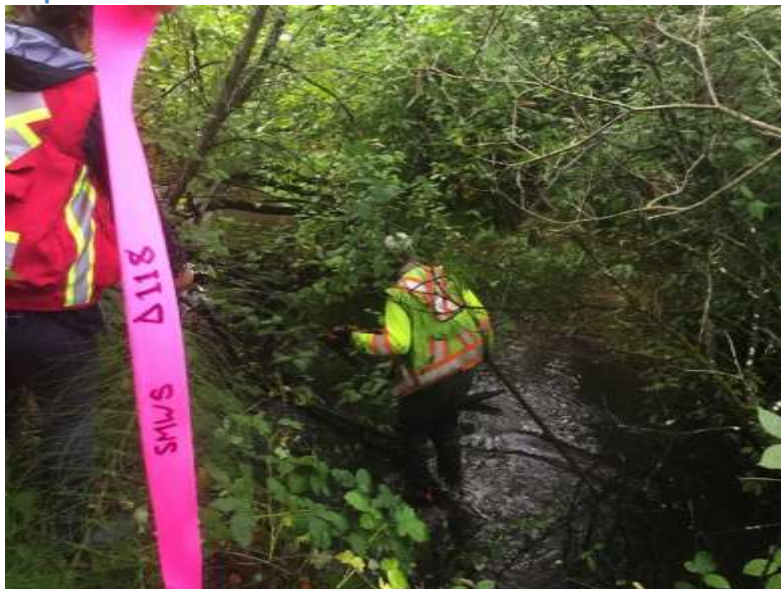
R2- Spawning Gravel addition sites 117,118

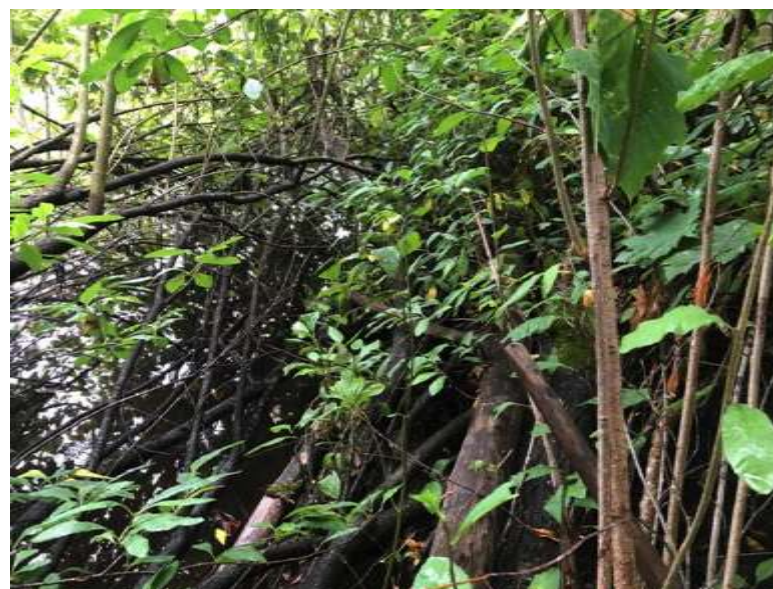
R2 – Beaver dam(Site 17) floods to Mary St.

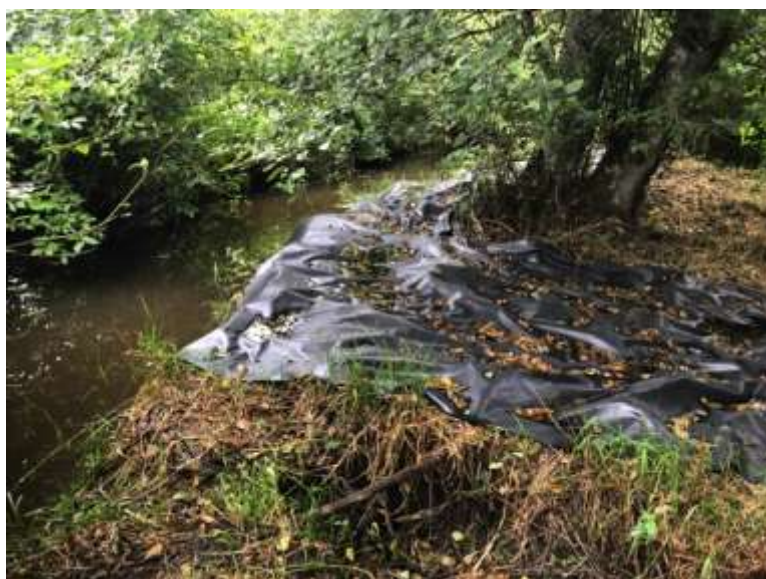
R2 – Riparian planting on grass (Site 16)

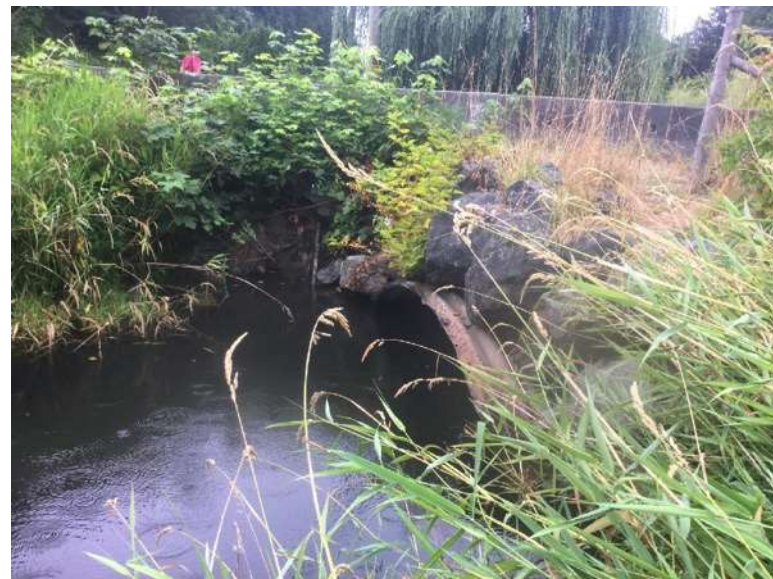
R2 Beaver flooding Mary St culvert

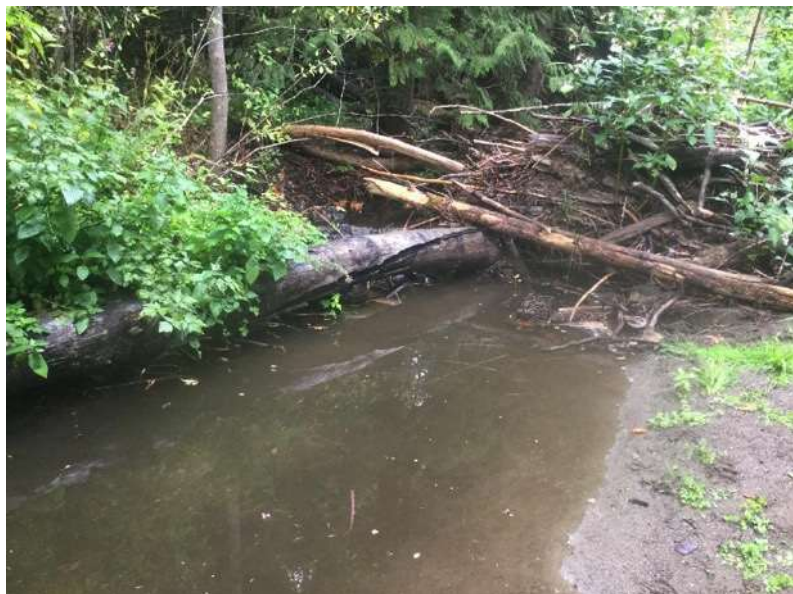
R3 -Log jam has garbage deposits as well, needs cleaned.

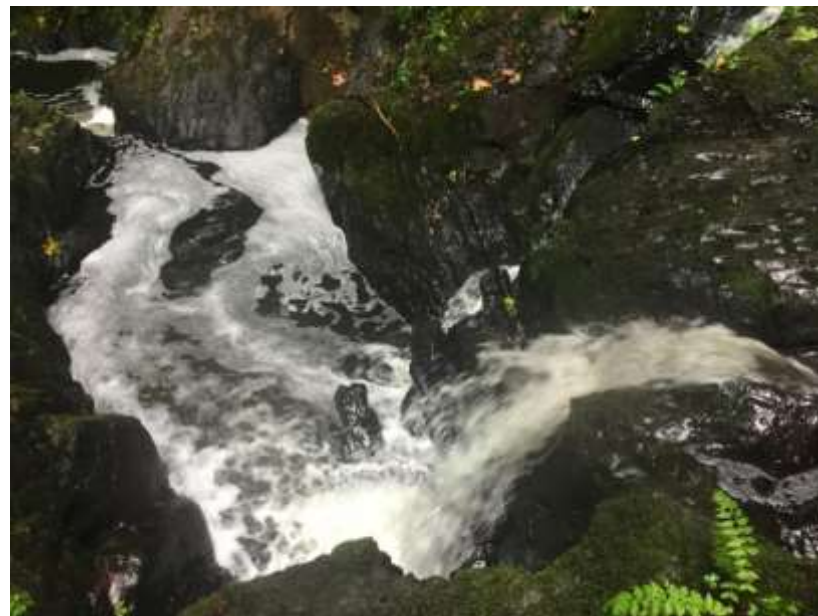
R3 –Falls are small, stepped, a fishway may be possible.

R3	Obstructions	Reach 3 end	There are no man made obstructions, the debris jams are passable. There has been interest in making a fishway at the falls. This would be expensive and first require agency approval and considerable fish population information.	L
R3	Water Quality	No concerns from survey	Water Quality Monitoring program is highly recommended as a first priority item.	H
<b>Reach 4</b> Falls Ravine to TC Trail	Riparian Restoration	Entire length has steep bank that is mostly unchanged	Infill planting in gap areas with property owner permission.	L
R4	Spawning Gravel	Poor opportunity- too confined and fast		L
R4	Cover Habitat	Poor opportunity – too confined and fast		L
R4	Obstructions	Natural barriers (2) Man Made (CNR culvert)	Fishway construction to permit salmon access has been historically considered – review with agencies  The CNR/Valley Trail culvert is collecting debris and appears undersized. A plan should start on its replacement and it must be designed according to agency fish passage criteria.	L  M

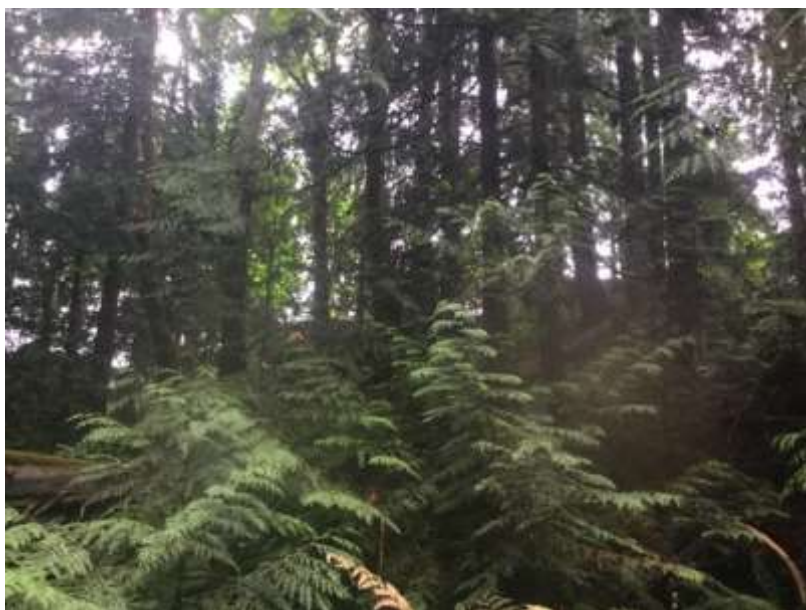
R3 –Riparian Area is healthy and regenerating.

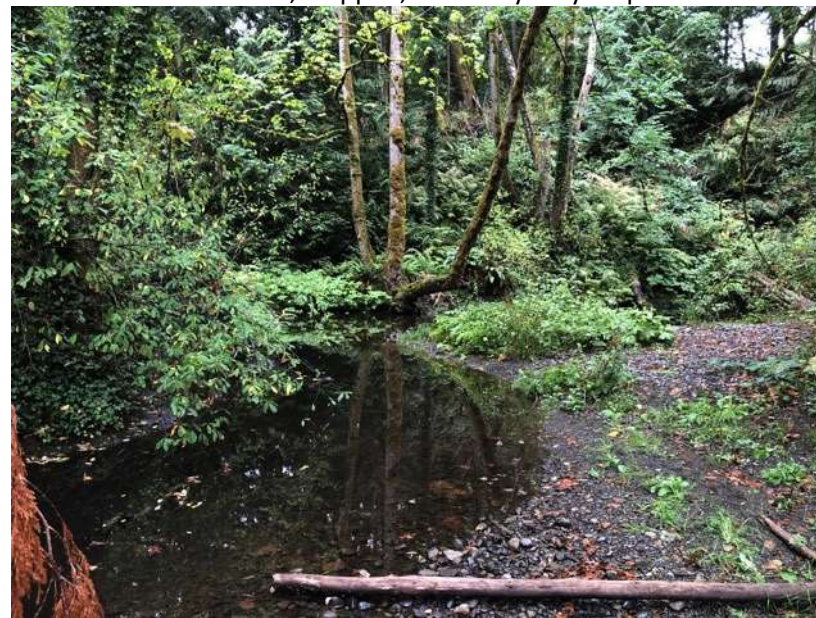
R3 – abundant gravel deposits for spawning.

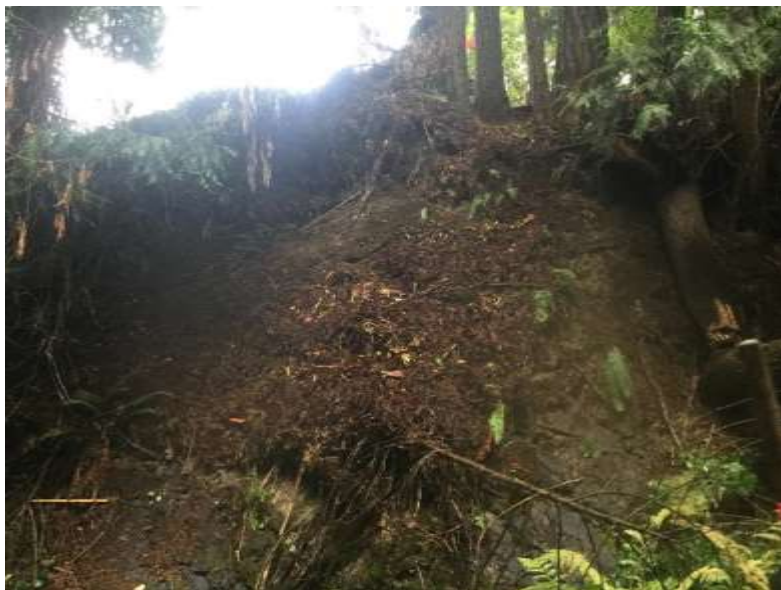
R4 - Lawn clippings dumped on bank by falls (Site 42).

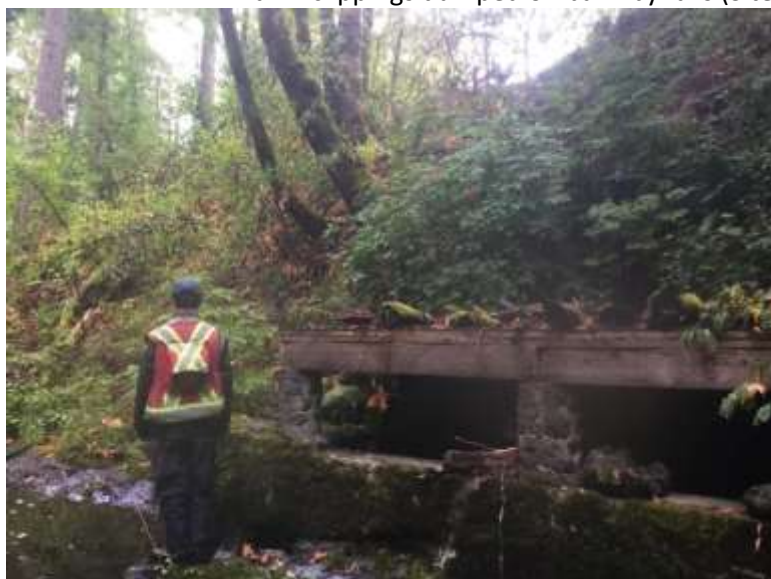
R4 - Site 46, decommissioned water inlet, no concerns.

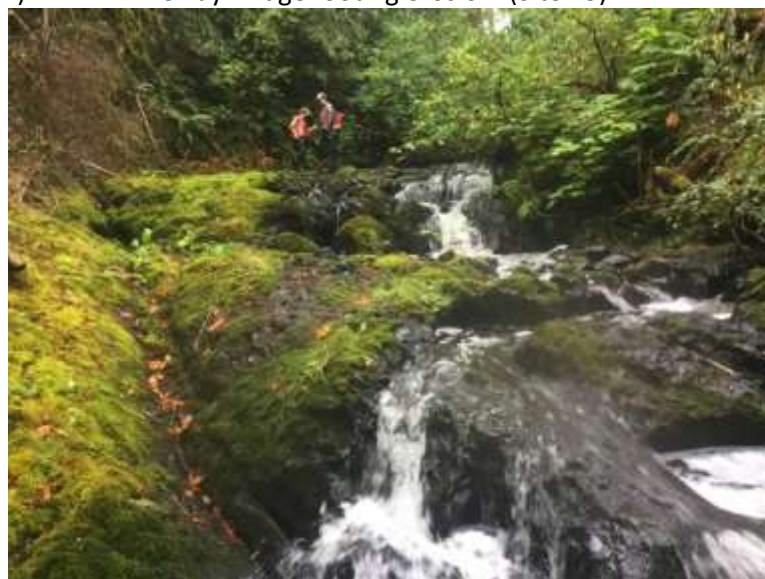
R4 - Falls 2 (Site 47) is stepped with fishway potential

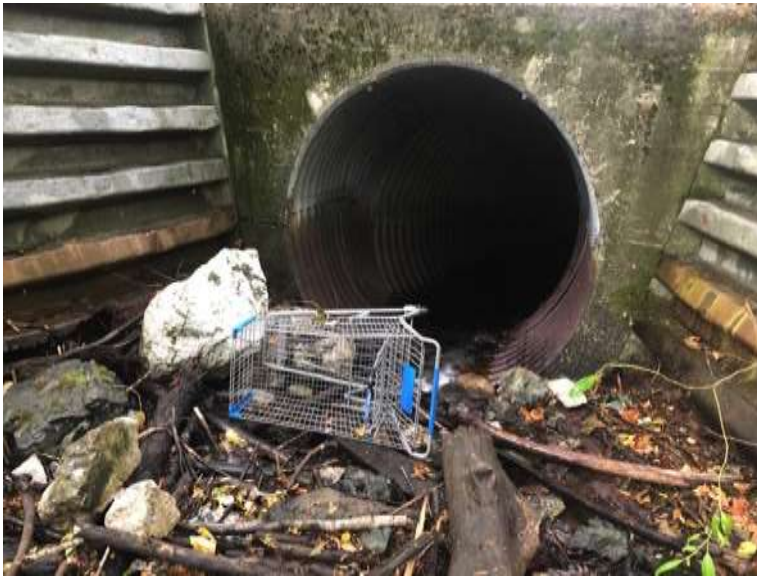
R5 – Garbage and debris plugging CV Culvert (Site 50)

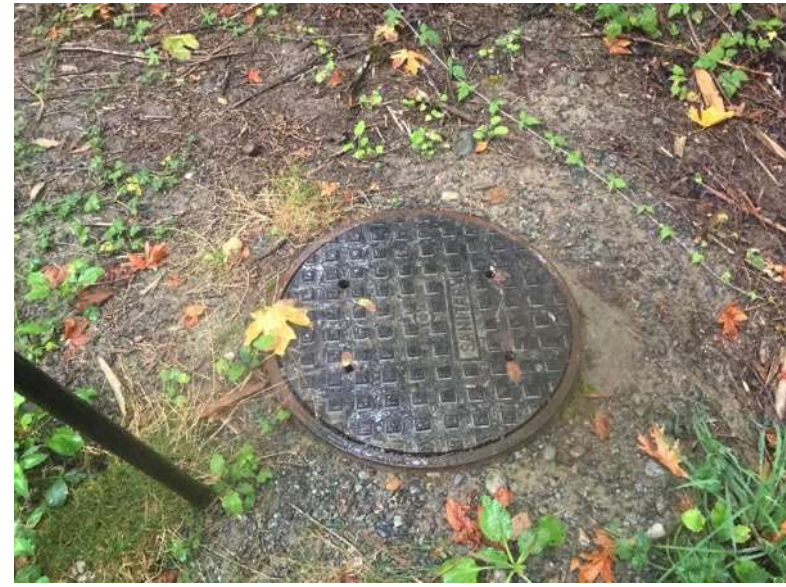
R5 –Sewer line runs parallel Creek. (Site 69 near Keystone)
