# Bings Creek Watershed Habitat Assessment and Restoration Plan.

December 2020

Prepared by  
D.R. Clough RP Bio  
D.R. Clough Consulting  
6966 Leland Road,  
Lantzville B.C. V0R 2H0  
drclough@shaw.ca

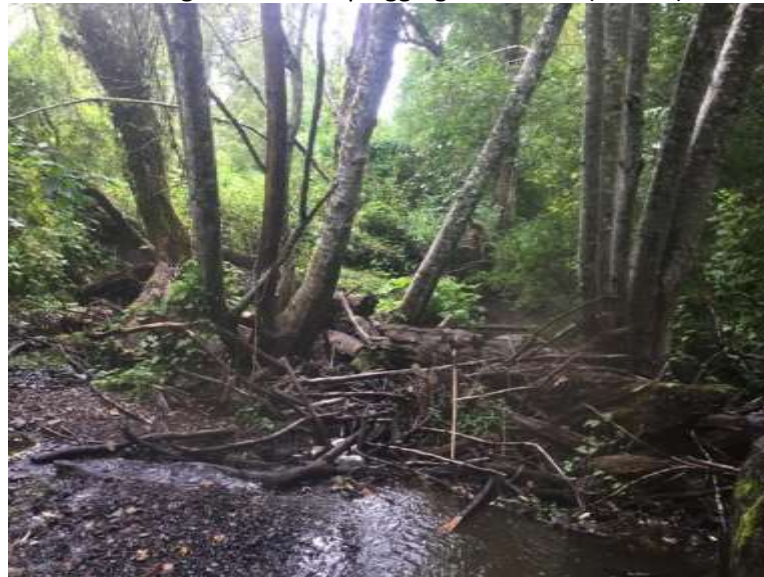
R5.Debris jams from thinning Alders need maintenance

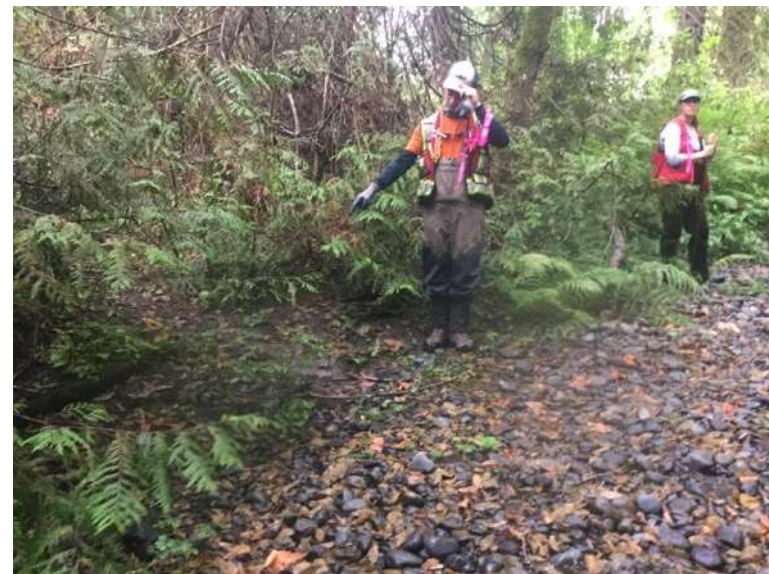
R5 erosion on right bank is significant from people

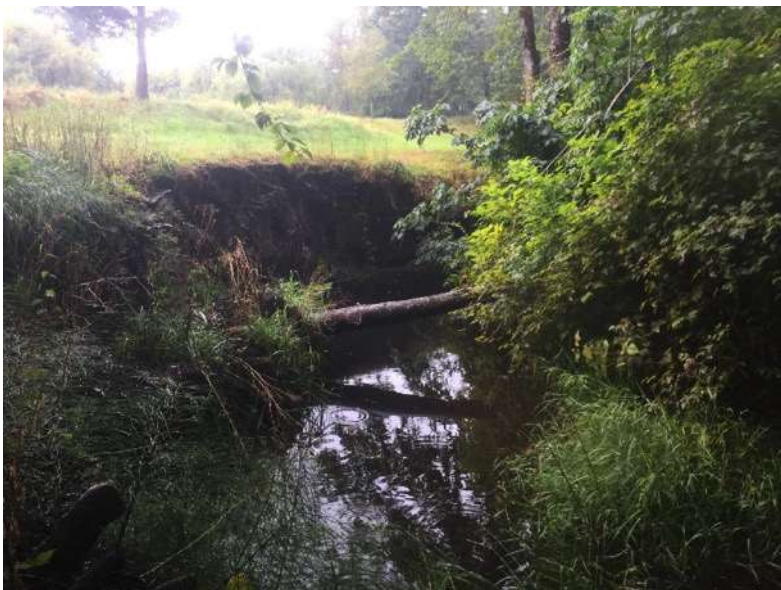
R6 – Farm Bank Erosion from blowdown/undercutting (Site 88)

structure.	
R6	Water Quality	Entire length	No pollution sources identified. Monitoring recommended.	H
R6	Erosion	Cleve Road	Cleve farm pasture right bank (10m) in need of erosion protection (taper bank, add stumps/Rock, replant)	H
R6	Erosion	Valley trail culvert by Cleve Rd	Trail culvert outlet hung and along 5m right bank in need erosion protection (taper bank, add stumps/Rock, replant)	M-H
<b>Reach 7</b> Highway to Drinkwater	Riparian Restoration	Entire reach length	Maple dominated canopy needs understory conifer planting.  Riparian area is CWD deficient. There are old routes to permit machinery delivery into the riparian areas. Silviculture prescription for planting may include removal of select Maple trees which would then contribute to the CWD. This would improve wildlife and amphibian habitat in the reach.	M  L
R7	Spawning Gravel	Entire reach length	Gravel is plenty but dries and is instable, not a good candidate until the channel is stable with more water.	L

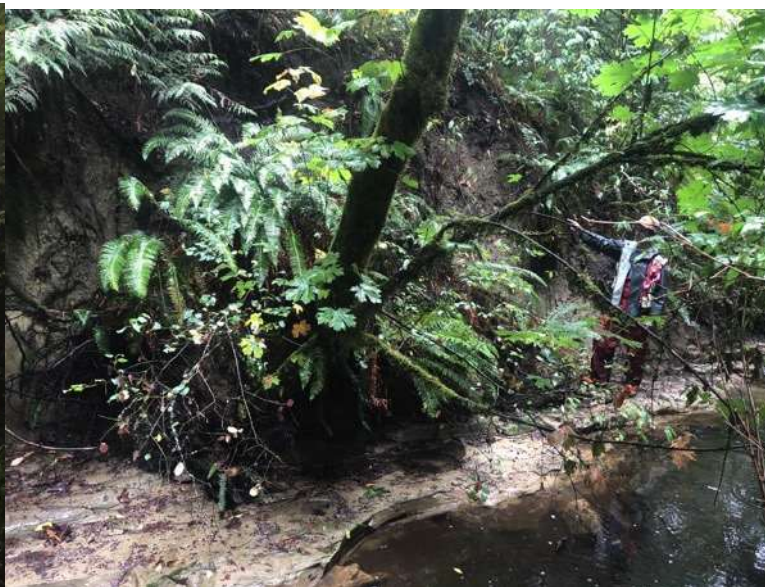
R6– Eroding left bank Clay bank (Site 92).

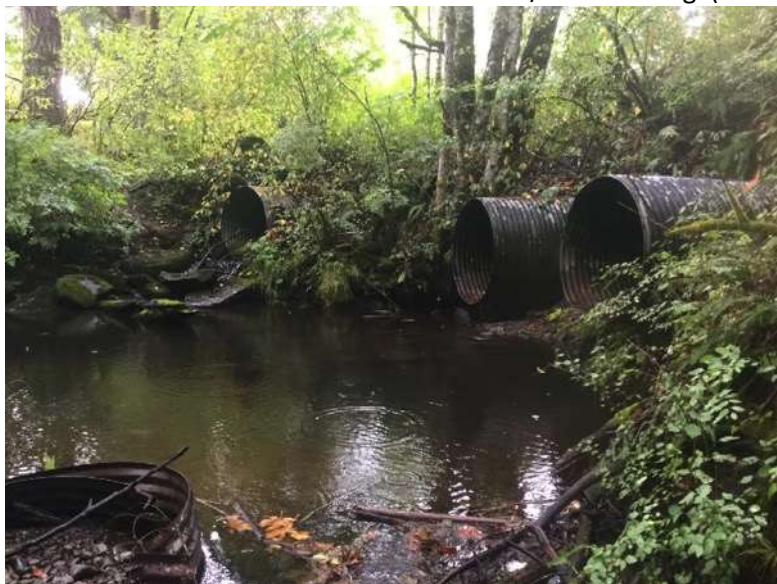
R6. Hung CV Trail culverts near Cleve Road (Site 94)

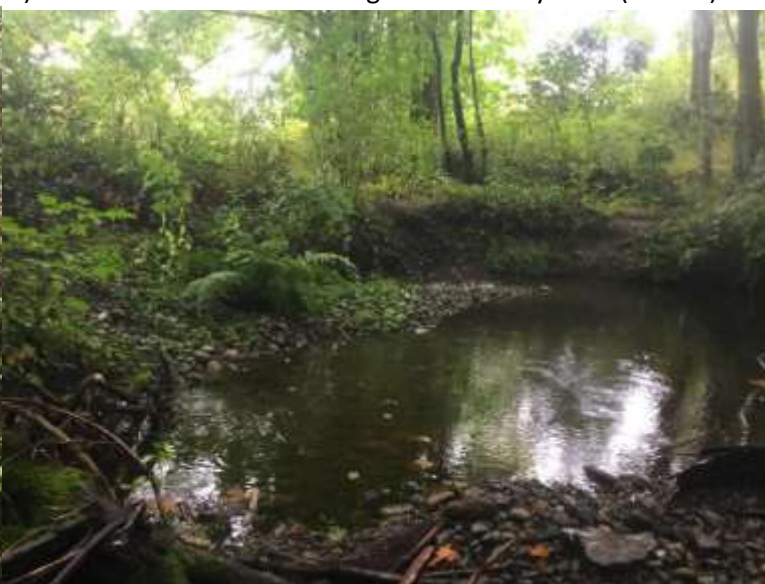
R6 – CV Trail Culverts opposite bank erosion.

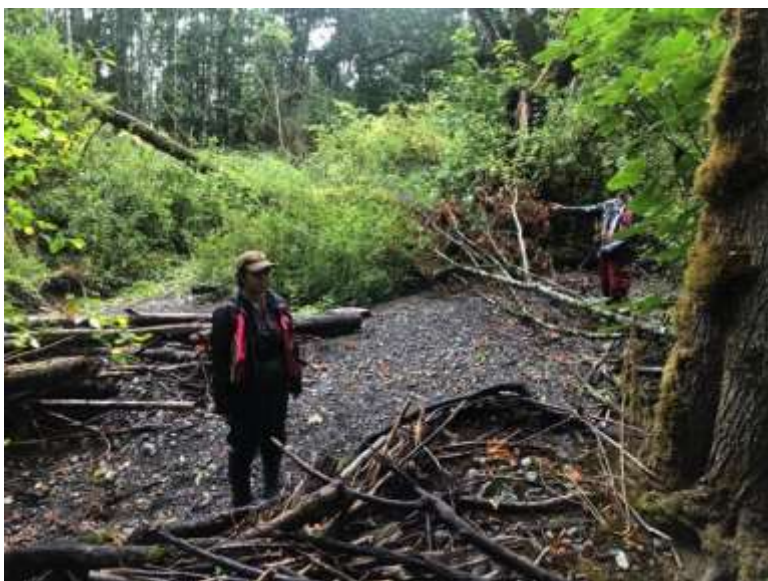
R7b at Site 107 with 15m wide alluvial fan, lack of

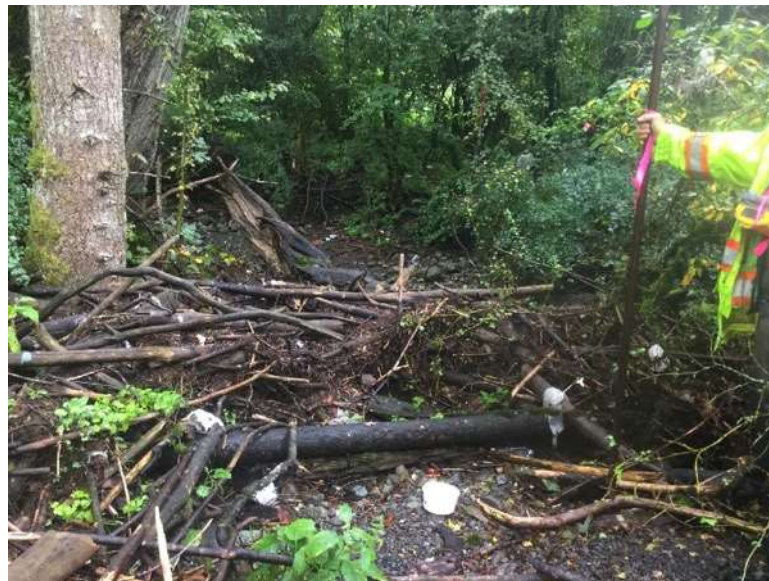
R7a – Site 103 debris jam & garbage

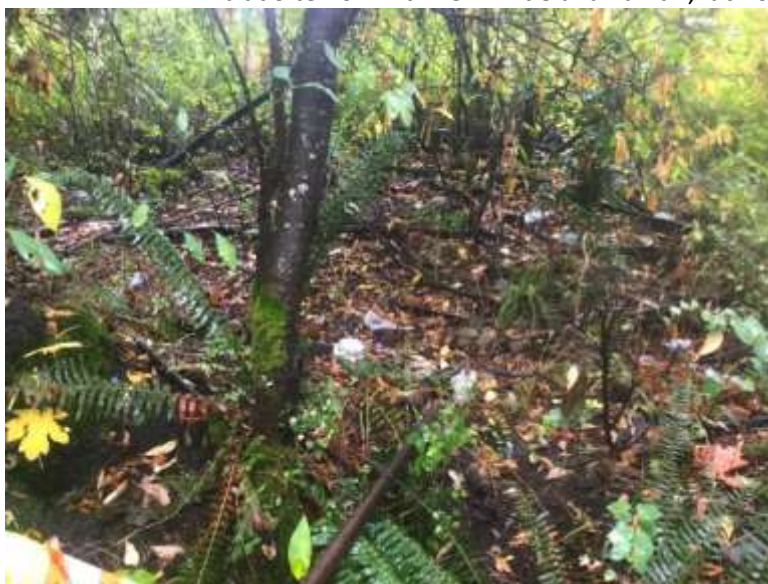
R7a.) Garbage litters riparian ( Site 100) next to dump

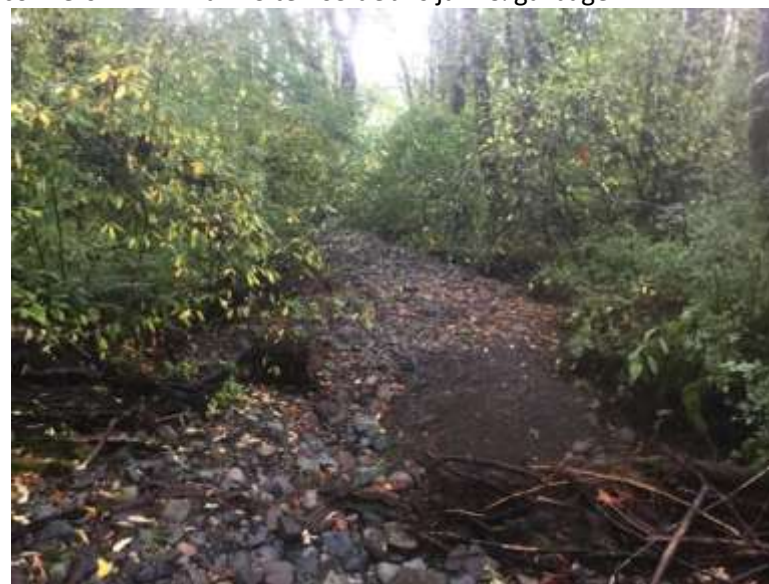
R7b – Low banks, lack of conifers, dry channel Site 109
