Parrot's Feather Mat Assessment
Assessed on August 11th, 2021, by Adam Dewar and Gina Hoar

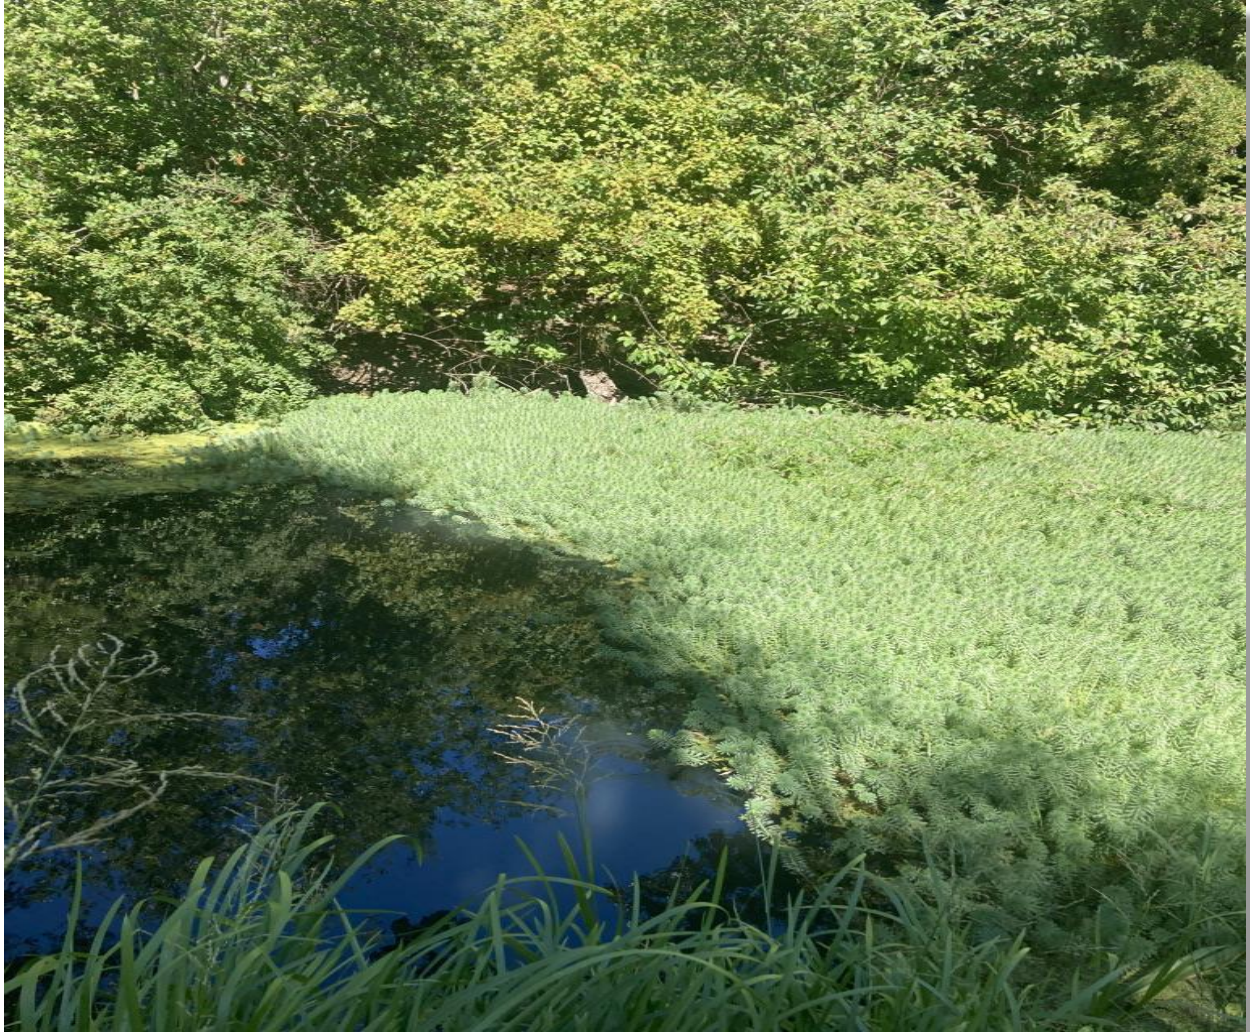
Figure 1: The leading edge of a parrot's feather mat. Note that the mat beginning right at the shadow's edge.

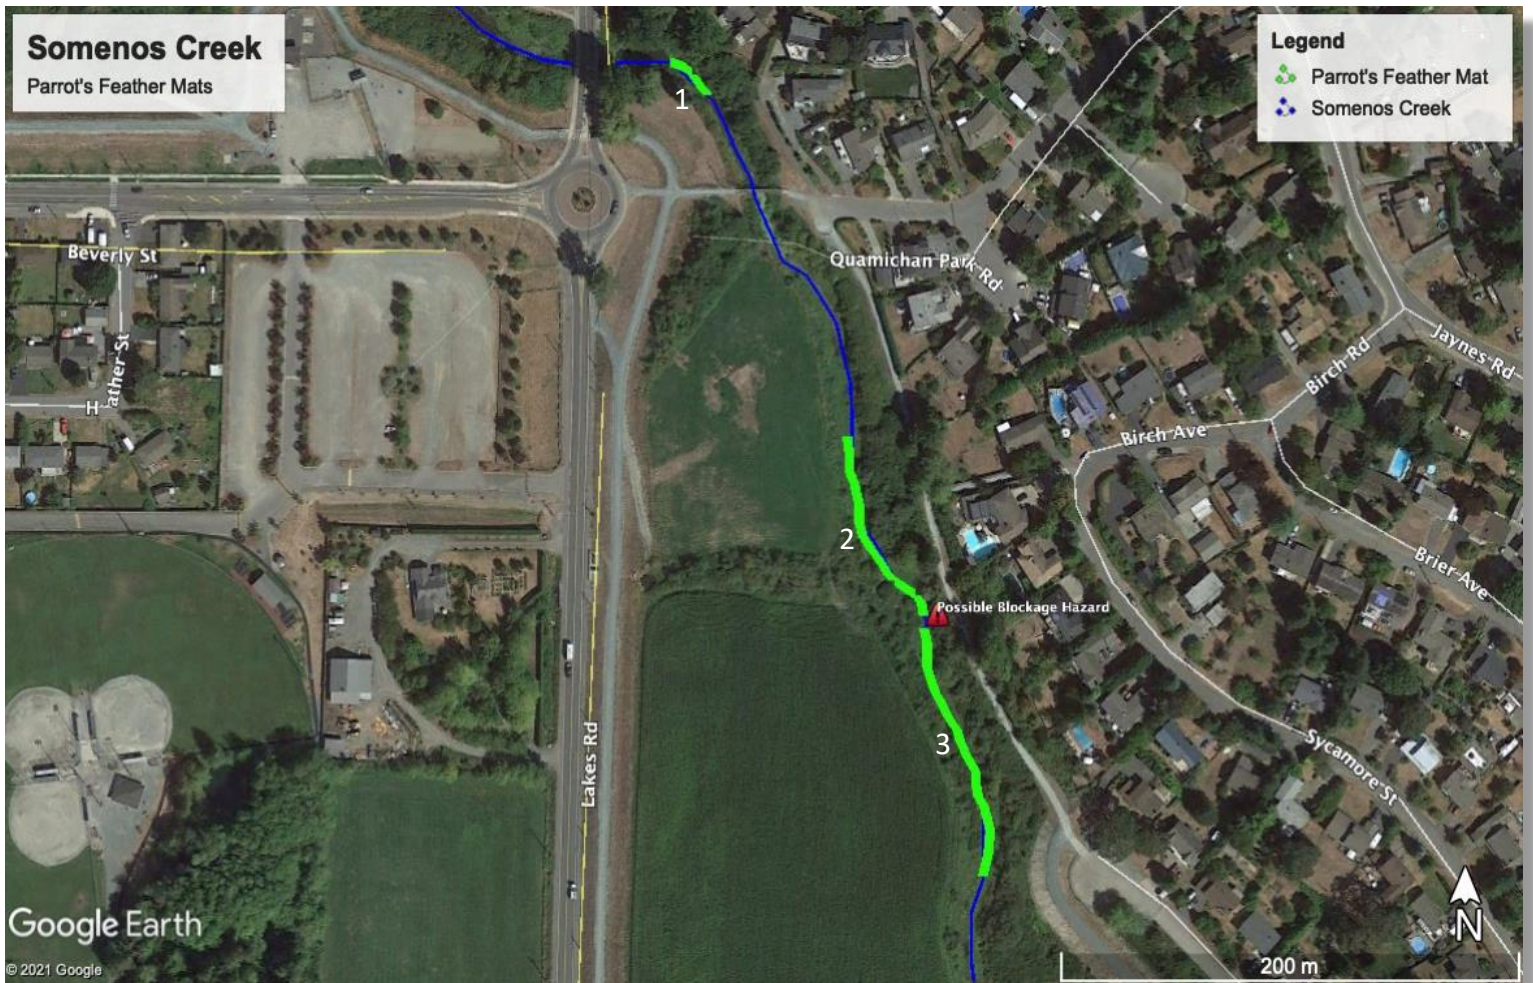
Figure 2: The three problematic mats of parrot's feather present in Somenos Creek between the Lakes Road Bridge and the Tzouhalem Road Bridge.

During this assessment, 3 possibly problematic mats were discovered. The first is a shorter, smaller mat, and the second two cover much more surface area. Mats 2 and 3 are presented here as separate because they do have a little break of open water between them, however that water break is quite small, and they could easily be looked at as a single, giant clump.

Mat 1 covers a length of 22.5m and has an average width of 5.1m as measured on Google Earth Pro. This means that the first mat covers a total area of 114.75m². The leading (upstream) edge of mat 1 had a creek depth of 1.45m, and the mat itself at this point was only about 10cm or 0.1m thick. The trailing (downstream) edge shows very similar characteristics with the creek

depth being 1.5m and the parrot's feather thickness was consistent at 0.1m. We believe that this mat, on its own isn't too much of a clogging risk, however when you couple it with what's downstream, we could see problems in the future. We also determine that this mat is not a physical barrier to fish passage. There is plenty of space between the bottom of the mat and the creek bed for fish to swim through – here the main issue remains the dissolved oxygen concentration, which is quite low the whole creek over.

Mat 2 covers a length of 85m and with an average width of 7.8m it covers a total area of 663m². The leading edge of this mat has similar conditions to mat 1, where the creek has a depth of 1.4m and the thickness of the parrot's feather was also 0.1m. The plant gets thicker through the section, however, and the trailing edge has the same creek depth, but with a parrot's feather thickness of 0.5m. This still seems to have plenty of space (0.9m) for fish passage and is thus not considered a definite physical fish passage barrier.

In the area between the 2nd and 3rd mats there is what could be seen as a potential blockage hazard. A couple of the trees on the far (eastern) streambank have fallen into the creek. While these trees alone would not act as a dam, they could certainly create one in concert with dislodged clumps of parrot's feather during the rainy/high water season. This could lead to early and prolonged inundation of the adjacent fields and possibly delay drainage in the spring. We would recommend that the municipality look at this section of the creek and assess for possible mechanical removal.

Mat 3, a near continuation of mat 2, is slightly larger and covers a length of 110m. When we combine that with an average width of 8.2m, it covers a total area of 925.9m². This mat, combined with the blockage hazard just upstream, is where we start to get a bit nervous about things. Its leading edge has a creek depth of 1.25m and a parrot's feather thickness of 0.5m. Its trailing edge exhibits a parrot's feather thickness of 1.4m in a creek depth of 1.5m. This leaves only 0.1m of space between for fish passage, something that could possibly present a challenge to larger fish.

Mat 3, along with the fallen tree blockage should be assessed by the Municipality of North Cowichan and considered for removal prior to the rainy season of 2021 in order to mitigate potential flood hazards as well as later season drainage and fish migration issues.
