Richards Creek Watershed Habitat Assessment and Restoration Plan.

June 2021

Prepared by
D.R. Clough RP Bio
D.R. Clough Consulting
6966 Leland Road,
Lantzville B.C. V0R 2H0
drclough@shaw.ca

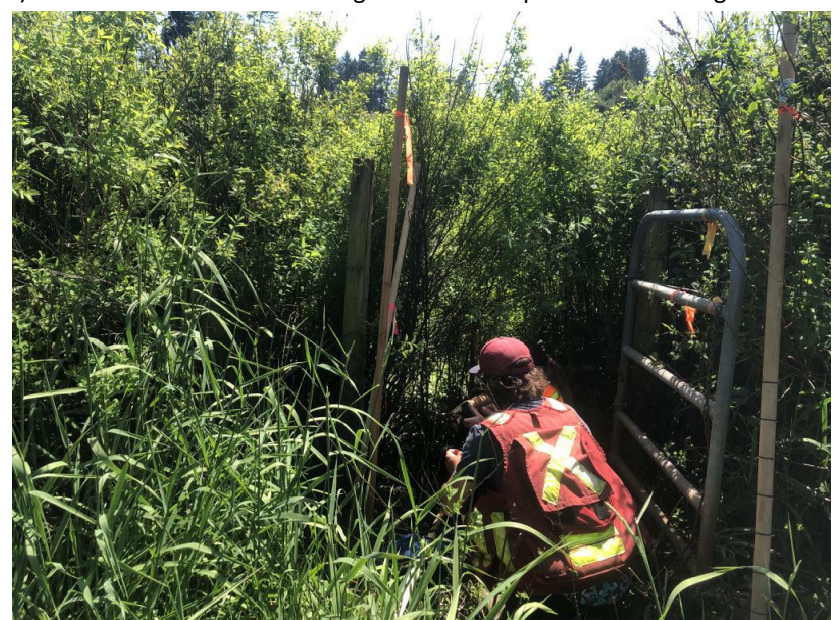
4.) Placemark 20- Reach 1B, shrub and grass dominated riparian

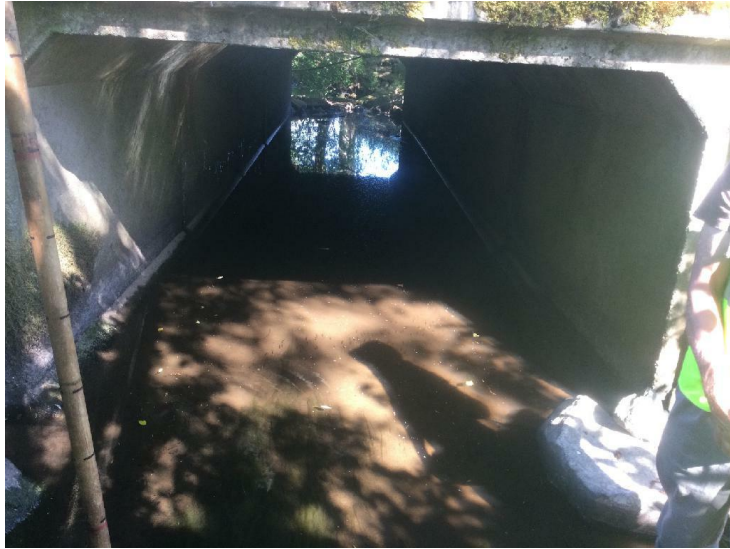
1.) Reach 2, Pool 1- Richards Trail box culvert full of coho fry.

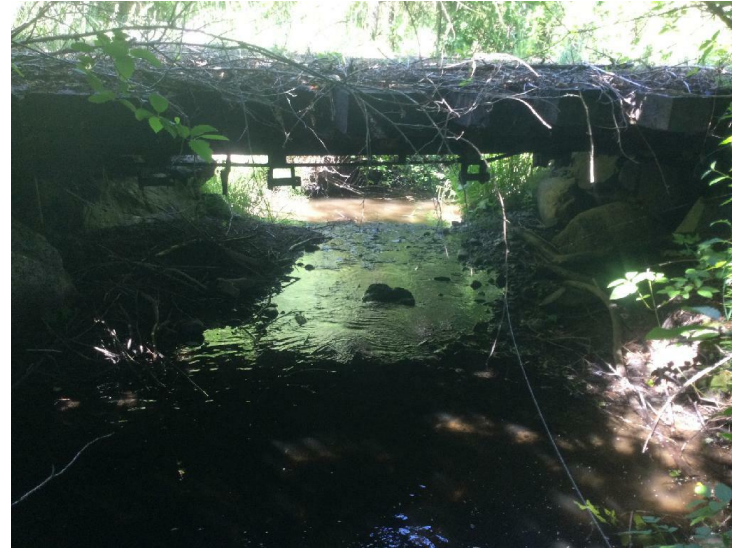
2.) Reach 2, Riffle 3- Riffle under old farm bridge.

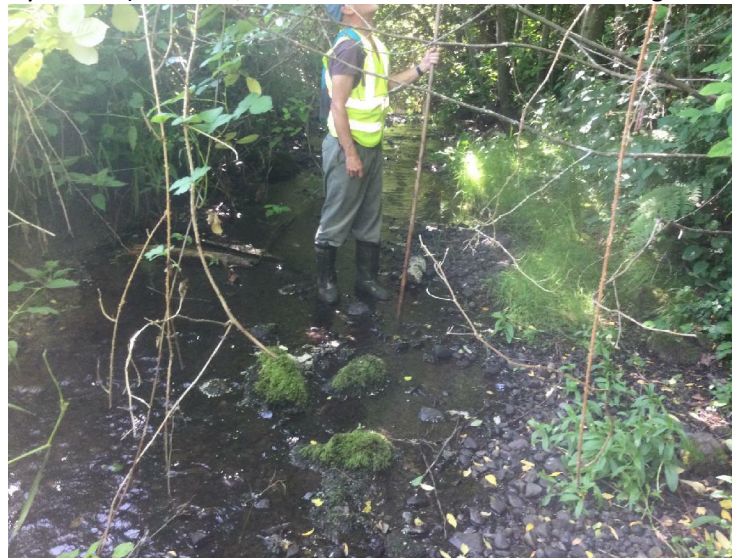
4.) Reach 2, Riffle 2- Wide channel, shallow riffle

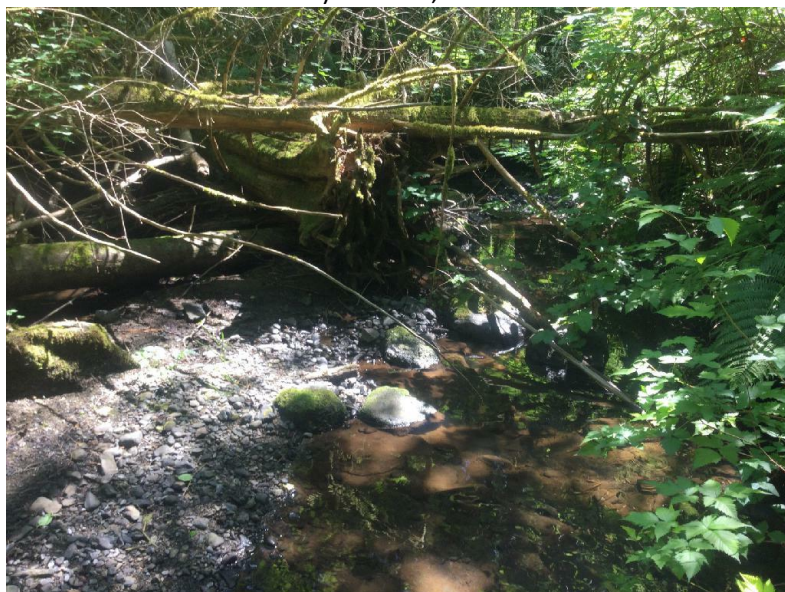
3.) Reach 3, Pool 4 Debris Jam

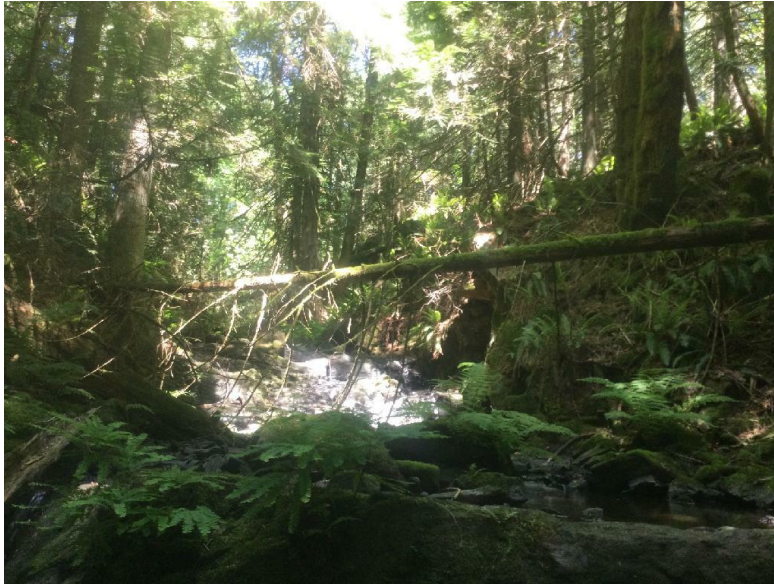
1.) Reach 4, 2m tall falls.

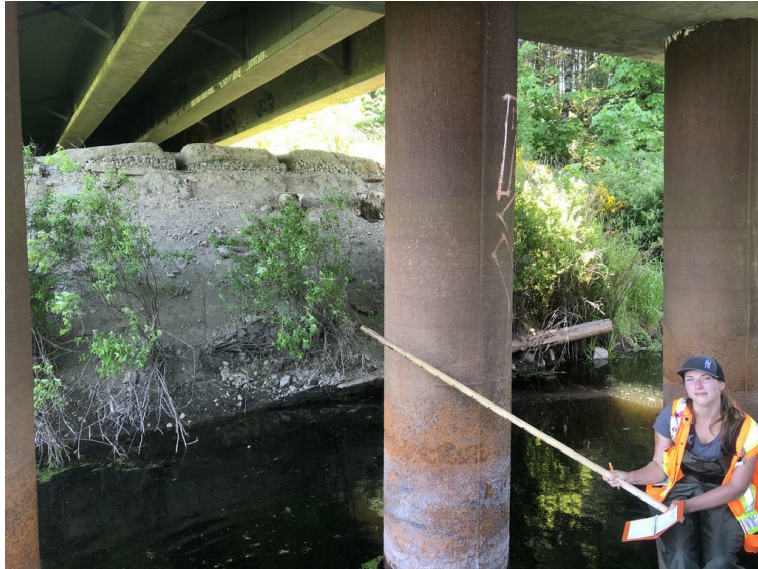
R1A- Herd Rd Bridge erosion.

R1a	Education/Partnerships	River left floodplain south of Herd rd. bridge	Wildlife viewing boardwalk	M
R1b	Fix bridge erosion	Herd rd. bridge	Mitigate runoff from road and address soft, erodible substrates under bridge with materials and/or planting.	M
R1b	Riparian Restoration	Any property owner open to expanding riparian.	Sitka Spruce and fast growing, water tolerant trees such as Red Alder or Pin Cherry planted on mounds. Prioritize banks on the southern aspect and areas without existing shrub cover.	H
R1b	Soil Conservation	Farms in floodplain	Educate farmers on the positive impacts of planting alternative crops overwinter to prevent soils loss and increased flooding potential. Consult an agriculture specialist.	H
R2	Stabilize erosion	Riffle 1, 2, 3, and pools 5 and 7.	Red Osier dogwood or native willow cuttings planted in the bank. This treatment can be coupled with large rock placement to offer immediate stabilization. It is important that cuttings are used in conjunction with rock to not only provide physical stabilization, but also, shade, organic input, and wildlife value.	M

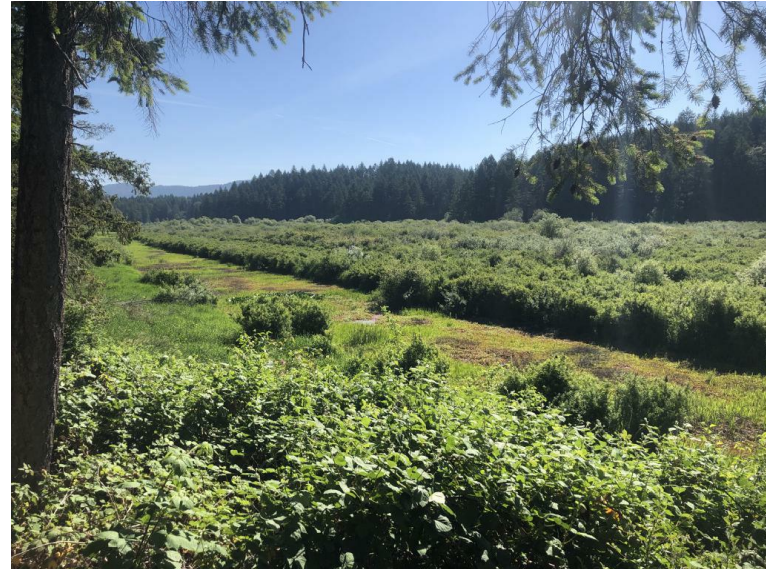
R1A- Floodplain Riparian restoration area

Reach	Issue	Location	Prescription	Priority
R1a	Riparian Restoration Logged and farmed riparian area entire length. It was flattened and channelized for farming and the recovery is hampered by uniformity of the old pastures.	Both Banks. Entire reach.	Riparian throughout this reach is dominated by shrubs due to dredging. The creek needs fast growing deciduous trees such as pin cherries and alder to provide shade. They should, however, be planted alongside water and heat tolerant conifers such as Sitka spruce. Sitka spruce has been proven to do well in similar habitats in the watershed such as lower Bings Creek. Planting benches of imported substrate may be required to provide substrate and elevation above the flood plain. Long term: Potential for Trembling Aspen grove creation on river left floodplain, downstream of Herd rd. Upland: There is opportunity to enhance the Garry Oak ecosystem on river right bank from Placemark 4 (McGregor Farm) up to Herd Rd. Recommended planting here is primarily Garry Oak ecosystem plants. Microsite Opportunistic Planting: Deciduous or conifer planting (ie. Pines, Sitka Spruce, and Hemlock) on mounds and stumps throughout floodplain.	H M H M

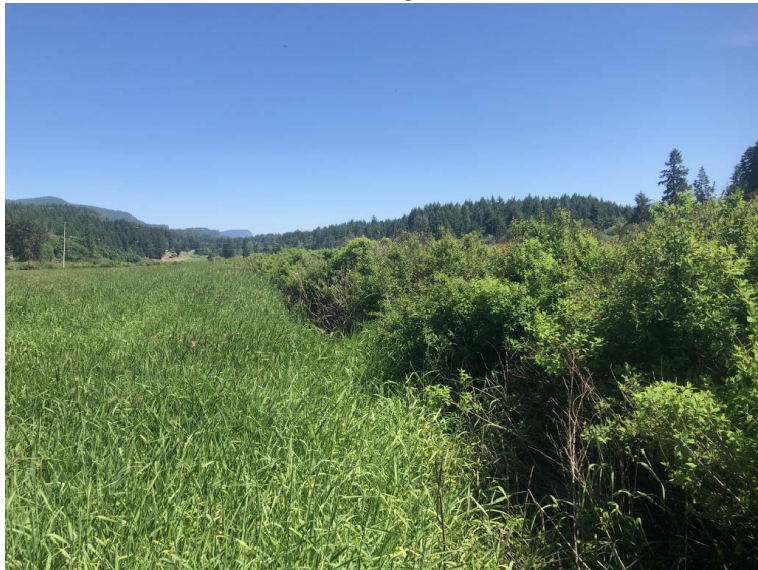
R1B- Grass and shrub dominated riparian.

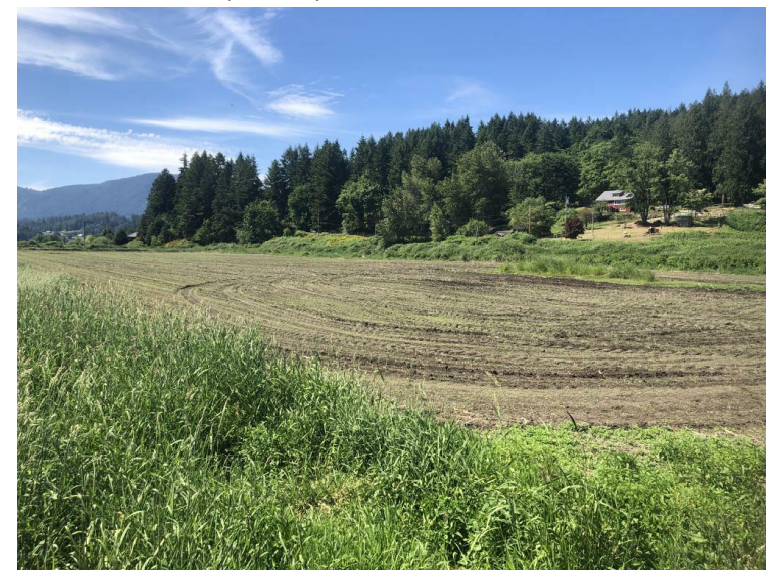
R1B- Intensive farming practices.

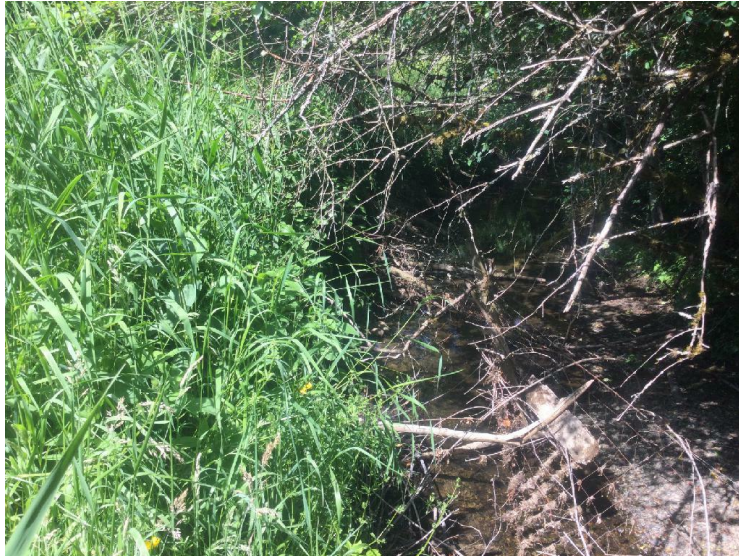
R2- Erosion, fencing collapsed in channel, canary grass riparian

be focused within the first 5 meters of riparian and infilling areas with strictly deciduous species.	
R3	Stabilize erosion	Riffle 1, 3, and pools 4-6	Red Osier dogwood or native willow cuttings planted in the bank. This treatment can be coupled with large rock placement to offer immediate stabilization. It is important that cuttings are used in conjunction with rock to not only provide physical stabilization, but also, shade, organic input, and wildlife value.	M
R3	Pool creation and cover habitat	Long riffles (8-10)	Addition of weirs and LWD structures to create scour. This will diversify habitat and offer survivable summer habitat when flows are very low.	M
R3	Invasive Removal	Waypoint: Ivy forest	Remove or exercise control measures to kill the ivy.	M
R3	Log Jam Removal	Waypoints: Debris Jam (2)	Remove SWD. LWD can be cut and rearranged in the creek for increased functionality as fish habitat or placed in the riparian area as CWD, offering amphibian habitat.	M

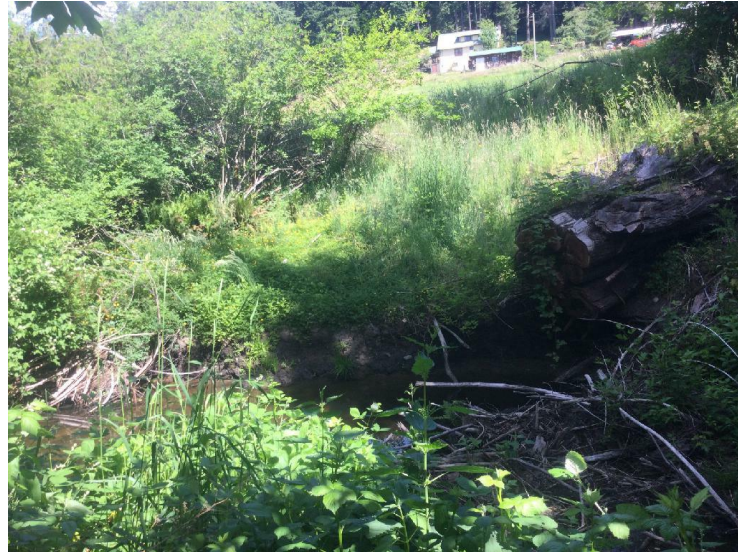
R2 – Debris jam and grass riparian.

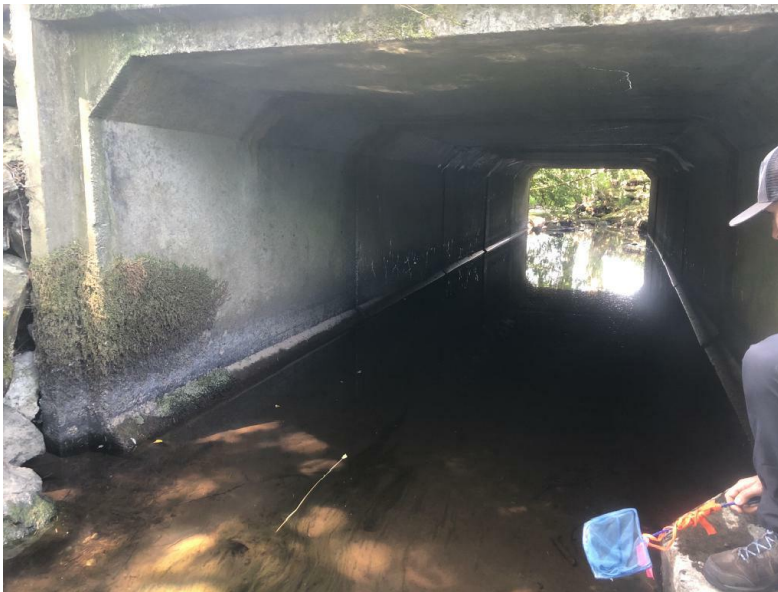
R2 – Box culvert at Richards Trail

R2	Spawning Gravel	Culvert under Richards Trail	Spawning gravel placement at both the entrance and exit of the concrete box culvert.	H
R2	Boulder placement	Riffles throughout the reach	Long and wide riffles should be prioritized. Boulders placed in clusters of 3, at least 1 meter from each bank and 1 meter apart. Non-uniform placement is preferred by fish.	M/H
R2	Pools cover habitat- LWD and brush covers	All pools; prioritize access and larger pool size (pools 3-6)	Anchor LWD to banks using duck bills. Placement should be supervised by a biologist to ensure placement that does not cause bank erosion. When placed correctly, LWD can offer both cover and scour (Increasing pool depth/ habitat quality). A short term, more cost manageable solution to lack of pool cover is brush bundles. These are bundles of evergreen branches, tied together and tied to the bank. Brush bundles offer shade and predator protection to fish.	M/H

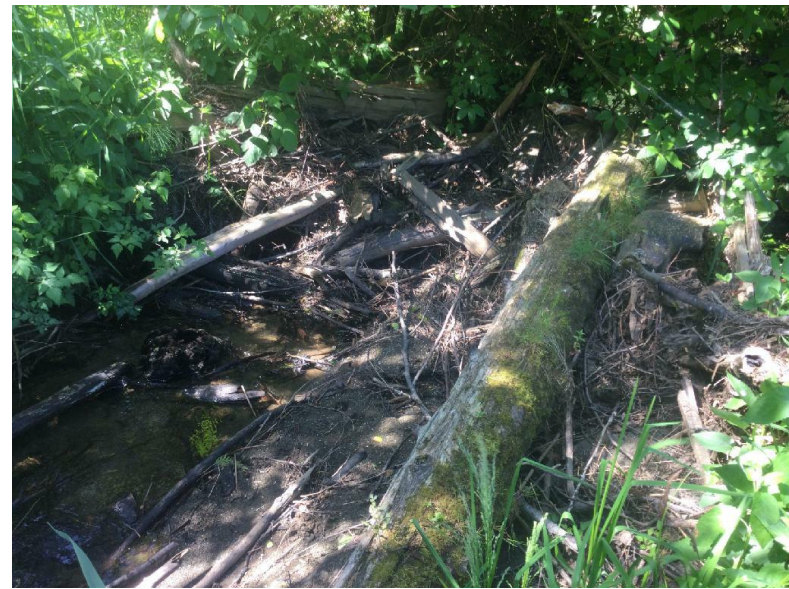
R2 – Debris build up

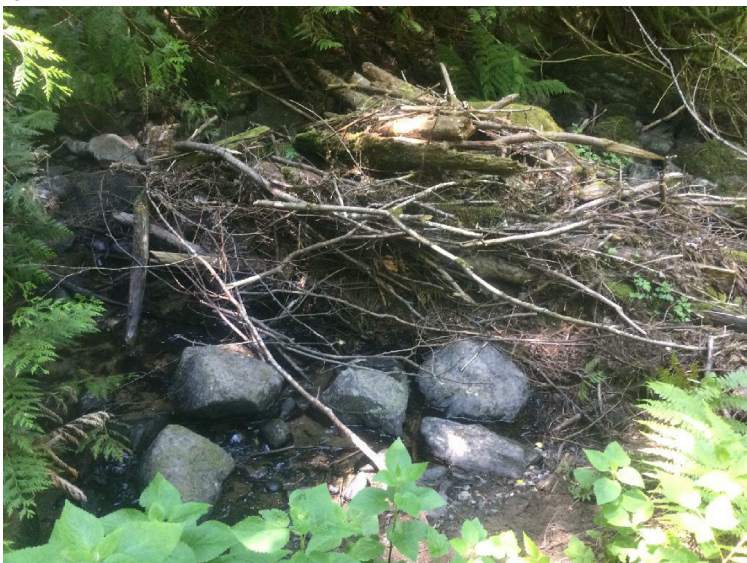
R3 -Lower debris jam.

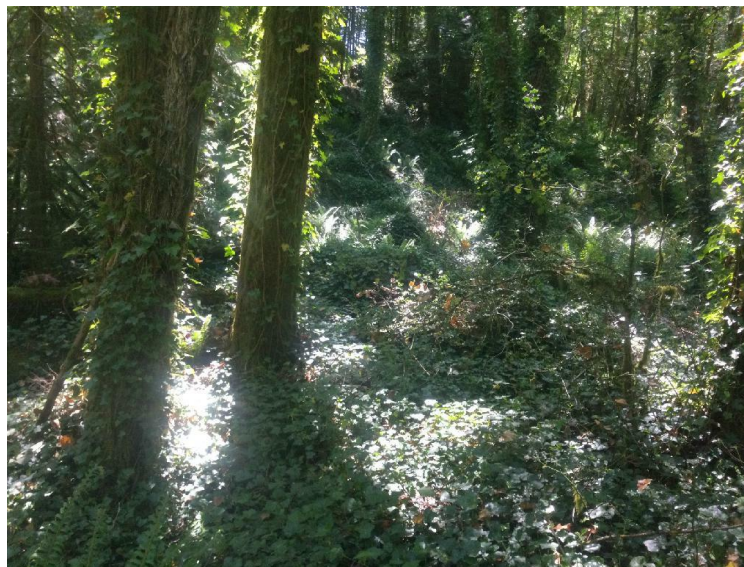
R3 – Ivy infestation on river right.

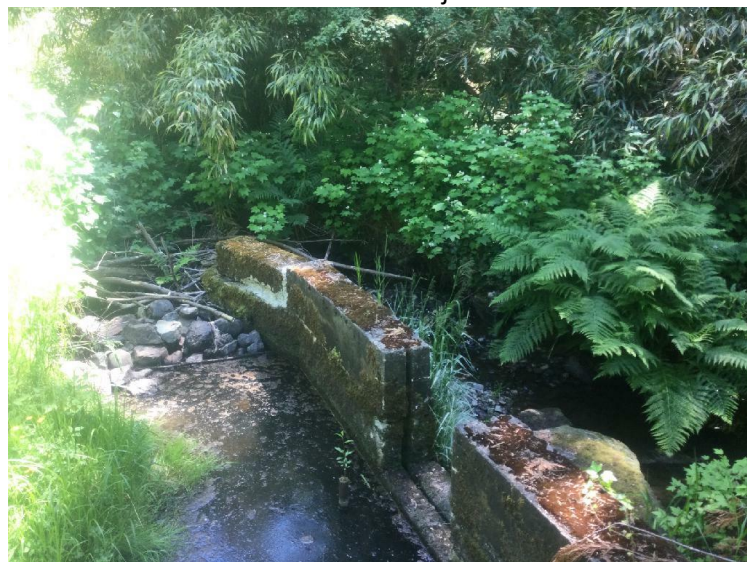
R3 –Abandoned concrete weir in the upper reach.

R3	Human obstruction removal	Waypoint: Old Weir	Remove unused concrete weir from the creek to allow improved fish passage.	H

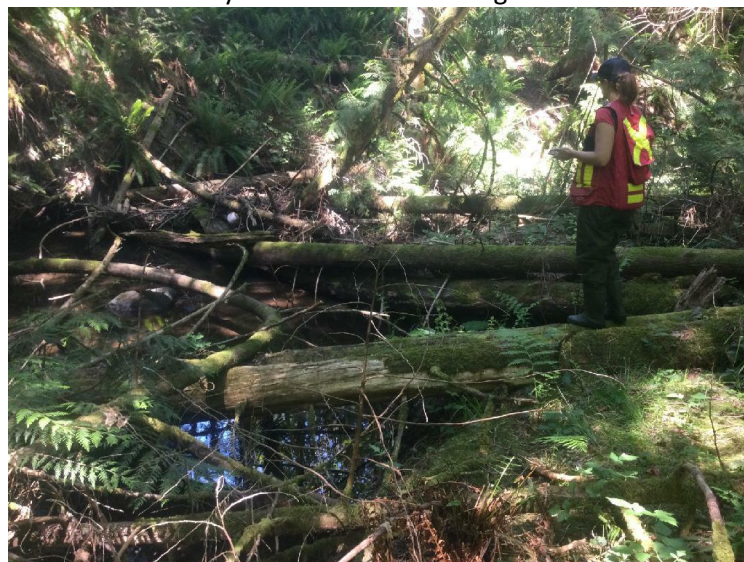
R3 – Upper debris jam.
