2021 SOMENOS CREEK PARROT'S FEATHER REPORT

Prepared by Adam Dewar, SMWS Watershed
Stewardship Specialist

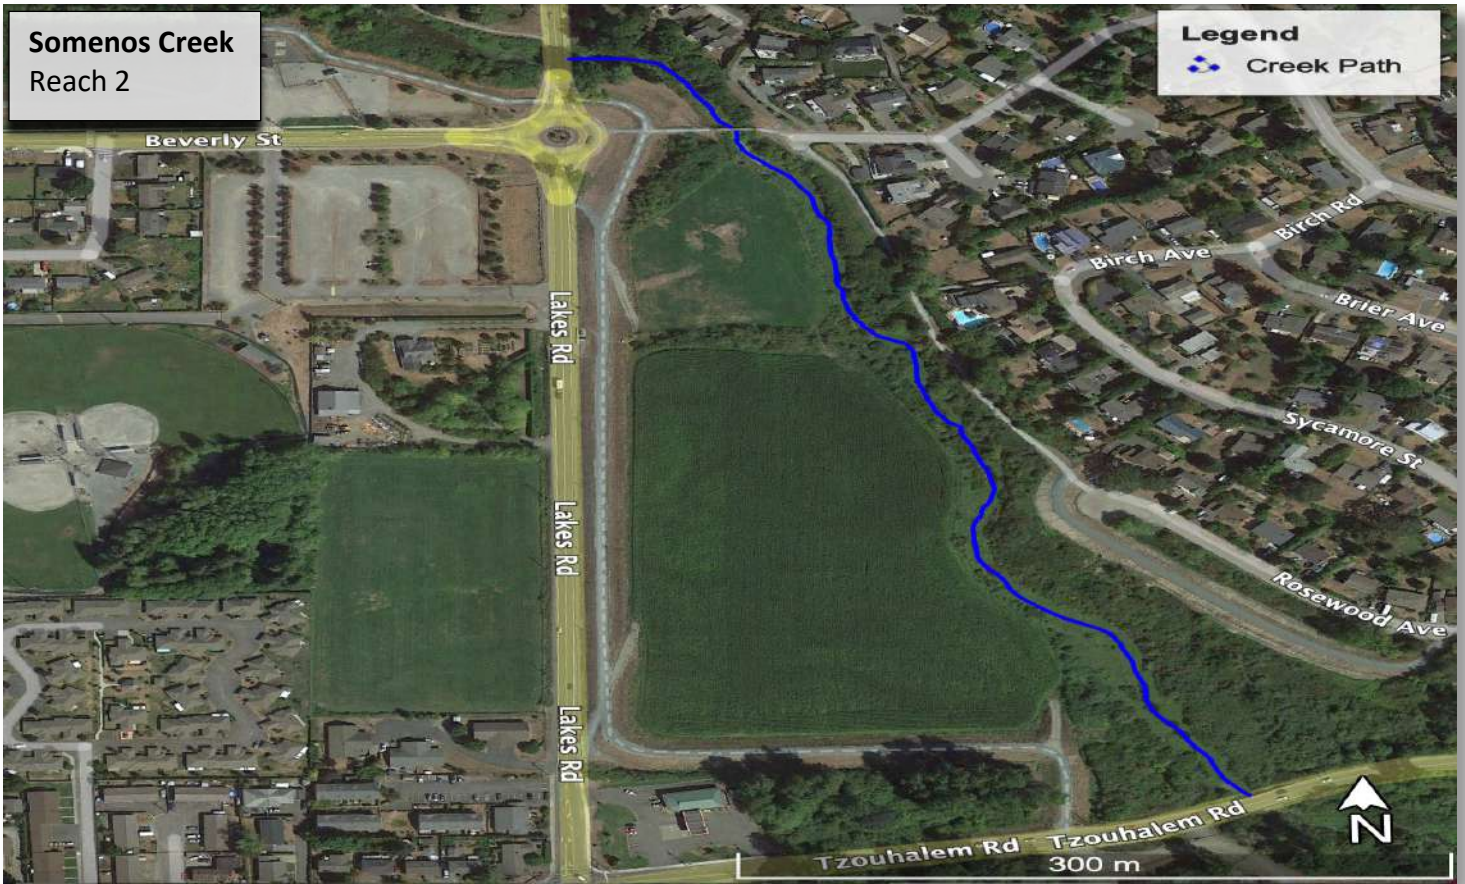
Reach 2 of Somenos creek begins at the Eastern side of the Lakes Road Bridge and flows South Southeast to the North side of the Tzouhalem Road Bridge (Figure 3). This reach is characterized by an essentially completely open canopy, with little to no shade. It flows directly adjacent to agricultural fields on its Western bank, and a residential development on the Eastern bank. The agriculture consists of a hay field and a corn field that are actively cultivated each year. The agricultural fields bordering this reach provide a substantial floodplain which is used in the wet season by many species of waterfowl for overwintering and migration. This reach has also been dredged in 2004 (Municipality of North Cowichan, 2019) however sedimentation continues to plague it.

Figure 3: Reach 2 of Somenos Creek. This reach runs from Lakes Road Bridge to Tzouhalem Road Bridge

Reach 2 showed the most significant fluctuation in parrot's feather coverage of all three reaches of Somenos Creek this season (Table 2).

The parrot's feather in reach 2 went through substantial transformation in the summer of 2021. This reach saw the most dramatic changes of all three reaches, both in the increase in coverage from June to August (18%), but also in the decrease from August to December (39%). Interestingly, in this reach, while the coverage decreased drastically, we are unsure as to whether or not much of the parrot's feather has actually left the system. During the December survey, it was noted that several larger areas of open water had opened up, however, it appeared that the sections of parrot's feather that had broken free had

drifted downstream and been blocked by other clumps that had not become dislodged. This was evidenced by apparent thickening of the downstream mats.

A point of concern in this reach is the fact that there are a couple of pinch points that are associated with substantial mats of parrot's feather. These mats were assessed by the SMWS in August in preparation for rainy season to see if they could potentially increase the flood risk in the area ([Link to assessment](#)). The first of the two pinch points is a narrowing and sharp bend in the creek about 70m downstream of Lakes Road Bridge. This area has been cleared by fall flows and doesn't seem to present a current hazard. The second pinch point is just downstream of where Chesterfield Creek joins Somenos Creek about one third of the way through the West bank farmer fields (Figure 3). This point is a narrowing portion of the creek where a tree has fallen from the Eastern bank and is now a potential blockage hazard. As of December, this appears to be the main point of collection for parrot's feather drifting downstream. This area is prone to flooding even when clear, so it's difficult to determine the risk this pinch-point may create with regards to flooding. The main concern with this area is that if the mats get thick enough, they may present a physical barrier which could negatively impact fish migration through Somenos Creek and into the rest of the watershed.

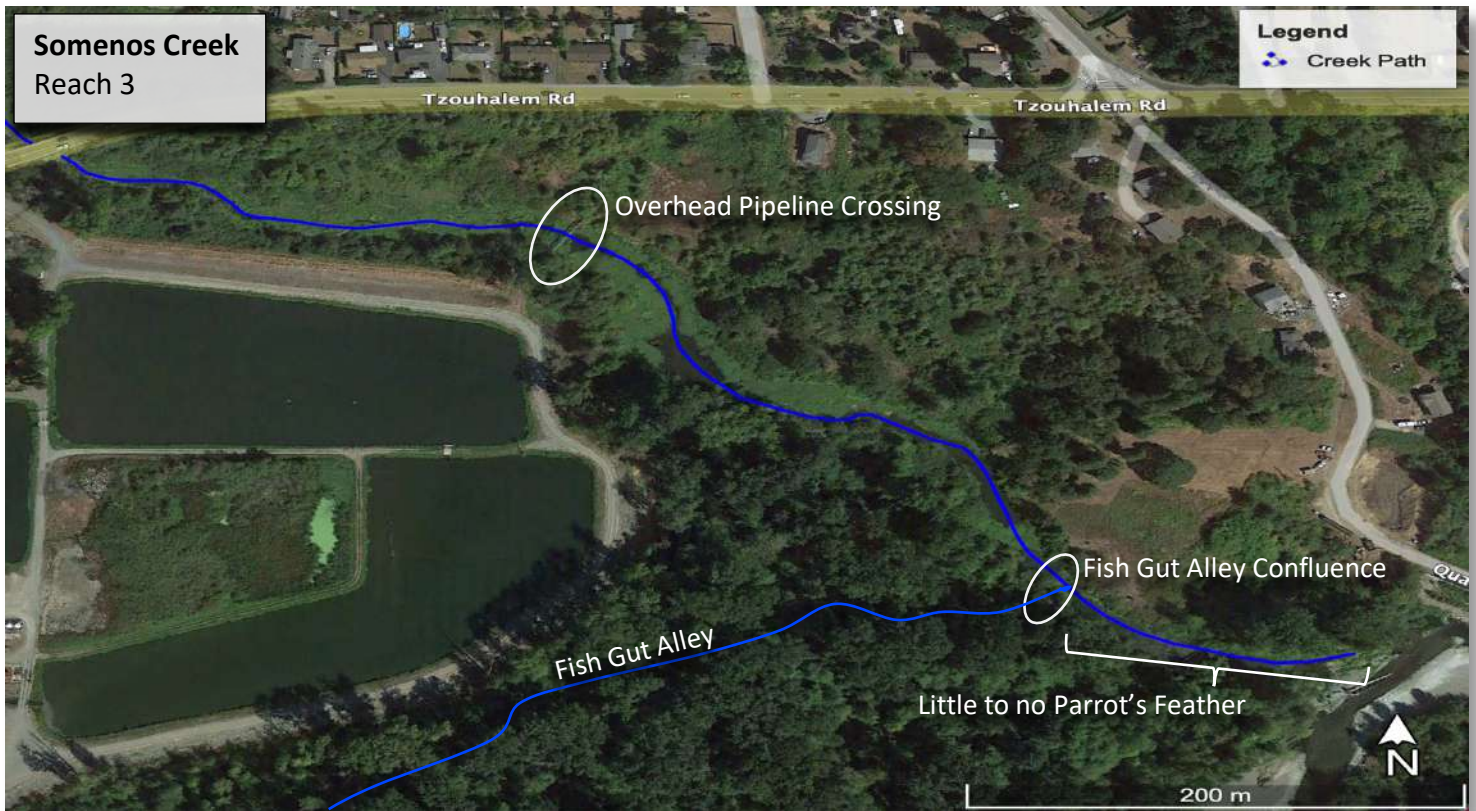
Reach 3 of Somenos Creek begins at the South side of Tzouhalem Road Bridge and flows Southeast before joining forces with the Cowichan River. This reach is characterized by a more natural shape and bank, as it has not been dredged in the past, as reaches 1 and 2 have. It is crossed about a third of the way downstream by an overhead water pipeline. The banks are higher than elsewhere in the creek, and while they are wide enough to give the creek access to some floodplain, it is generally a more confined reach than the other two. This reach also boasts the most natural vegetation on its banks, and the greatest riparian depth, supporting large trees in its Southern half. Although greater than reaches 1 and 2, reach 3's canopy cover certainly still leaves something to be desired. This reach is entirely located on Cowichan Tribes land.

Figure 4: Reach 3 of Somenos Creek. This reach runs from the Tzouhalem Road Bridge to the Cowichan River

Reach 3 was surveyed three times this season, whereas the other two reaches were surveyed 4 times. However, the trends remain consistent, with a quick climb in coverage during the summer, followed by a sharp drop off in the fall and early winter (Table 3).

Reach 3 of Somenos Creek showed the lowest start and endpoints with regards to parrot's feather coverage. There are several points of note within this reach. First, there is an overhead water pipeline crossing about one third of the way downstream in this reach (Figure 4). This area is accompanied by the lowest canopy coverage in the reach and consequently experienced the most consistent complete coverage of parrot's feather in this area. Even during the December survey, there was still a bank-to-bank mat underneath and directly adjacent-downstream of this pipeline. Beyond the lack of shade, we are

unsure if this pipeline or the infrastructure required to install it has any direct impact on parrot’s feather. The second point of interest is the confluence with a stream referred to as “Fish Gut Alley” (Figure 4). In June, large portions upstream of this confluence had high coverage, while below this confluence, there was no parrot’s feather at all. The water coming from Fish Gut Alley (FGA) was much colder and flowing much more quickly than the water upstream in Somenos Creek. When we returned in August, FGA was experiencing very low flow and consequently the coverage of parrot’s feather had drastically increased downstream of the confluence. We tested water in FGA (Table 4, Figure 5) and found it to be much colder and more oxygenated than that in the rest of the creek (Table 5), potentially creating conditions that were too harsh for parrot’s feather to thrive. Remember, it’s an Amazonian plant and does better in warmer water.

Something else of note in reach 3, is the fact that it saw the greatest drop (47%) in coverage from its peak in August to its low in December. There are several possible explanations for this dramatic fall decrease. Firstly, this is the terminal reach of Somenos Creek that flows directly into the Cowichan River, meaning that when parrot's feather dies and breaks off, it has less distance to travel to be ejected. Simply put, less distance travelled means it's likely to encounter fewer blockages and pinch points. Secondly, there's the aforementioned influence from the water entering the creek from FGA. Perhaps since it had a shorter growing season downstream of FGA, the root systems weren't as well established, allowing for easy ejection come rainy season. Finally, while the banks along reach 3 are fairly wide, there is far less floodplain when compared to the first two reaches. This could lend itself to higher flow velocities in this reach due to a more constricted flow path, thus making ejection of the parrot's feather easier as it begins to die off. The upper two reaches have such extensive floodplains that during high-flow, water simply flows around the parrot's feather mats, rather than pushing them downstream, as we see in reach 3.
