**Description of an anomalous discharge of containment pond water
into Bings Creek on 10 May 2019**

Somenos Rapid Science Communication 2019-01

Dave Preikshot, PhD, RPBio
Somenos Marsh Wildlife Society

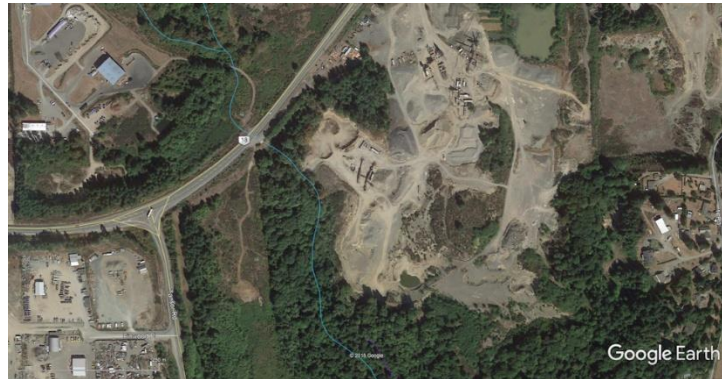
Figure2: Bings Creek (blue line) near the Duncan Paving Property on the Cowichan Lake Highway. The containment pond can be seen just below the center of the photograph. The Bings Creek Transfer Station can be seen at the upper left.

This anomalous high discharge event has been identified as originating from an unplanned release of water from a containment pond on the Duncan Paving Property on Highway 18 (Barron 2019), Figure 2. Reporting indicates that the property owner took corrective action and reported the event to both the provincial Ministry of Energy, Mines and Petroleum Resources and Environment Canada. Because no one was available to take water samples during the event there is no way to draw any conclusions as to the presence of metals, nutrients or other pollutants in the discharged water. However, data from the Environment Canada water gauge near Agira Road can be used to make inferences on the total amount of water released, its physical characteristics and its potential effects on fish and fish habitat in Bings Creek.

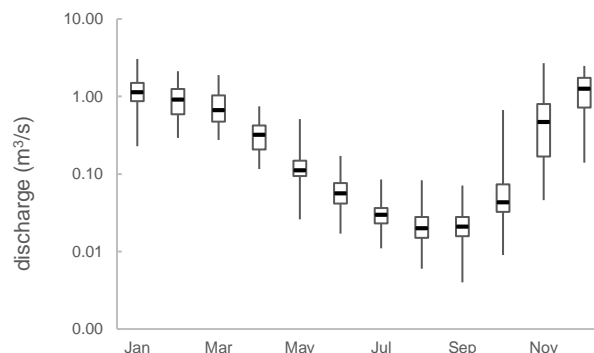
Figure 3: Monthly discharge observed in Bings Creek, 1961-2019. Horizontal black lines are medians, boxes are $\pm 50\%$ confidence intervals and vertical black lines show monthly maxima and minima. Data from: wateroffice.ec.gc.ca/mainmenu/historical_data_index_e.html

Historic data from Environment Canada (2019a) shows that during the observation period of 1961-2019 the median observed discharge for Bings Creek in May is $\sim 0.1 \text{ m}^3/\text{s}$, with a 50% confidence interval ranging between 0.09 and $0.15 \text{ m}^3/\text{s}$, Figure 3. Real time observation data from 10 May 10 2019 (wateroffice.ec.gc.ca/mainmenu/real_time_data_index_e.html) shows that Bings Creek discharge was $0.076 \text{ m}^3/\text{s}$ before the discharge event, Figure 4.

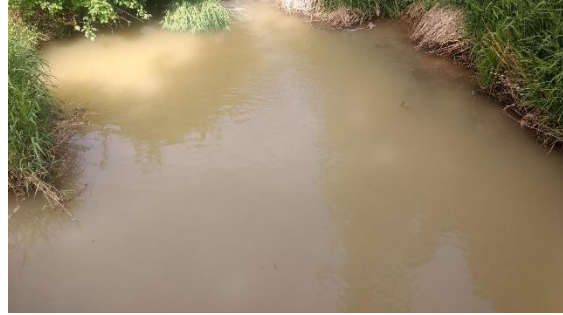
Figure 6: Bings Creek at Phillip and Mary Streets looking West, photo taken at 1130 hrs 11 May 2019.

The author visited Bings Creek on Saturday, 11 May 2019 at two locations; the culvert at the intersection of Phillip and Mary Street (about 4,700 m downstream of the containment pond) the culver where Bings Creek crosses Cowichan lake Road (about 700 m downstream of the containment pond). Despite almost 12 hours having elapsed since the end of the timing of excess water input to Bings Creek, the water at Phillip and Mary Street was still very turbid, Figure 6. Juvenile trout and salmon were observed both upstream and downstream of the culvert at Phillip and Mary Street. Further upstream at Cowichan Lake Road, the water appeared to be much clearer, Figure 7. This change in turbidity suggests that excess sediment and fine particulate matter put into Bings Creek during the discharge event was moving along the creek bed and significant amounts had accumulated in stream reaches between the containment pond and Somenos Lake.
