June 2021 Parrot's Feather Report

Somenos Creek

Somenos Lake to Cowichan River

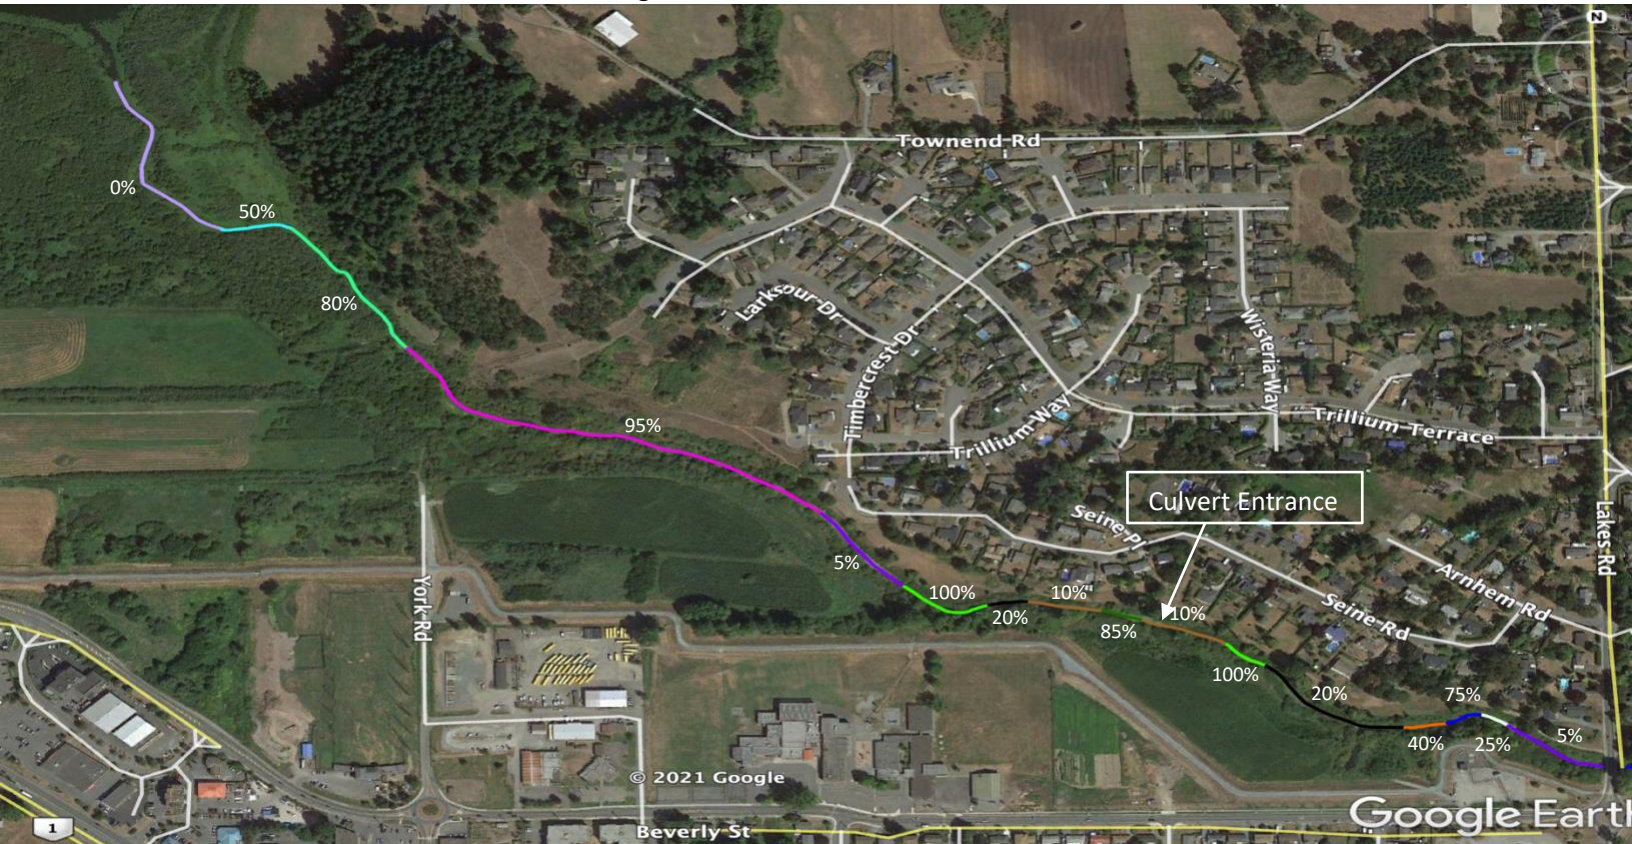
Figure 2: Reach 1 of Somenos Creek. This reach stretches from Somenos Lake to the Lakes Road Footbridge. Percentages refer to parrot's feather coverage as of late June 2021.

Reach 1 had a total parrot's feather coverage of 63% (Table 1), this statistic does not include the Northernmost section of Somenos Creek before the presence of parrot's feather begins (mauve line, top left of figure 2). There are many variances in the coverage throughout this reach, varying from as little as 5%, to long stretches of near-complete coverage. As far as the assessment team could note, there were no specific features of this reach that could accurately predict where the parrot's feather coverage would be the thickest (water depth, crown cover, shade, creek width). Water quality was tested at the culvert entrance highlighted in Figure 2. This was because right at this culvert, there was no parrot's feather present, and this was also the only place where live Coho fry were observed in this reach of the creek. Water quality results are highlighted in Appendix 1.

Water quality was tested in several areas of interest throughout this survey. In figure 2, a culvert that enters Somenos Creek from an adjacent neighbourhood is highlighted as the only area in Reach 1 where Coho fry were observed. We decided to test the water that was coming out of the culvert, and then compare that to where the water meets the creek (confluence), water in the creek's open channel, and water below the parrot's feather mat. The results are in the table below:

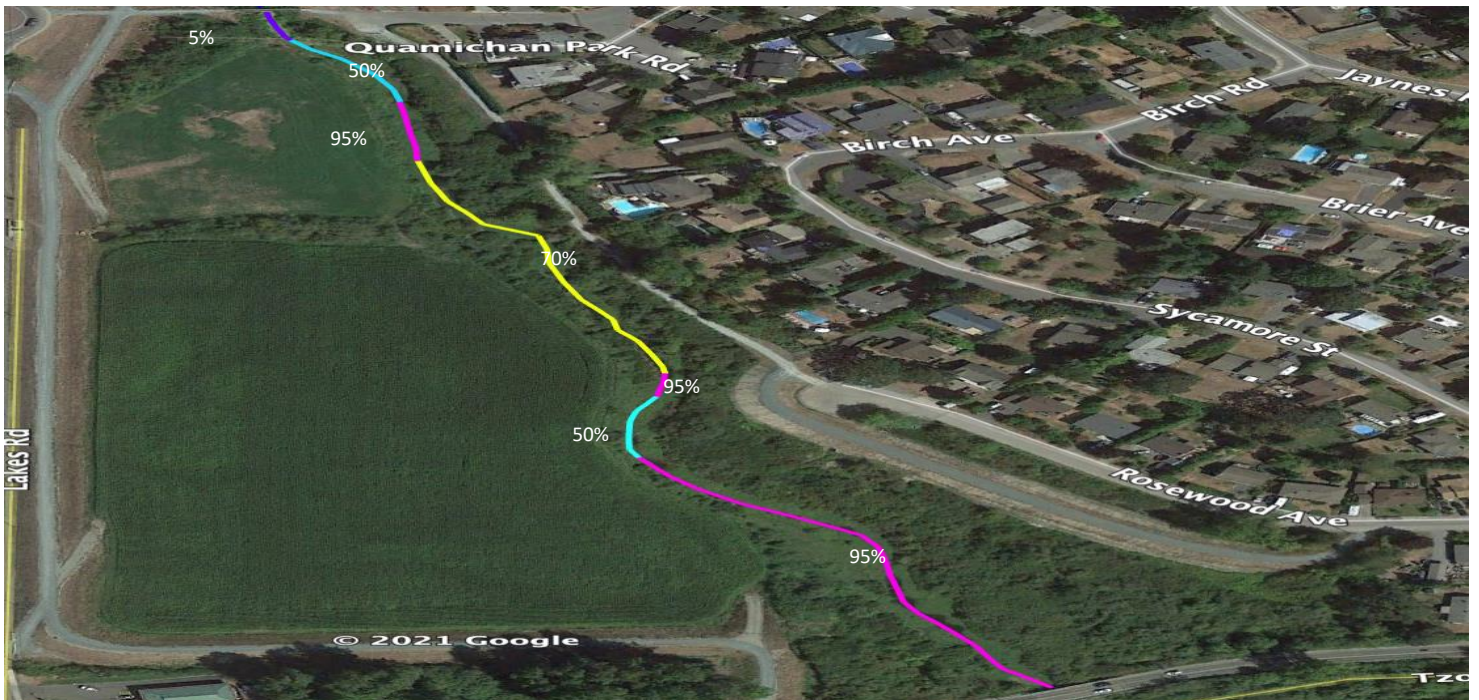
Figure 3: Reach 2 of Somenos Creek. This reach stretches from the Lakes Road Footbridge to the Tzouhalem Road Bridge. Percentages refer to parrot's feather coverage as of late June 2021.

In reach 2, the parrot's feather coverage totaled 78% (Table 2). It shows considerably less variation than the coverage in reach 1. However, coverage still drops to as low as 5% near the footbridge, and sees coverage peak at around 95% on longer, more open stretches. In this reach, there seems to be a bit more correlation between coverage and shade. The bottom stretch in Figure 3 is an area with very little, if any, streambank canopy coverage. The middle yellow stretch, showing a coverage of 70%, coincides with the one section of this reach that has a bit more canopy coverage. It is worth noting, however, that the canopy coverage even in this section is very limited, and most of the taller riparian trees are a fair distance from the creek, thus limiting their shading efficiency. It will be interesting to note changes in coverage during the July assessment and see if the coverage percentages still reflect differences in riparian vegetation.

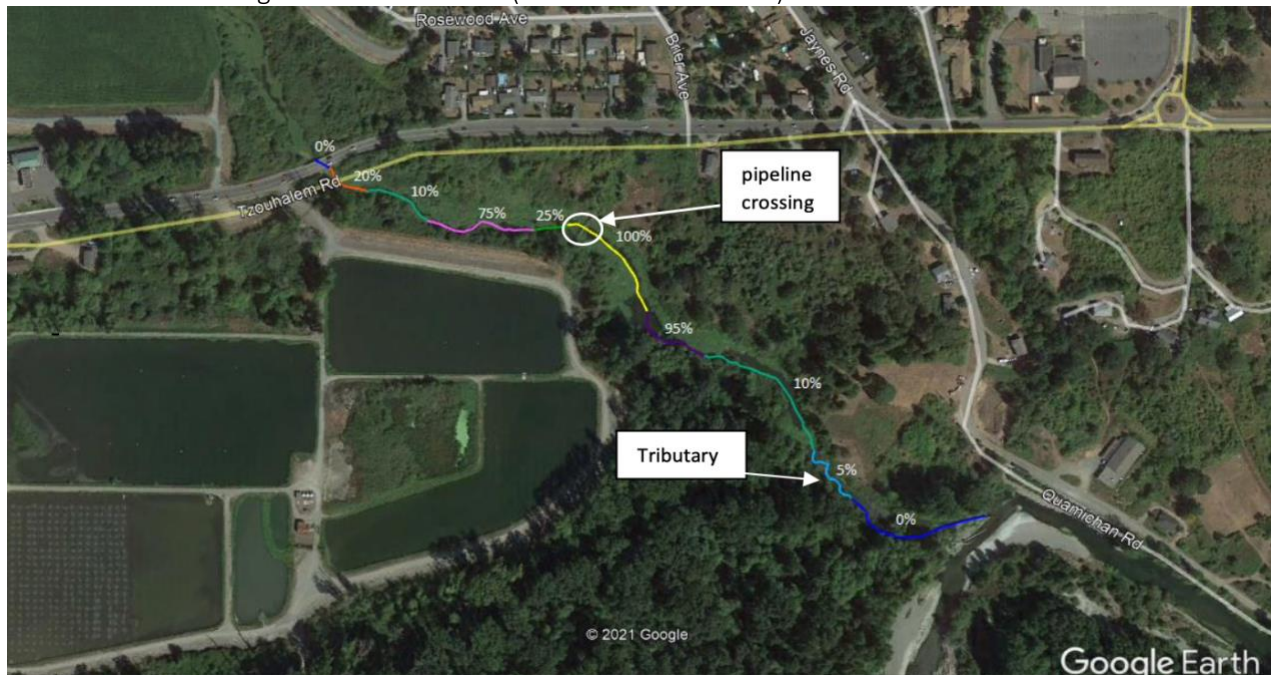
Figure 4: Reach 3 of Somenos Creek. This reach Stretches from Tzouhalem Road to the Cowichan River. Percentages refer to parrot's feather coverage as of late June 2021.

Reach 3 of Somenos Creek was determined to have a cumulative coverage of parrot’s feather totalling 54%. However, below the tributary inflow that is shown near the bottom of figure 4, shows remarkable “parrot’s feather resistance” (water quality info in appendix), with no parrot’s feather present between the tributary and the confluence with the Cowichan River. If we were to include only areas with parrot’s feather present, we have a reach coverage of 71% (both percentages are shown in Table 3). This reach showed no meaningful correlation between riparian changes and parrot’s feather coverage percentages.

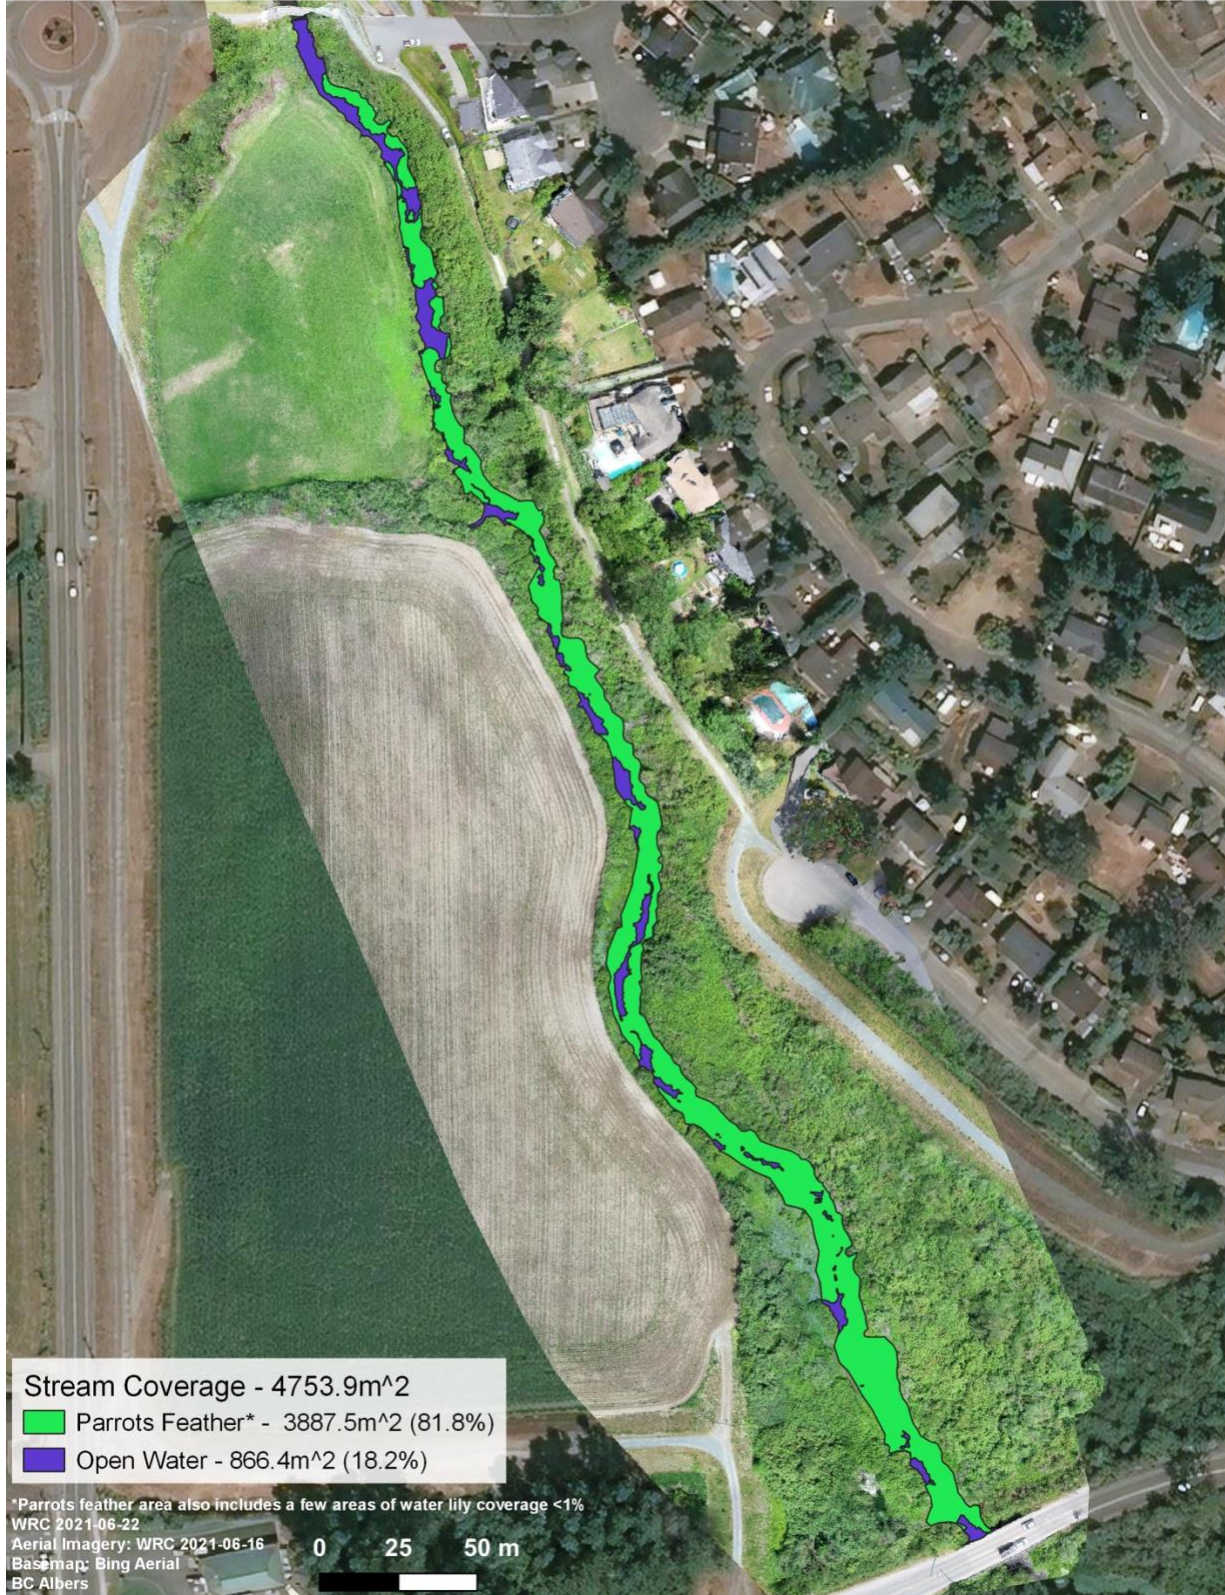
Somenos Creek - Parrots Feather extent June 16, 2021

Below are the results of the drone survey that was done as a part of the planting plan for the reach 2 riparian area. If we consider the numbers in the image below, versus the numbers that were assessed by the staff members from kayaks and the streambank, we find that there is only about a 3-4% error rate in our assessment methods, giving us confidence in the accuracy of our methods going forward.

Stream Coverage - 4753.9m²
Parrots Feather* - 3887.5m² (81.8%)
Open Water - 866.4m² (18.2%)

*Parrots feather area also includes a few areas of water lily coverage <1%
WRC 2021-06-22
Aerial Imagery: WRC 2021-06-16
Base map: Bing Aerial
BC Albers

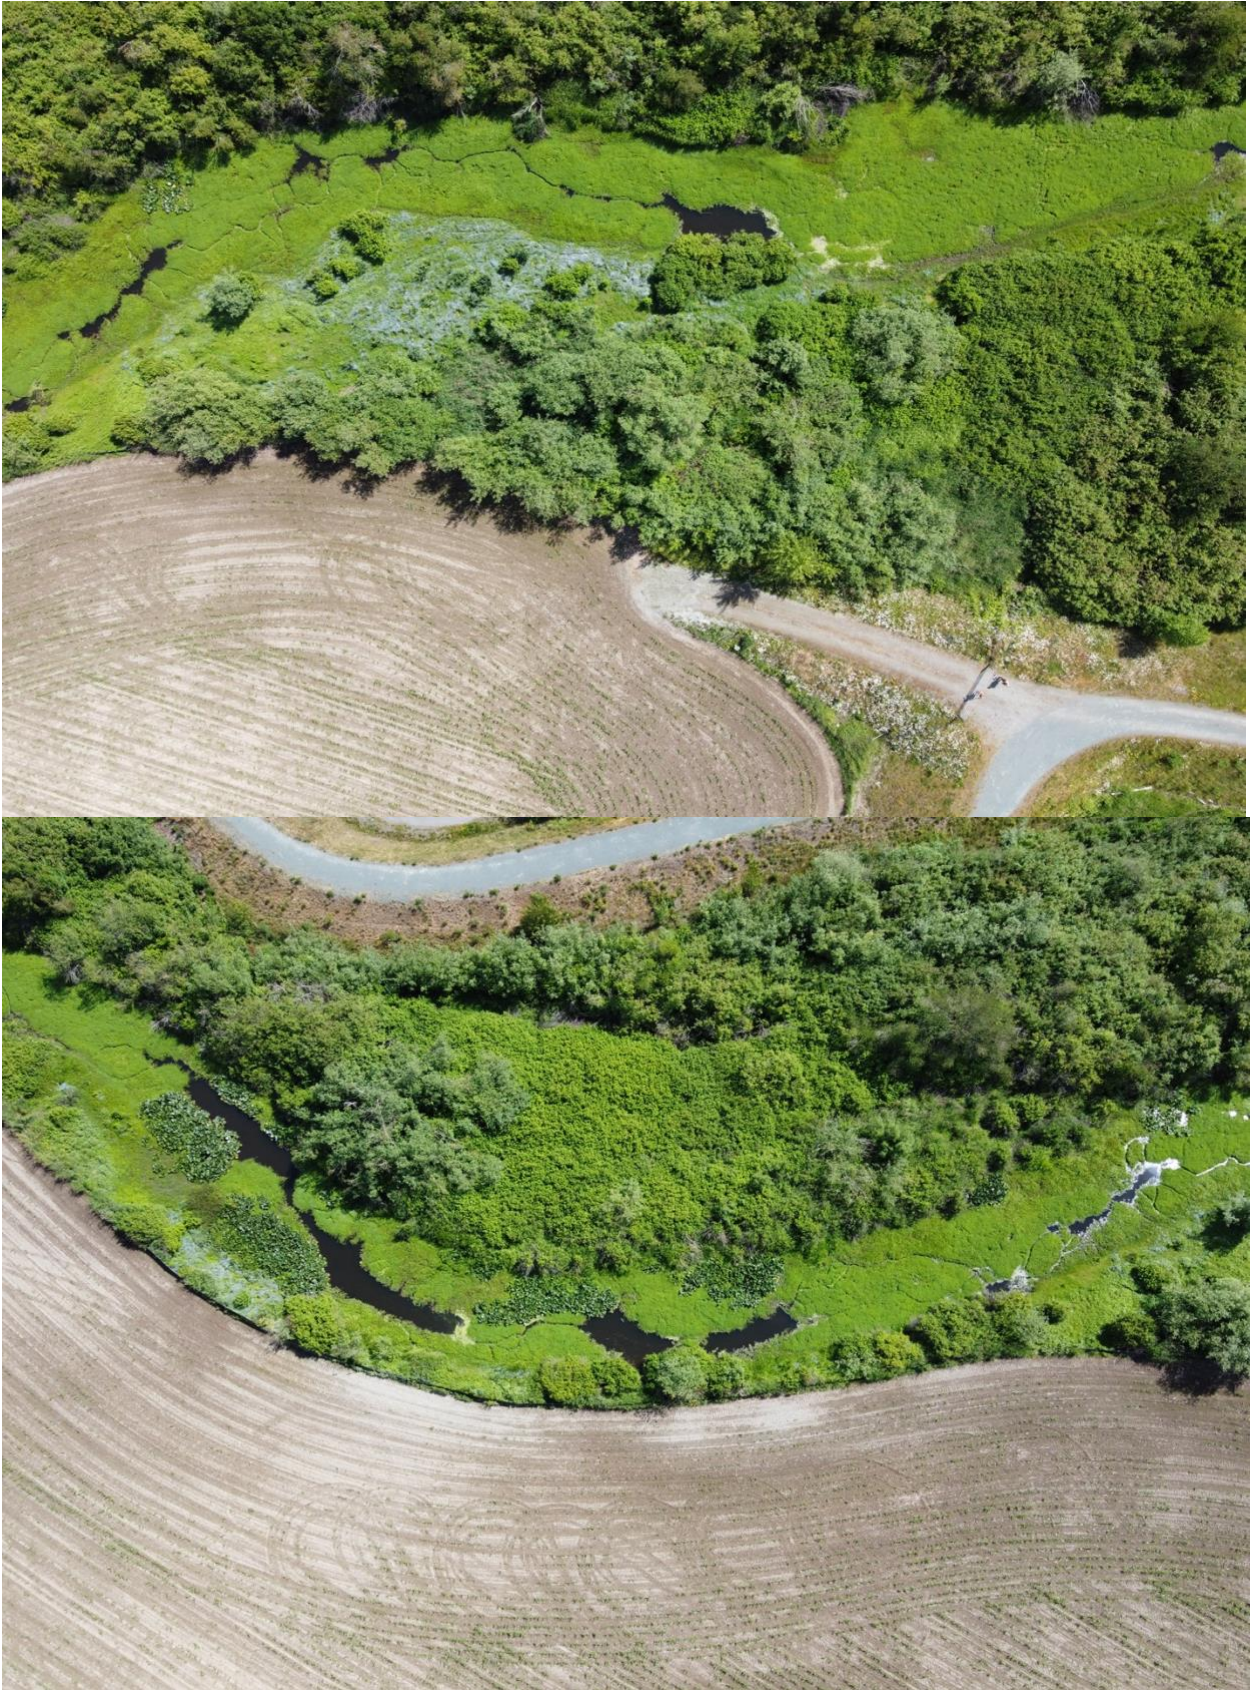
Parrot's feather drone imagery (Courtesy of Leh Smallshaw)
