Parrot's Feather Management Report of Activities & Survey 2021

Prepared by:

Gina Hoar, Aquatic Specialist

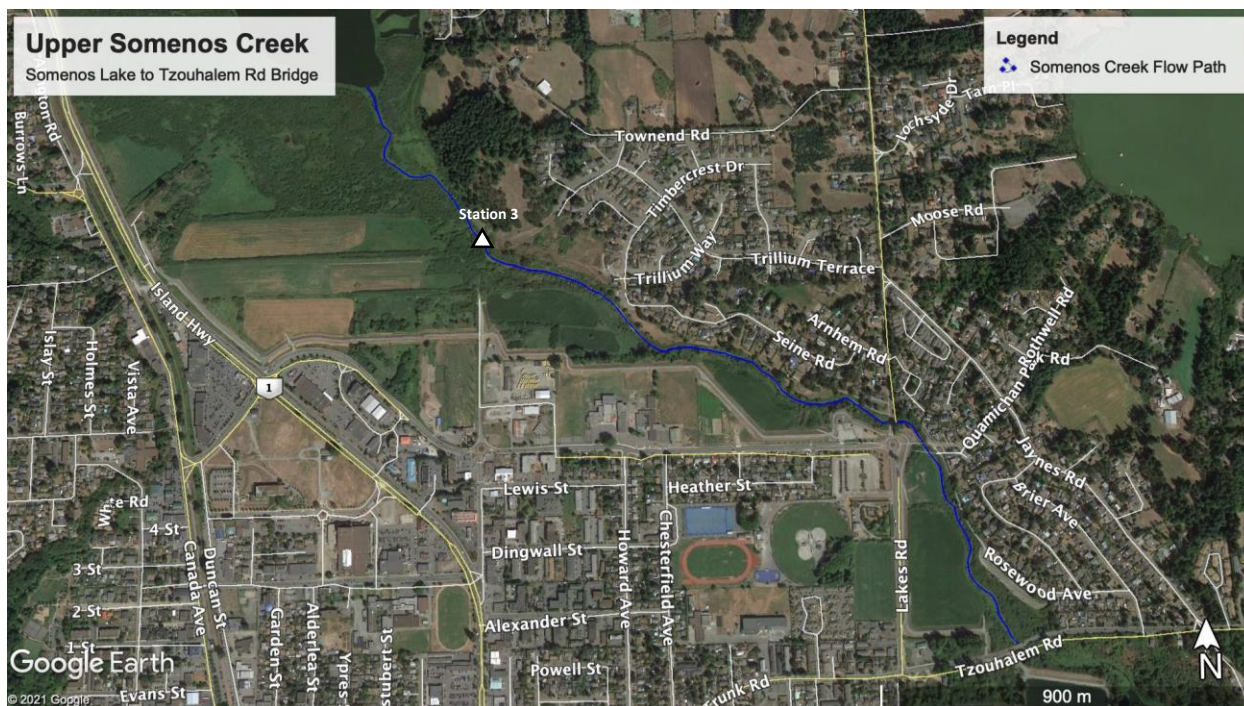
Figure 1: Location of the 4 pond liner re-installations at WQ Hobo MX2202 Station 3.

In June 2021, SMWS observed the pond liners remained anchored in place throughout the winter and spring; however, Parrot’s feather started to grow over top of it and some air bubbles brought some of the liner to the surface. Therefore, we planned to re-install the pond liner at the same location, which also allowed us to inspect the growth of it under the mat and the pond liner’s structural integrity to ensure it could remain for another year. In mid-July to early August, 2021 a crew of SMWS staff and volunteers removed all four sheets of pond liner from Station 3 (Figure 1) and re-installed the liners.

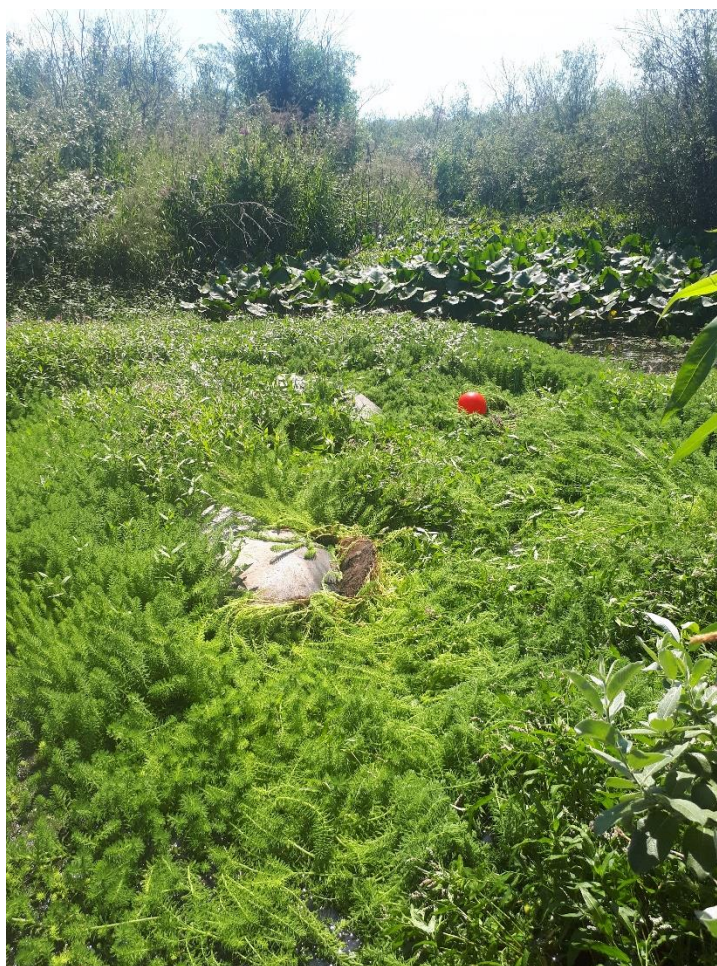
Prior to pond liner being re-installed, SMWS observed that Parrot's feather grew from the sides of the liner, overtop and covered most of it (Photo 1). Thus, during removal, the Parrot's feather had to be cut and rolled back to expose the liner (Photo 2). Once exposed, the pond liner appears to suppress some growth of the rhizomes underneath, and stolons from growing down and rooting. Photo 3 shows the open water after the pond liner was removed.

Photo 1: Pond liner covered by Parrot's feather before removal of pond liner. The red buoy is recording temperature and light data logger at Station 3.

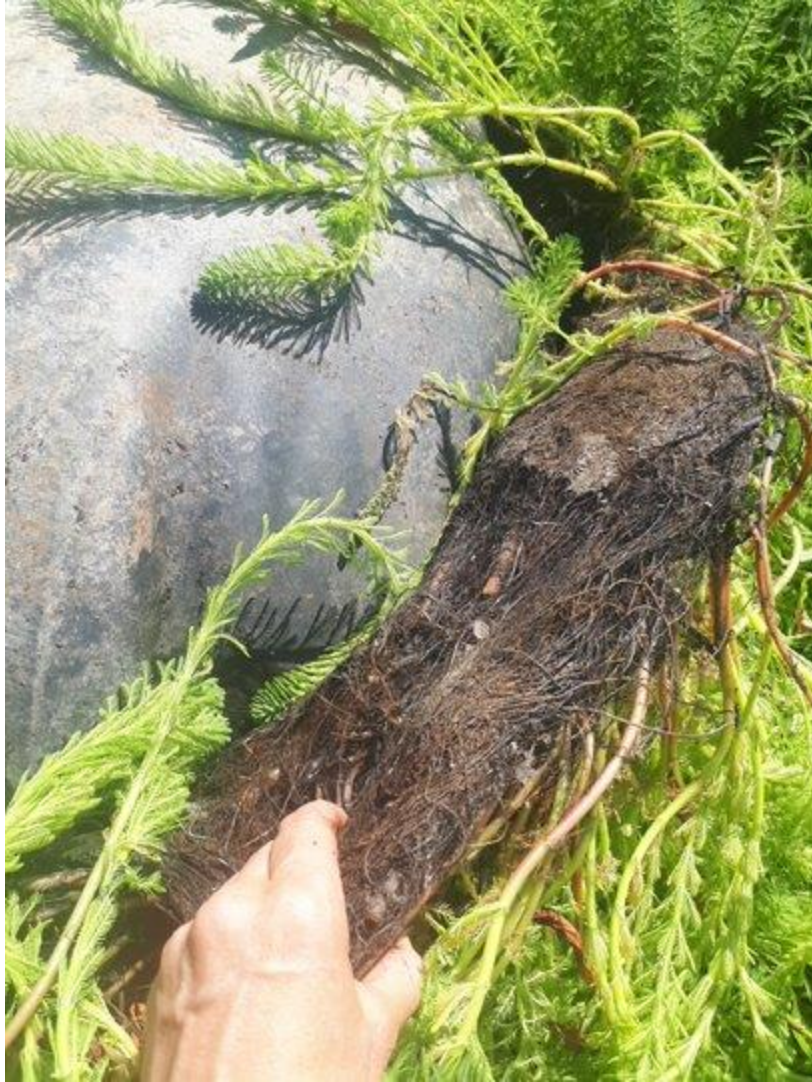
Photo 2: The Parrot's feather mat grew from the sides overtop the liner, not from underneath.

To remove the pond liner, the Parrot’s feather that grew overtop was cut and rolled back to reach the rebar and weights that held the sheets in place. The zip ties were cut to remove the rebar first, then the mats were hauled onto shore for inspection. Besides having some sediment and detritus on the mats, they were structurally sound and were prepped for re-deployment. Preparations required scrubbing and cleaning the pond liners clear of debris, algae and sediment to mitigate sedimentation when they are re-installed. Minor tears in the pond liner were patched and most of the rebar was re-used.

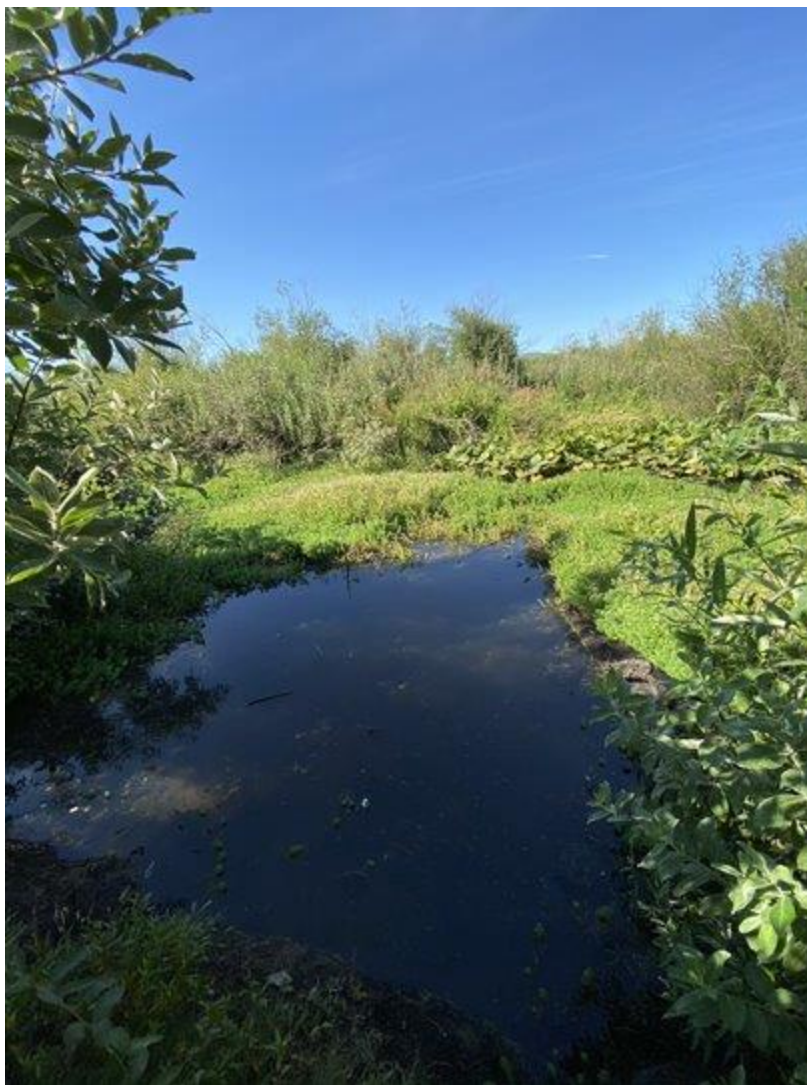
Photo 3: Station 3, after pond liner was removed in July 2021.
