# **Water Quality and Stream Invertebrate Assessment on Richards Creek, North Cowichan (BC)**

Tylyn Der, Stephanie Govier, Hailey Quist, and Heidi Richardson

RMOT 306

**Fall 2015**

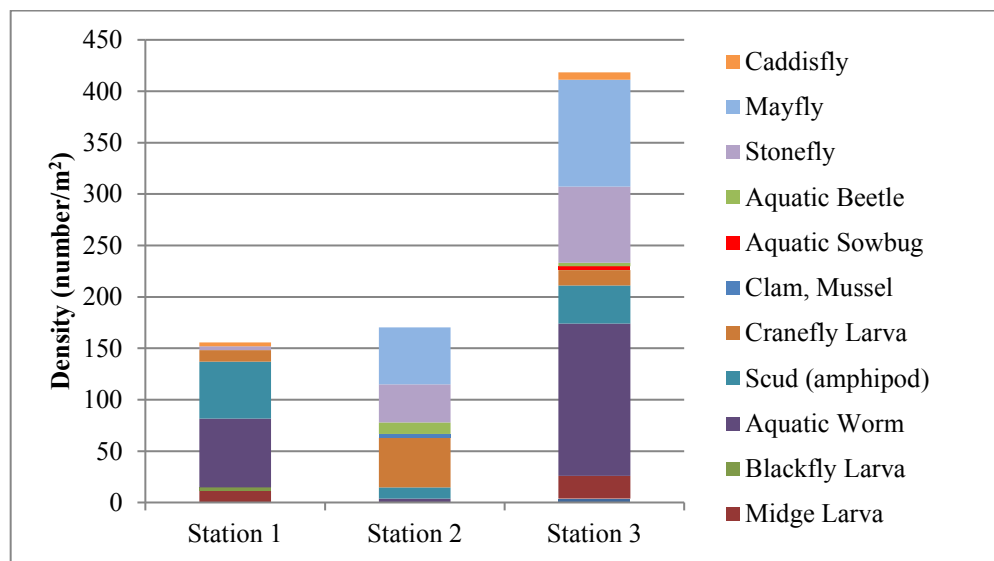
Figure 1. Density per metre<sup>2</sup> of taxa found in Richards Creek from triplicate samples from Stations 1, 2 and 3 taken on November 2, 2015.

Based on the Pacific Streamkeepers Handbook, a site assessment rating was given for each station out of a maximum rating of 4.00 based on the streams water quality and diversity (Taccogna and Munro 1995). Table 4 shows the invertebrate taxa found and site assessment results. Station 1 had the lowest site assessment rating; it was assessed as a 2.25 reflecting a “marginal” site and had an invertebrate density of 155/m<sup>2</sup> (Figure 1). Station 2 was 3.00 “acceptable” and had a density of 188/m<sup>2</sup> and Station 3 had the best site assessment rating assessed at 3.50 suggesting the site was “acceptable” to “good” and an invertebrate density of 419/m<sup>2</sup>. Invertebrate Survey Field Data Sheets can be found in Appendix II.

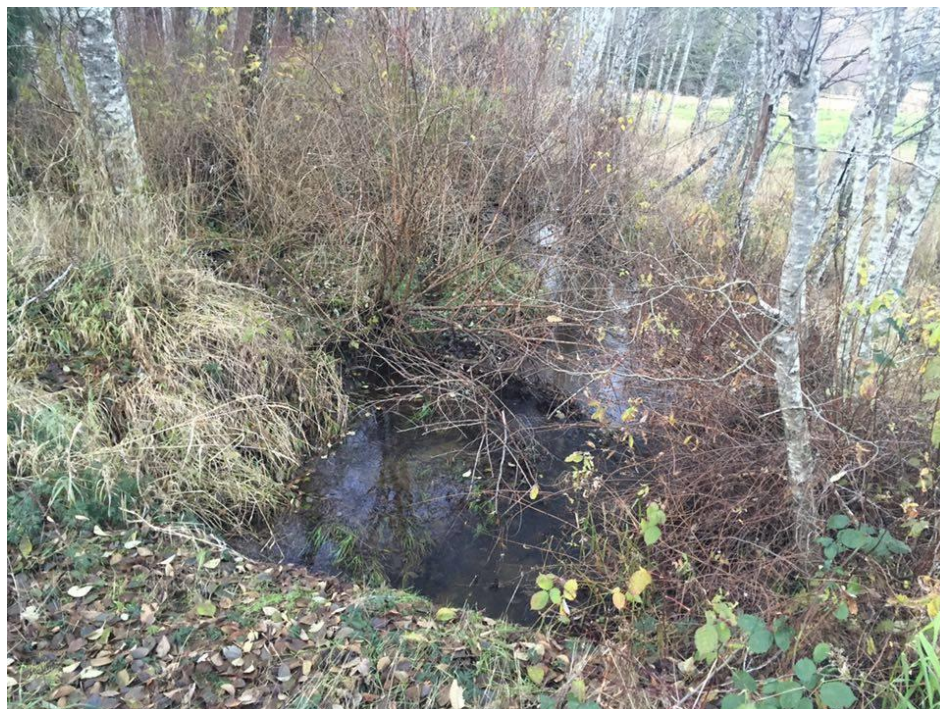
Station 1 was located on Escarpment Way, near Osborne Bay Road (Appendix I, Figure 2). The site was at the first bridge on this road, approximately 130 m from Osborne Bay Road. The site was overgrown with evergreens and thick brush of various species. The stream substrate consisted of cobble, with few large rocks dispersed throughout. The sampling site was shallow and had fast-moving water. There was residential housing near the creek and one agricultural field.

Figure 2. Site conditions at sampling station 1 on Richards Creek at the Escarpment Way crossing (Heidi Richardson).

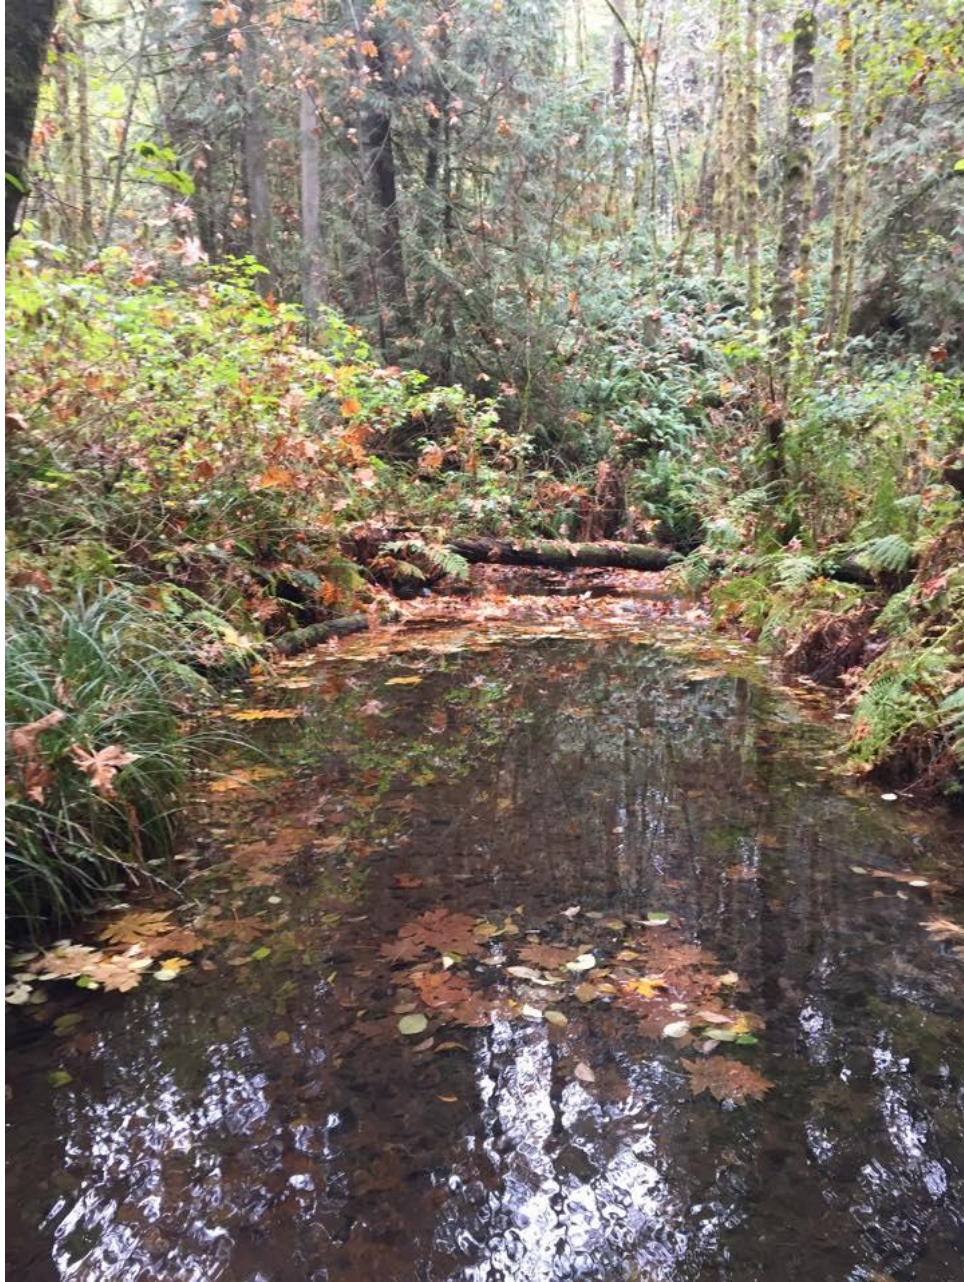
Station 2 was located at the end of Rice Road (Appendix I, Figure 3). A 25 m path on the left-hand side of a cul-de-sac was used to access the creek. The substrate of the creek consisted of large boulders, cobbles, and large woody debris. This station was in a gully, not near an agriculture field, and had a relatively large riparian buffer.

Figure 3. Site conditions at sampling station 2 off of Rice Road (Heidi Richardson).

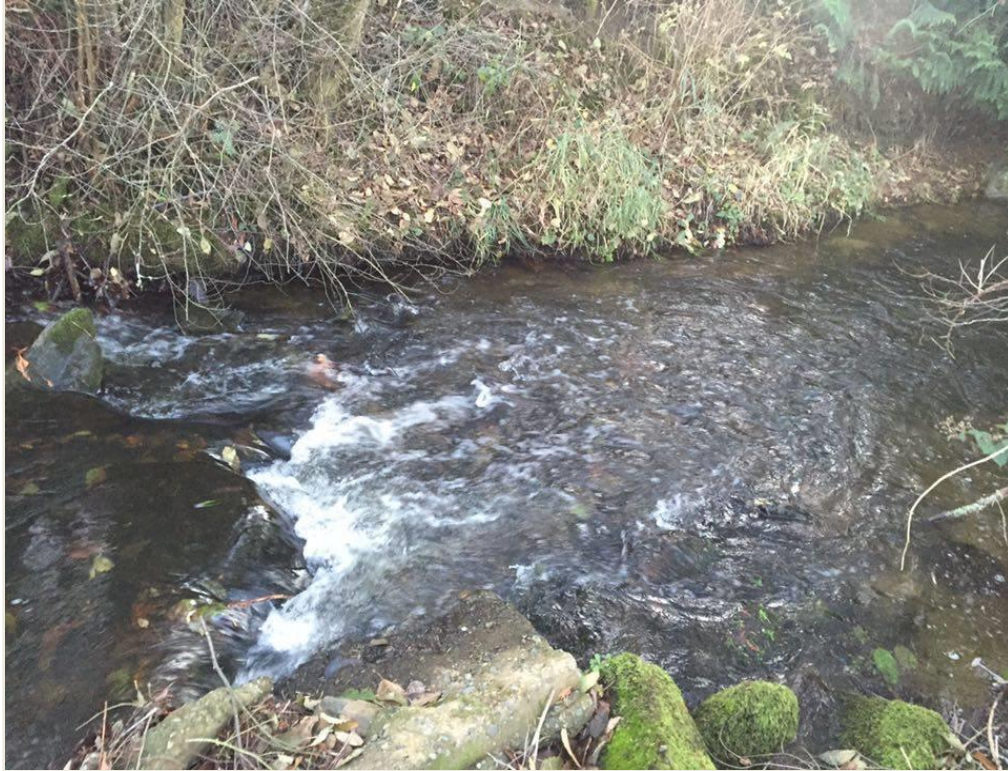
Station 3 was located at the bridge crossing of Richards Trail (Appendix I, Figure 4). For easier access, the station was located on the west side of the bridge. The substrate of the creek consisted of large cobbles but also had old cement slabs near the culvert/bridge from roadwork or farmers. Agriculture fields surrounded this station as well as a single tree-line of various tree and brush species.

Figure 4. Site conditions at sampling station 3 on Richards Trail Road (Heidi Richardson).

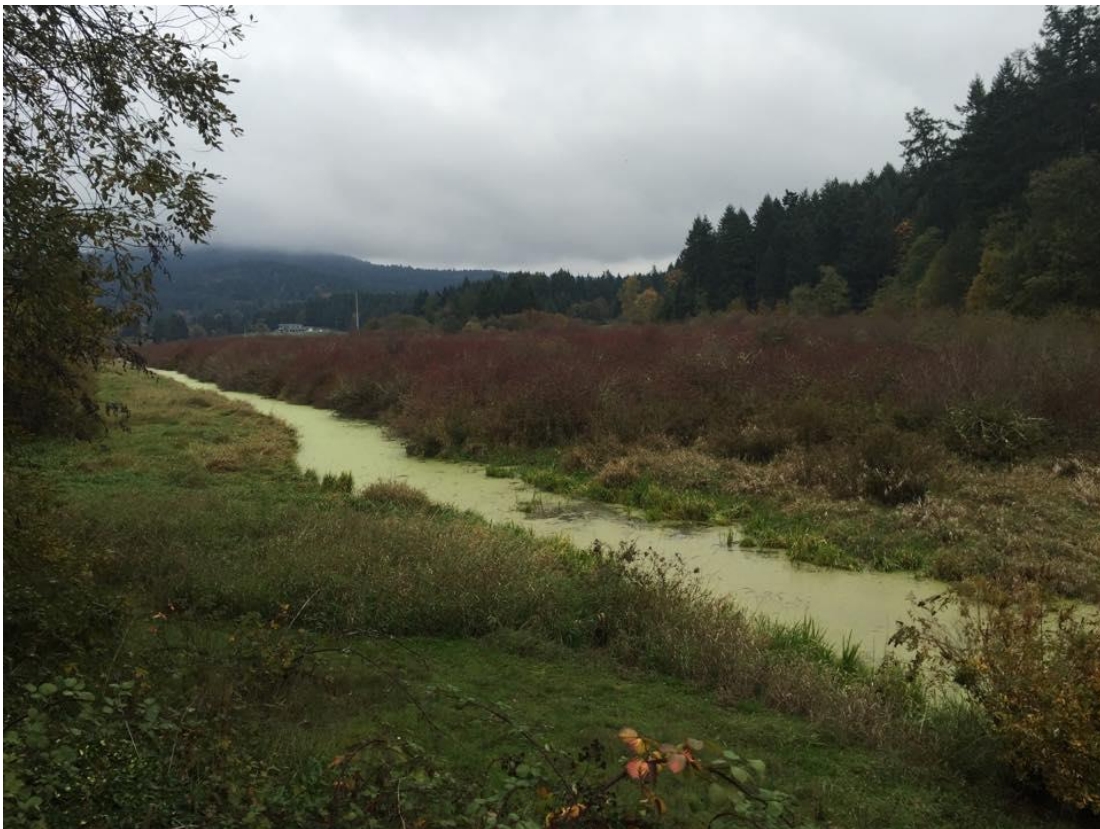
Station 4 was located at the bridge crossing on Herd Road, near Coastal Animal Services (Appendix I, Figure 5). The station was located on the west side under the bridge. There was a cleared gravel area under the bridge and the water was deep with a low gradient. The substrate

consisted of small cobbles. This site area was at the end of agriculture fields, had a relatively small riparian area, and duckweed was present during the first sampling event.

Figure 5. Site conditions at sampling station 4 on Herd Road (Heidi Richardson).
