S'amunu | Somenos Watershed
2020 Annual Water Quality Report

Somenos Marsh Wildlife Society
somenosmarsh.com

January 2021

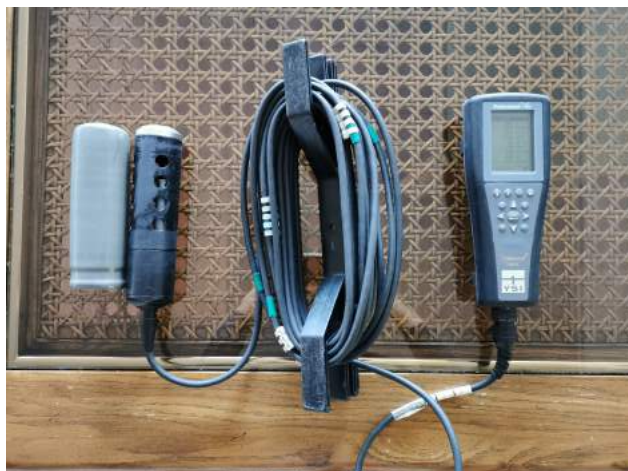
The YSI unit used to collect physical water characteristics is calibrated on a monthly basis to address potential drifts in data reading. Dissolved Oxygen, pH, conductivity and temperature probes quality are verified and calibrated. A record of maintenance, calibration dates and results are kept on file for long term equipment maintenance.

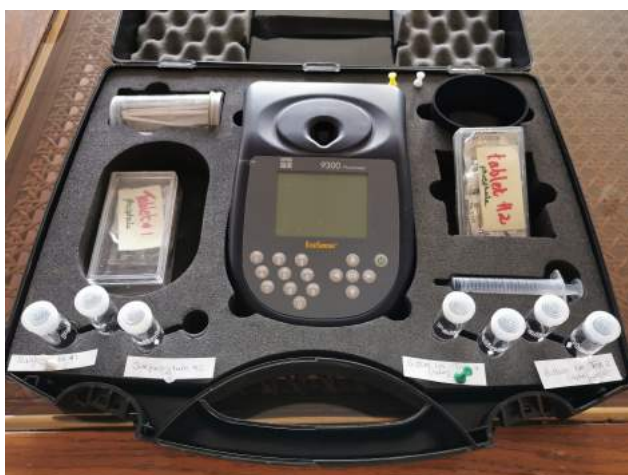
The YSI 9300 photometer is designed to ease calibration requirement. This device is pre-program to calibrate each test parameter. This photometer is built to sustain indoor and outdoor uses. Maintenance involves cleaning the device and drying the test tubes according to the manufacturer's instructions, after each use in the field. The carrying case is kept clean and dry after each session in the field.

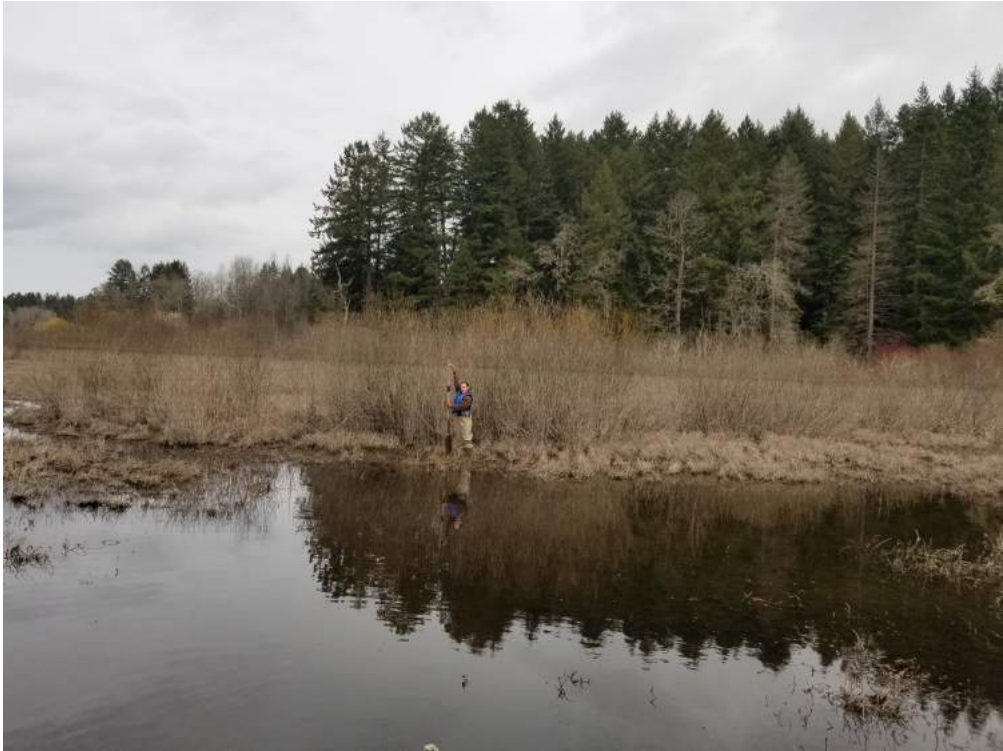
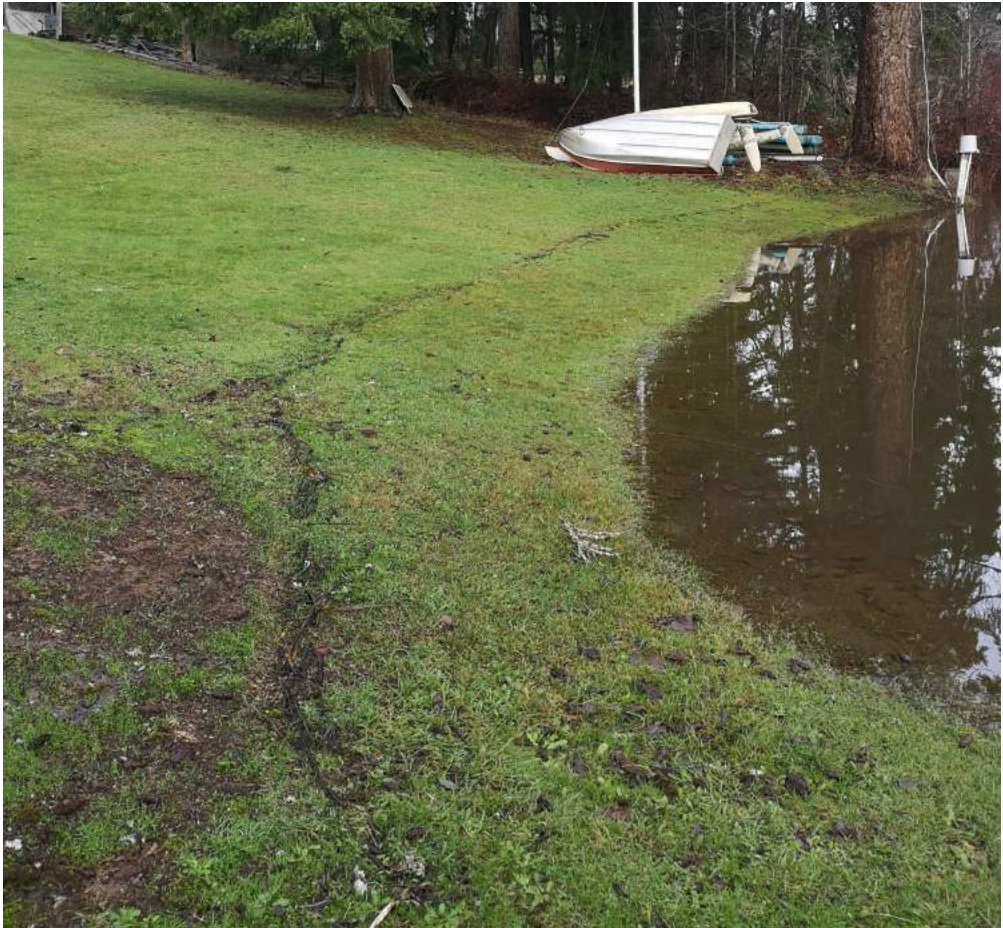
Turbidity measures the extent to which water loses its transparency due to suspended particles. On February 1st, 2020, the Cowichan Valley experienced unprecedented flooding, at which point a state of emergency was declared by the Cowichan Valley District (CVRD, 2020). This event was followed with an increase in turbidity in Somenos Creek, which usually remains consistently low (between 5-15 NTU) throughout the year. Somenos Creek returned to its average turbidity level within days after the event (Figure 2)

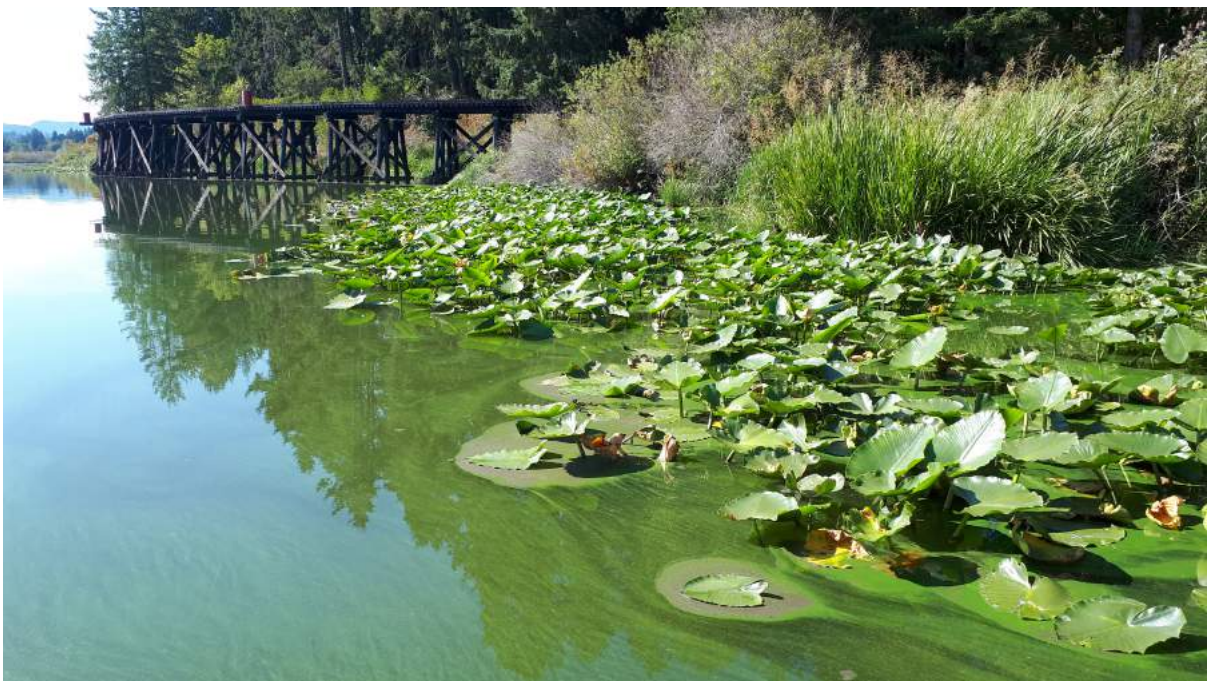
Figure 2: Somenos Creek turbidity measured weekly at the footbridge (Lakes Rd, Duncan), in 2019 and 2020 by Mr. Smith, citizen-scientist.

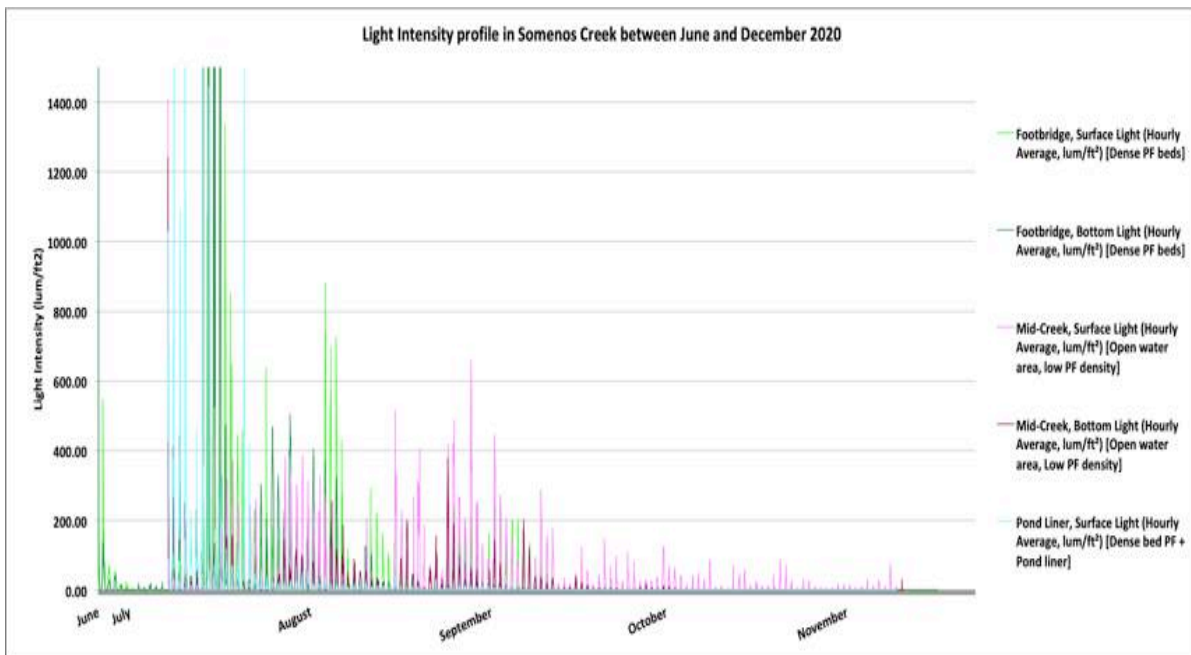
Figure 3: Light intensity in Somenos Creek between June and December 2020: Surface and bottom light intensity at three stations on Somenos Creek.

In addition to turbidity readings, water clarity in Somenos Creek was greatly inhibited due to the presence of dense mats of *Myriophyllum aquaticum*, an invasive species also known as Parrot's Feather introduced in Somenos Creek in 2015. Water clarity was compromised between June and September, ie outside of the Fish migration window observed for Coho and Chum salmon (Figure 3)

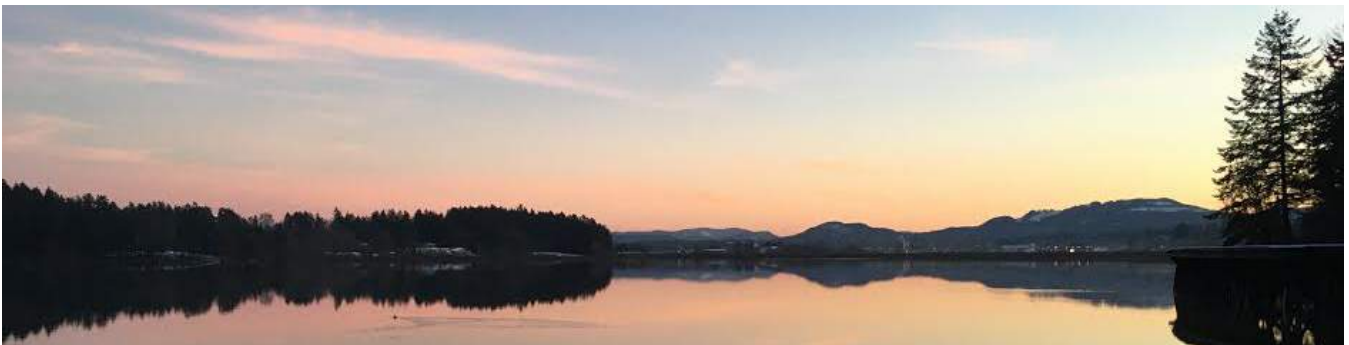
Figure 4: Surface temperature profiles for Somenos Lake and Somenos Creek, 2020. Data collected under the guidelines of the Society’s citizen-science program

Figure 4 compares Somenos Lake and Somenos Creek water temperature at comparable depth and identifies lethal water temperature for four months of the year in Somenos Lake. Maximum temperature in Somenos Lake reached 25.1 degrees at the surface and 19 C at the bottom of the Lake. Minimum temperature observed occurred on January 22 with 3.2 C at the surface and 3.3 C at the bottom.

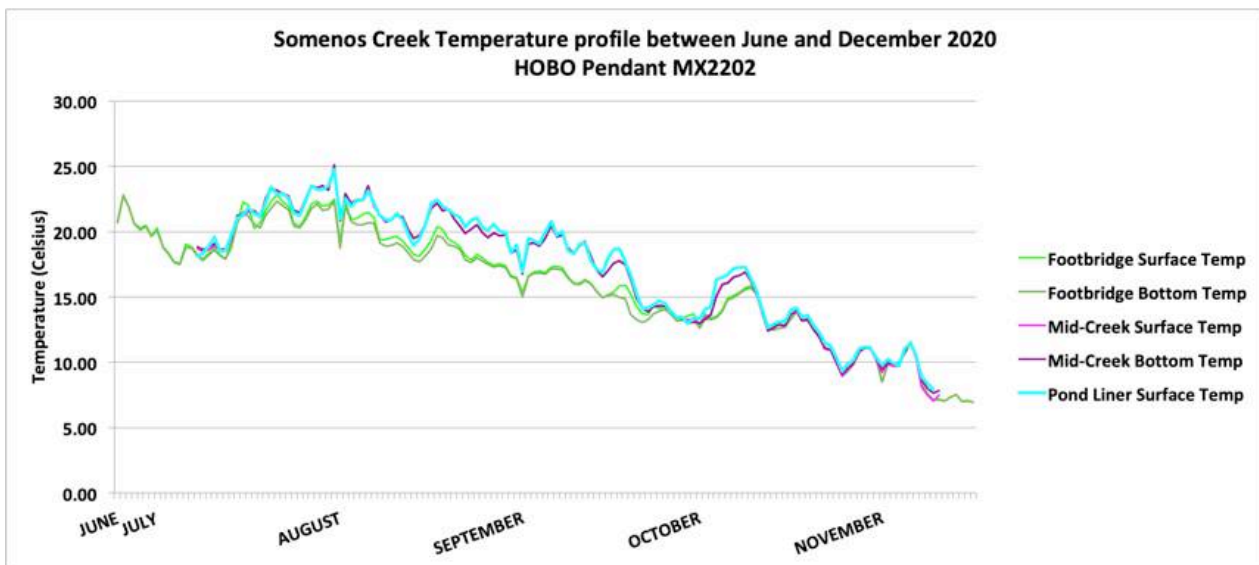
Figure 5: Water Temperature in Somenos Lake recorded at three stations using HOBO Pendant MX2202, 2020.

Figure 5 shows temperatures recorded by permanently installed data loggers in Somenos Creek. Bottom and surface temperatures at Station 1 appear almost identical as water level decreases considerably during the summer. Station 2, mid-creek, shows no significant temperature difference between surface and bottom temperatures. Station 3, upstream, was equipped with surface temperature data loggers only, which appear significantly warmer than other stations. This is explained by the fact the pond liner is a black thick sheet of liner, which increased water temperature in its vicinity.

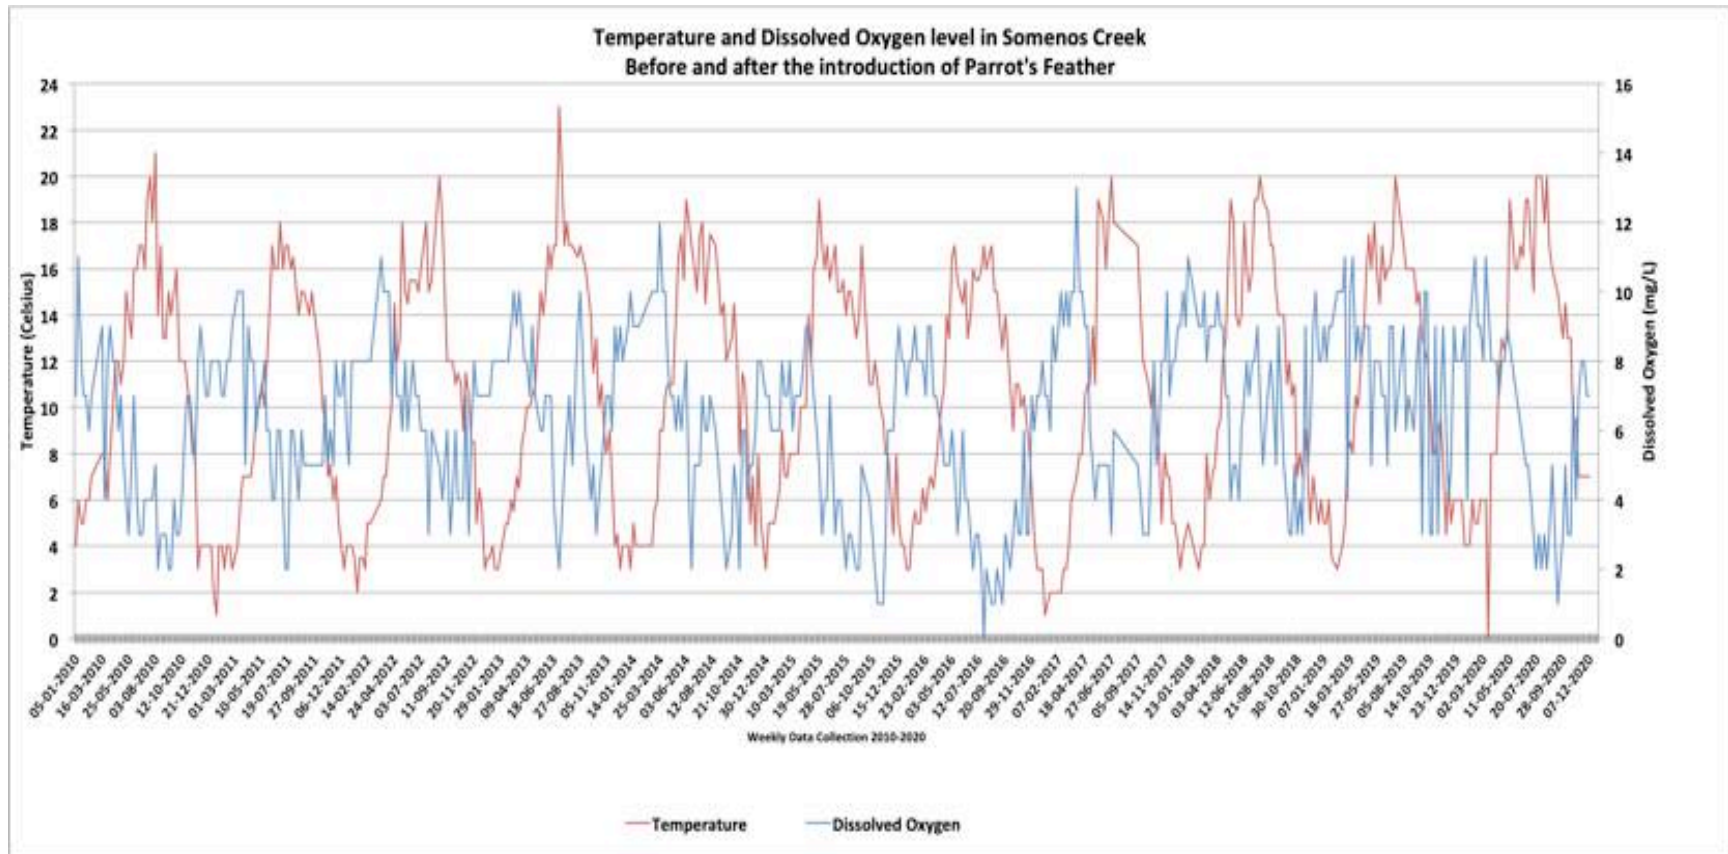
Figure 6: Temperature and dissolved oxygen concentrations in Somenos Creek between 2010 and 2020.

Dissolved oxygen levels in Somenos Lake (Figure 6, 7) were lower in the summer and recovered to higher levels in the fall with a lake turn-over occurring on October 8th 2020:
