**Investigation of Anomalous Hydrology in Somenos Creek
and an Assessment of Effects From Beaver Dams Near the
Confluence with the Cowichan River.**

Somenos Rapid Science Communication 2018-01

Dave Preikshot, PhD, RPBio
Somenos Marsh Wildlife Society
and
Tim Kulchyski
Cowichan Tribes

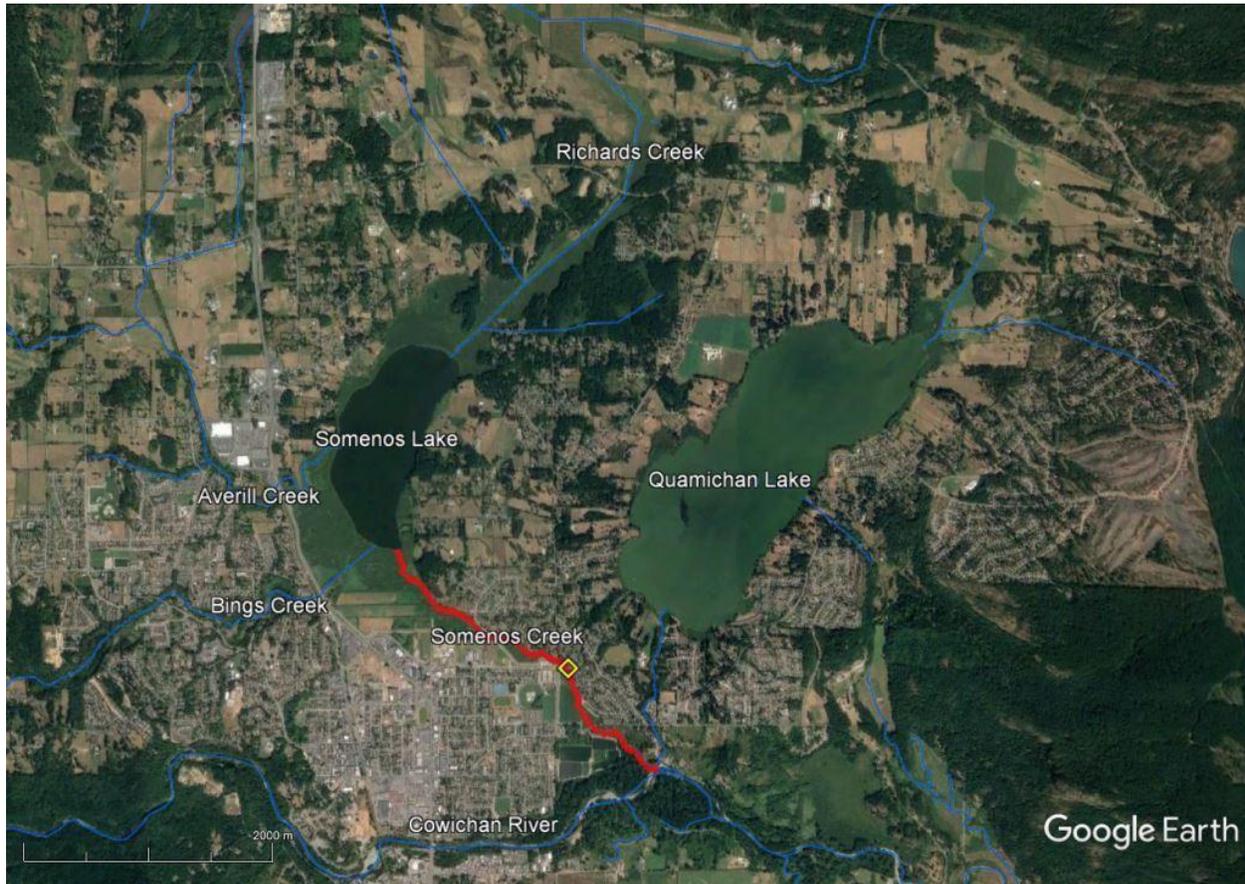
Figure 1: Somenos Creek, red line, with connected lakes and streams in the lower Cowichan River area. The Lakes Road foot bridge is marked by the yellow diamond.

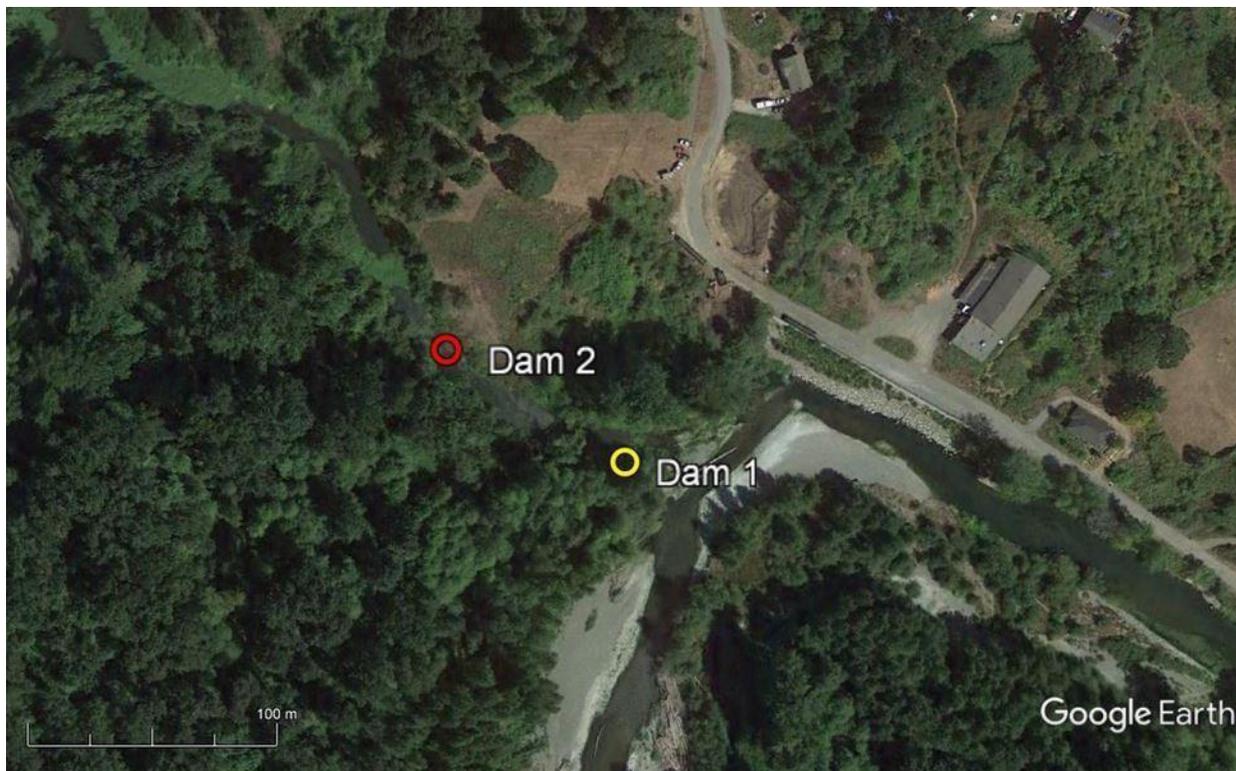
The first dam is near the mouth of the creek at the Cowichan River, while the second was approximately 100m upstream, Figure 2. We observed water to be moving over spillways, i.e., flowing downstream, at both dams. Because the discharge at the dams is similar in magnitude to that associated with the creek without beaver activity, it is our opinion that the dam is not impeding the passage of water or interfering with biological processes in Somenos Creek.

Figure 2: Lower Somenos Creek at the confluence with the Cowichan River.

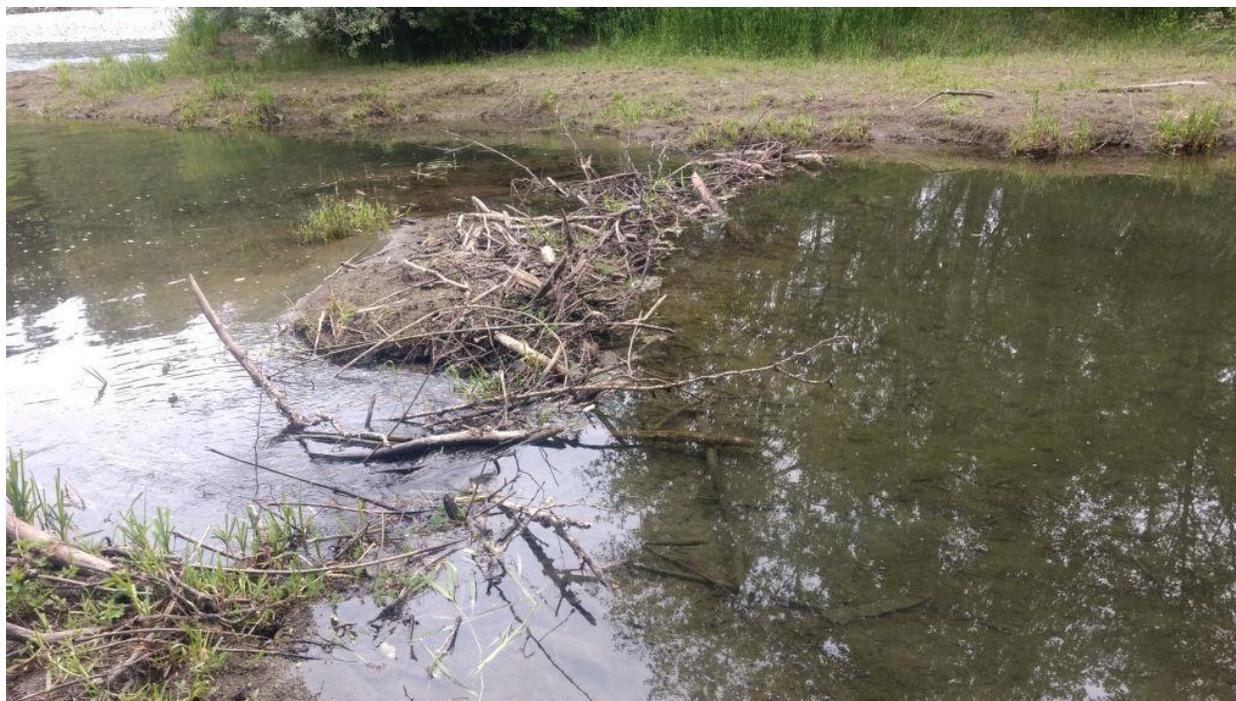
The first Beaver dam is approximately 10m upstream of the confluence of Somenos Creek and the Cowichan River. This dam appears to be an opportunistic structure in which the Beavers have added sticks and other material around a mid-channel sand and gravel bar, Figure 3. These gravel bars are common on the Cowichan River and occur regularly near the mouth of Somenos Creek. The photograph in Figure 3 shows one such bar in summer 2017. Historical imagery in Google Earth shows similar gravel bars at the mouth of Somenos Creek in the summers of 2016, 2015, 2013, and 2012. Such bars were not observed in pre-2012 imagery but it should be noted that the photo record becomes sparser before 2012. The water depth appeared to be between 1 and 1.5m for much of the reach between dams 1 and 2. The water surface elevation difference between the downstream and upstream sides is no more than 50mm. The pool created by dam 1 was observed to hold several dozen juvenile trout and salmon. The water upstream of dam 1 was significantly less turbid than water observed in other parts of Somenos Creek that day, e.g., at the Lakes Road foot bridge, at Tzouhalem Road, and upstream of dam 2.

Figure 3: Photograph of Beaver Dam 1 near the confluence of Somenos Creek and the Cowichan River. Water can be seen flowing over the spillway at the eastern portion of the dam towards the bottom left of the picture. The Cowichan River can be seen at the upper left corner.

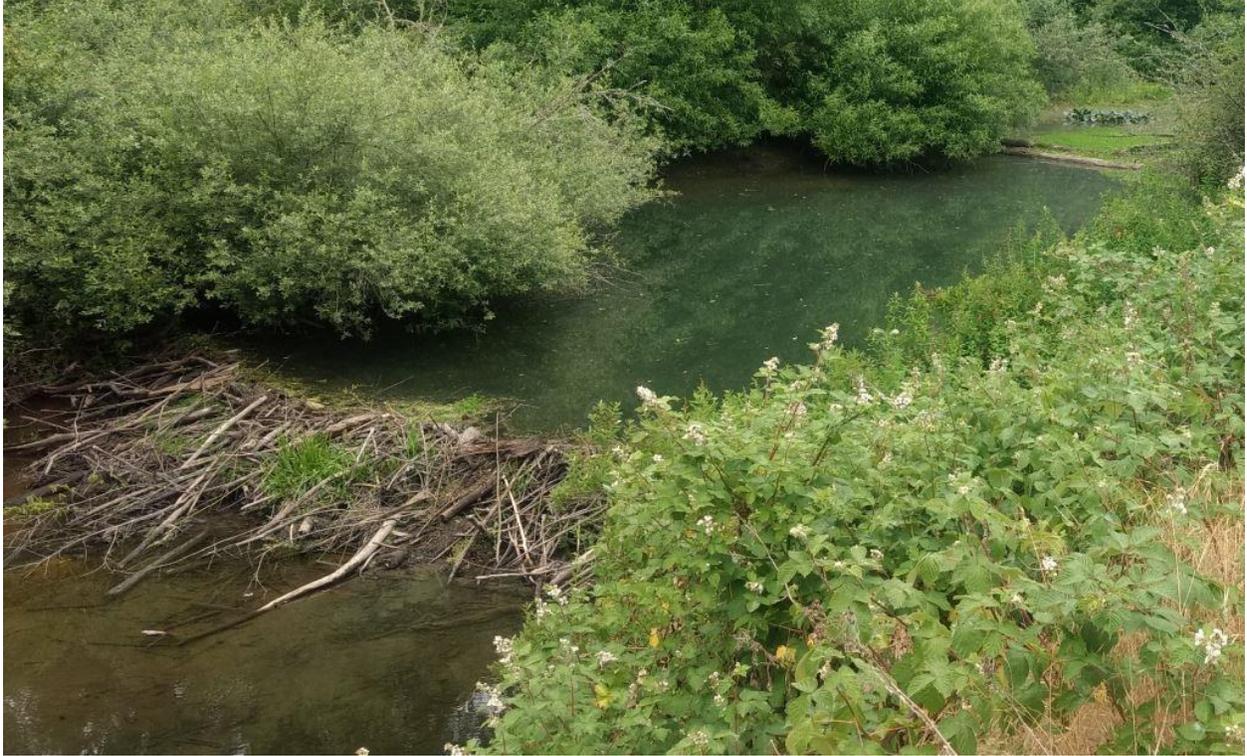
The Second Beaver dam is approximately 100m upstream of the confluence of Somenos Creek and the Cowichan River. Dam 2 is much more robust and is entirely constructed from sticks between 0.5 and 1m long, Figure 4. Dam 2 is constructed in a small ravine in which the creek channel narrows to a width of about 5m. The water surface elevation difference between downstream and upstream sides of dam 2 was estimated to be 500mm. Water was seen to be running over a spillway on the eastern side of dam 2.

An interesting observation was that dam 2 appears to be functioning as a barrier to the downstream movement of Parrot's Feather. Significant patches of Parrot's Feather were observed upstream of dam 2. We also observed fragments of Parrot's Feather accreting on the upstream side of dam 2.

Figure 4: Photograph of Beaver Dam 2 100m above the confluence of Somenos Creek and the Cowichan River. Water is flowing over the unseen spillway at the eastern shore of the creek. A mat of Parrot's Feather can be seen accumulating as the light green material on the upstream side of the dam near its center.

Because one method of Parrot's Feather spread is colonisation by fragments it may be unwise to remove the Beaver Dams as these appear to be preventing the downstream movement of Parrot's Feather fragments, see Figure 4. If Parrot's Feather were to move into the lower Cowichan River it is not difficult to imagine it being spread to back channels and side channels there and compromising salmon and trout habitat in the main stem. During periods of low discharge between July and September there could be a real threat of Parrot's Feather in the lower Cowichan River being spread upstream by adhering to aquatic birds, and mammals like Beavers and Muskrats.
