# Bings Creek Watershed Habitat Assessment and Restoration Plan.

December 2020

Prepared by  
D.R. Clough RP Bio  
D.R. Clough Consulting  
6966 Leland Road,  
Lantzville B.C. V0R 2H0  
drclough@shaw.ca

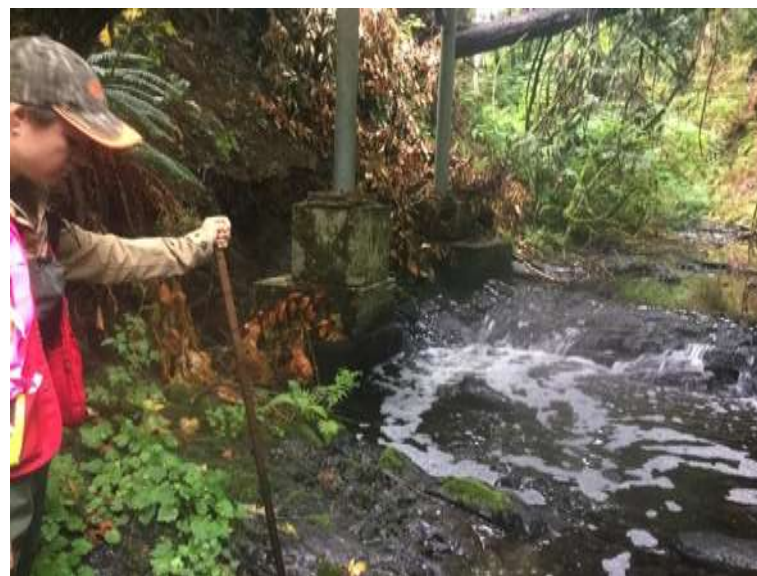
R4 - Driveway Bridge footing erosion. (Site 43)
