# Bings Creek Watershed Habitat Assessment and Restoration Plan.

December 2020

Prepared by  
D.R. Clough RP Bio  
D.R. Clough Consulting  
6966 Leland Road,  
Lantzville B.C. V0R 2H0  
drclough@shaw.ca

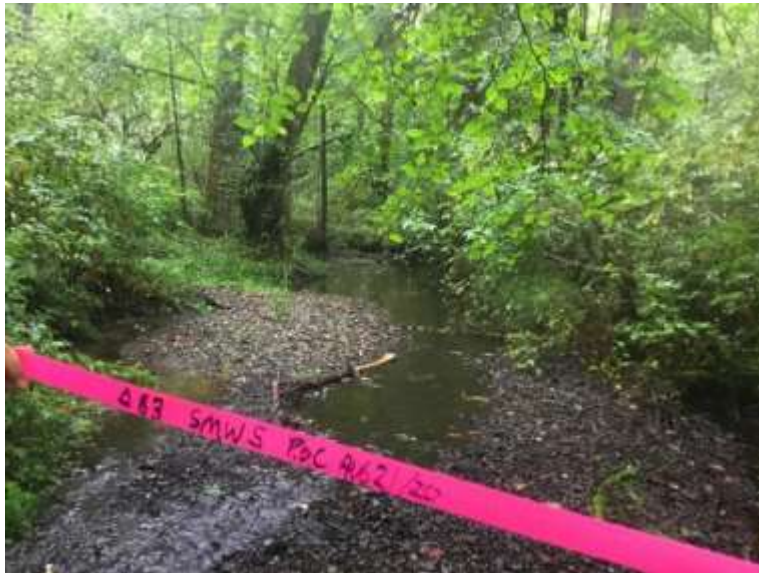
1.) R6 . First riffle at Site 83, lots of gravel.

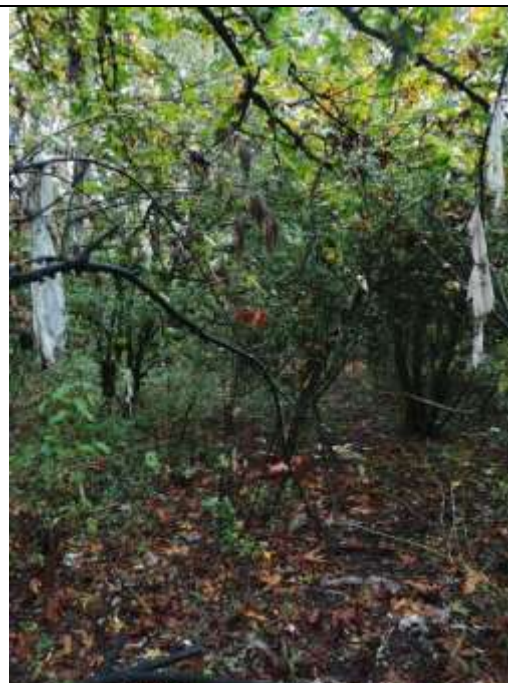
R7- Near Drinkwater Rd Waste management site

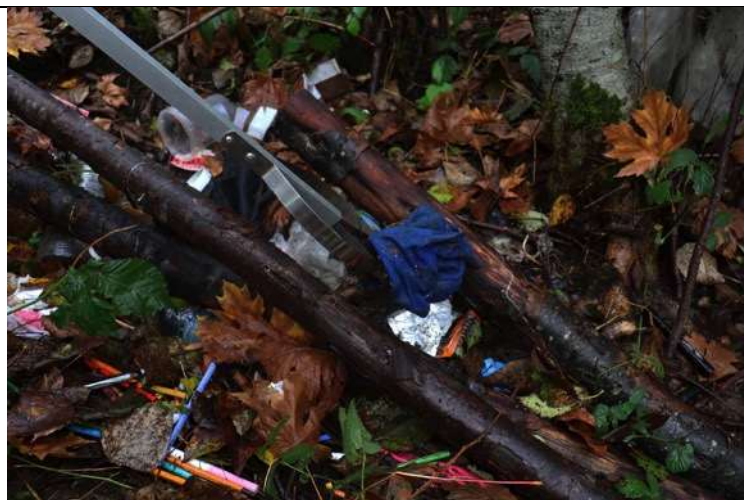
R5 near CV Trail

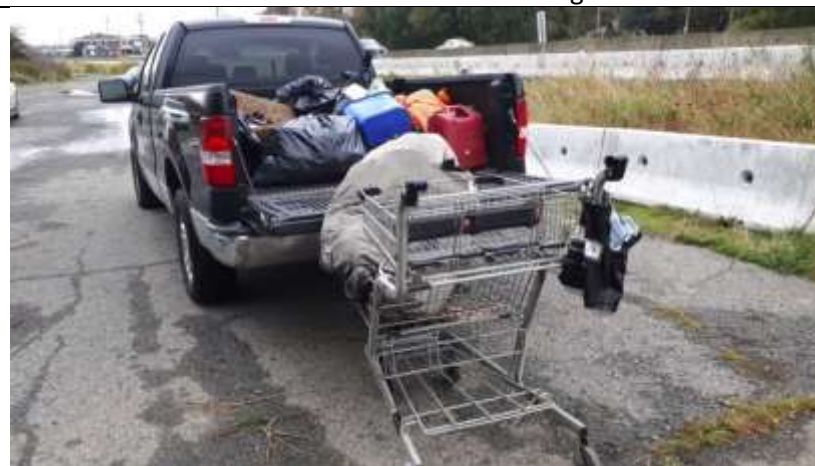
R1- October 20,2020 SMWS Garbage removal results
